Sutton-on-sea

Follow-Up Structural Inspection Report on North Colonnade

For East Lindsey District Council

Project number: 60586167
60586167-ELDC-ACM-REP-0001

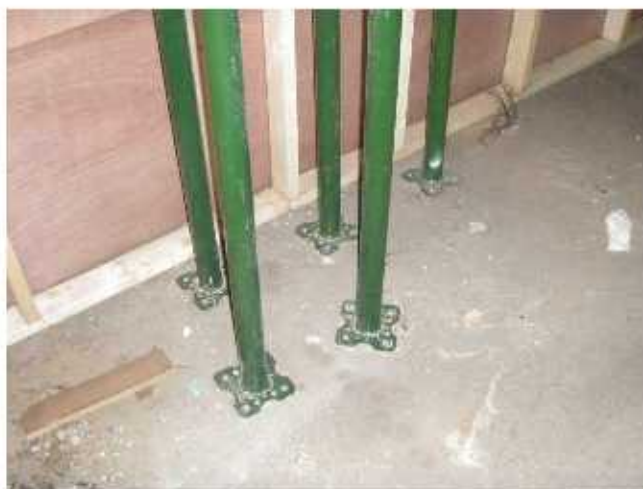
During the inspection the temporary structural props were inspected and found to be secured from unauthorised person interference.

Photo no 2. Temporary props at GL 1H structural joint, secured to floor.

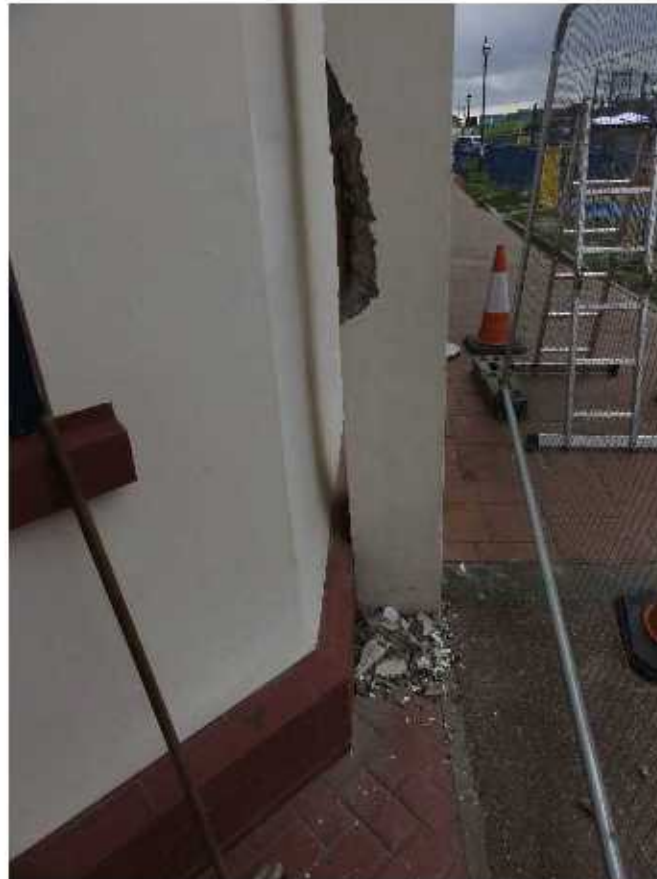
Visual inspection of the rectangular columns on the Northern stair through route showed a localised defects to one corner of column D1 where a previous concrete repair due to carbonation and ferrous rust oxide jacking had been undertaken.

Photo no 3. Column 1E Spalling.

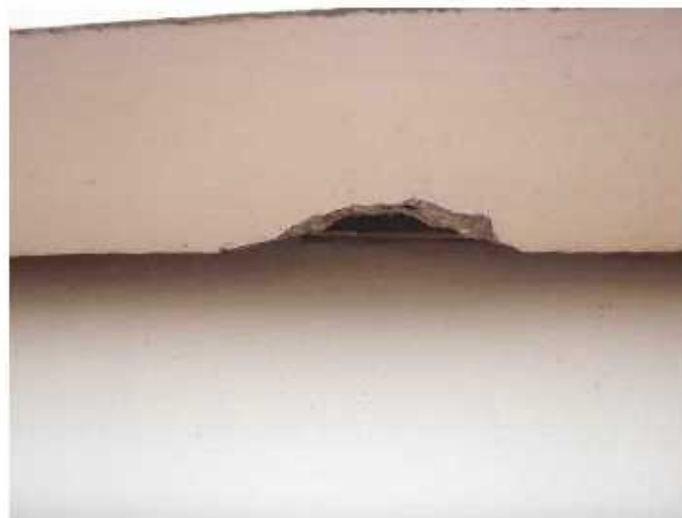
Visually inspection of the arched fascia beam over the front of the café on grid line 1, E-F revealed a small area, of hollow and cracked concrete on the corner of the beam, which was removed as a precautionary measure because it was over the seating area of the café. At the spalled concrete location the reinforcement had suffered some severe rusting but no significant loss of cross section to bar diameter.

Photo no 4. Fascia beam GL 1, F-G (near café) concrete spalling.

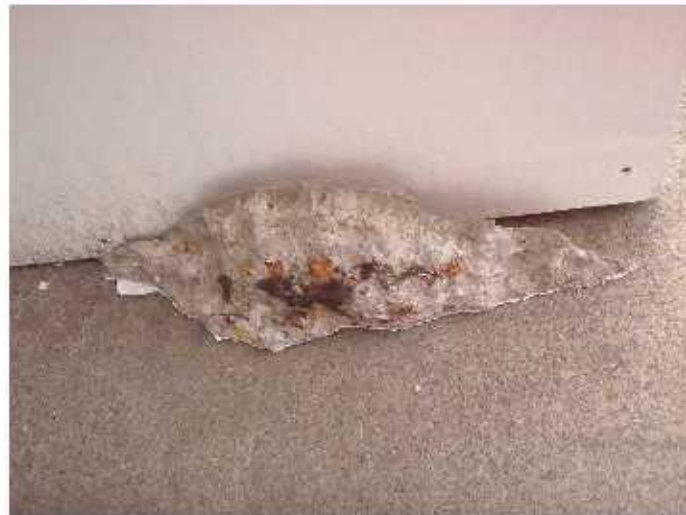
Photo no 5. Close-up of Fascia beam GL 1 F-G concrete spall sample.

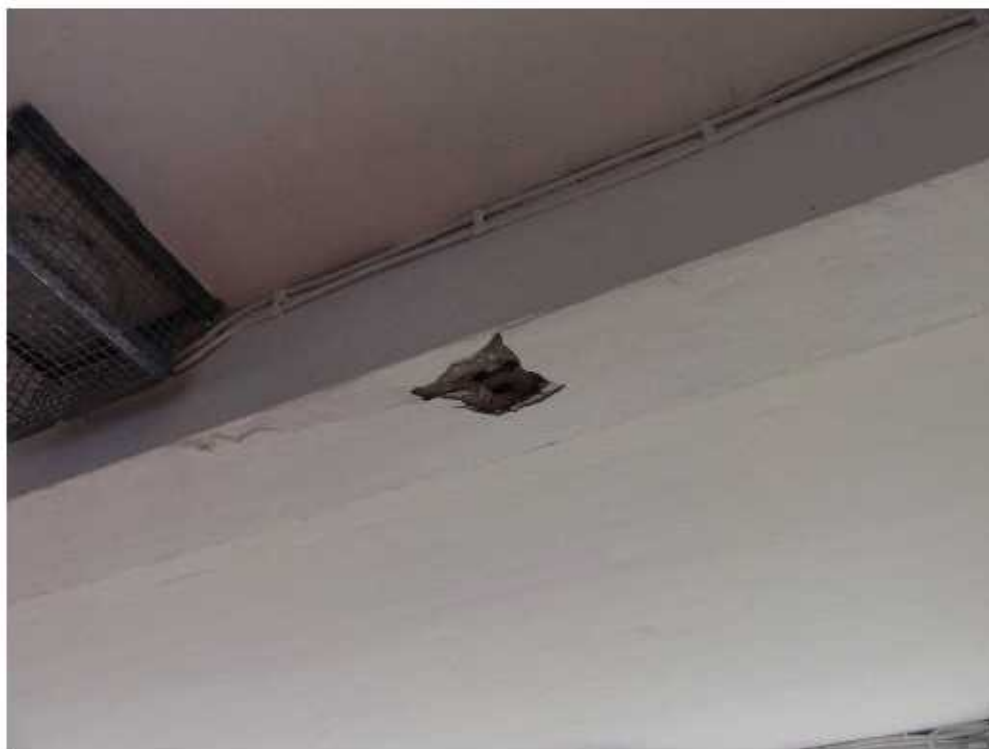
Inspection of the cross beam on GL 2, C-D revealed a small area of hollow concrete on the soffit which when tested further cracked and was removed for safety reasons.

Photo no 6. Cross beam GL 2 C-D concrete spalling.

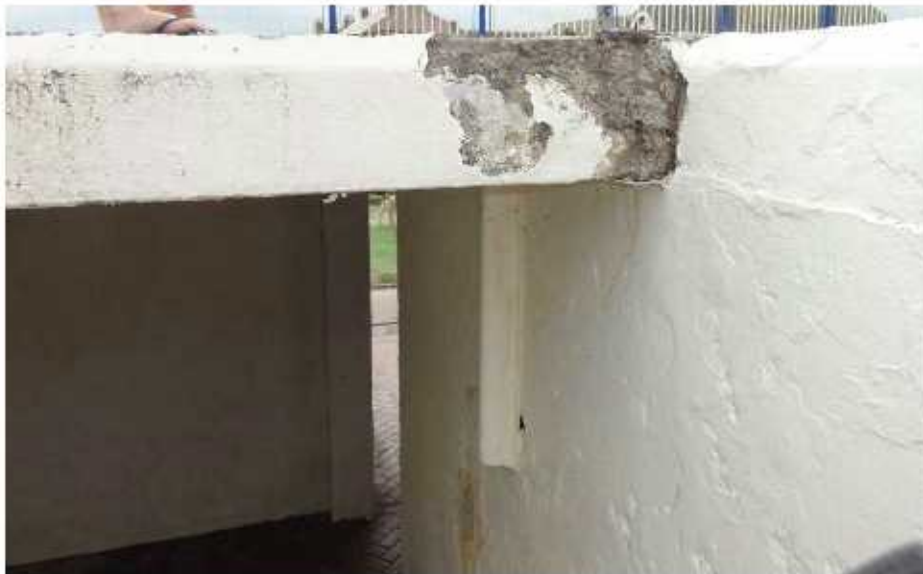
On the edge of the first floor slab spanning across the springing of the North staircase (GL 3, C-D), a small area of concrete was tested as hollow near the base of the balustrade standard, on the North east corner. This small section of concrete cover was removed for obvious safety reasons. The cause of the cracking is considered to be associated with the close location of a balustrade anchor bolt installation, as opposed to reinforcement corrosion.

Photo no 7. Edge of slab over North staircase, concrete spalling near balustrade anchor bolt installation.

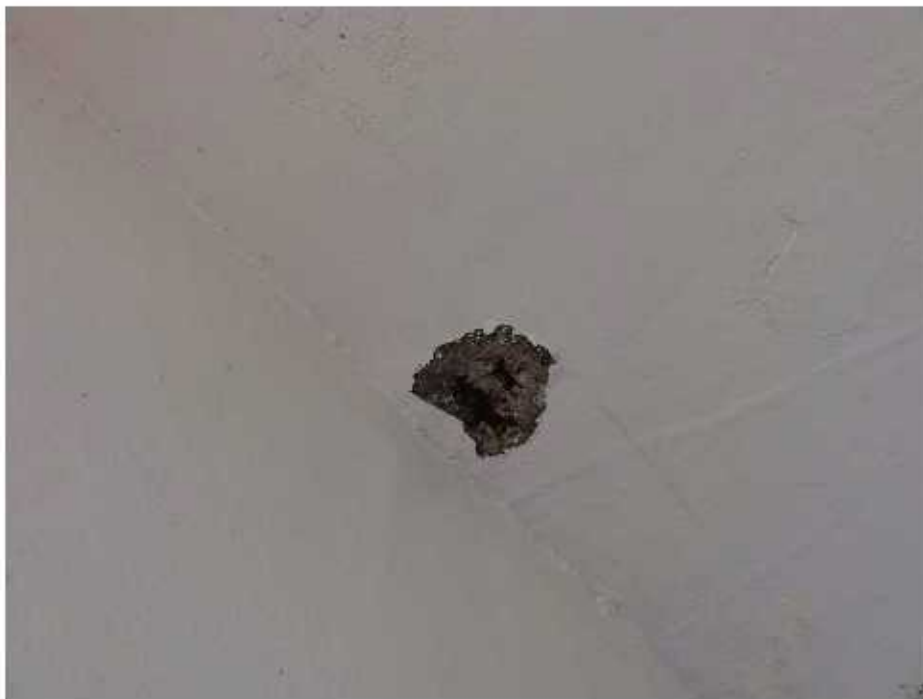
Inspection of the first floor soffit slab between GLs 1-2, C-D, four areas of hollow concrete were detected which on further hammer testing cracked and were removed as a precautionary safety measure. At the spalled concrete locations, the bar reinforcement had suffered some rusting but no significant loss of cross-section to bar diameter.

Photo no 8. Soffit of slab GL C, 1-2, hollow concrete & spalling.

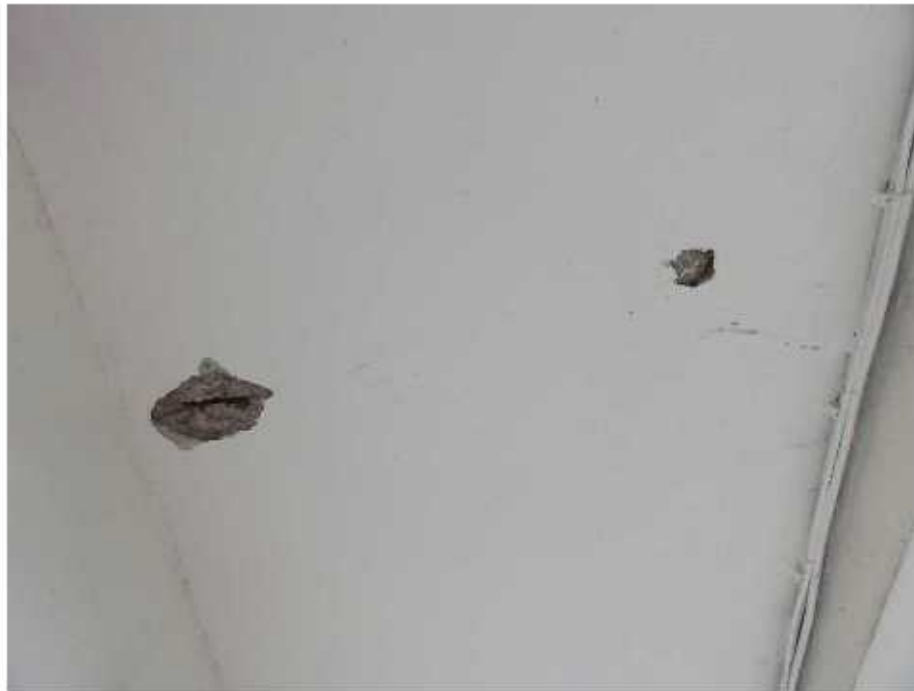
Photo no 9. Soffit of slab GL 1-2, C-D hollow concrete & spalling.

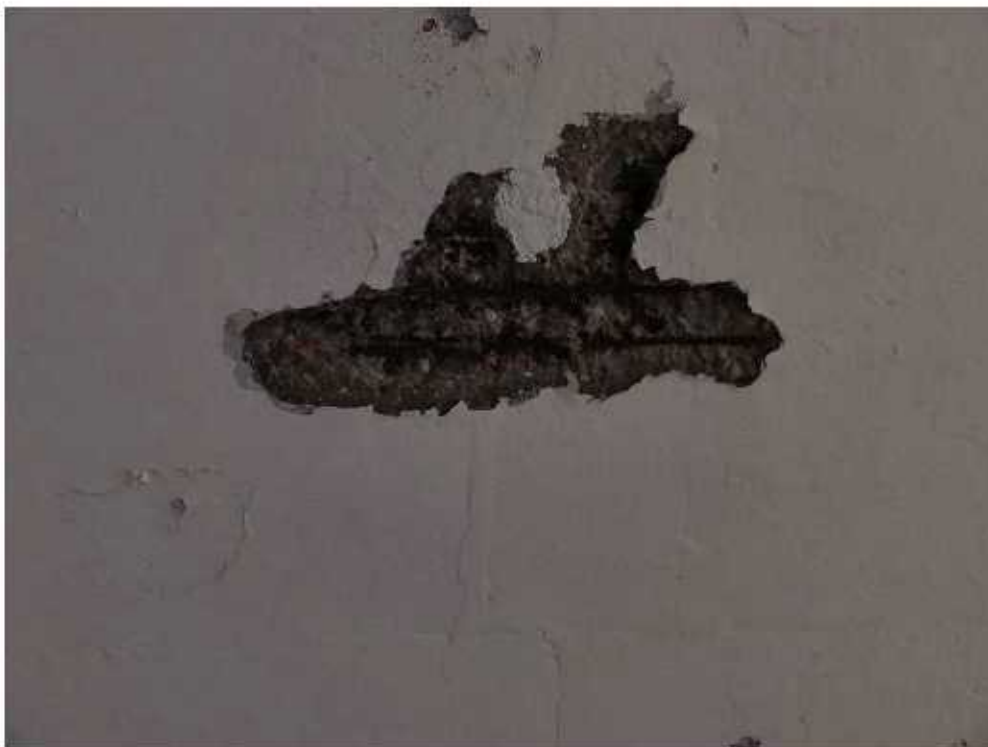
Photo no 10. Soffit of slab GL 1-2, C-D hollow concrete & spalling.

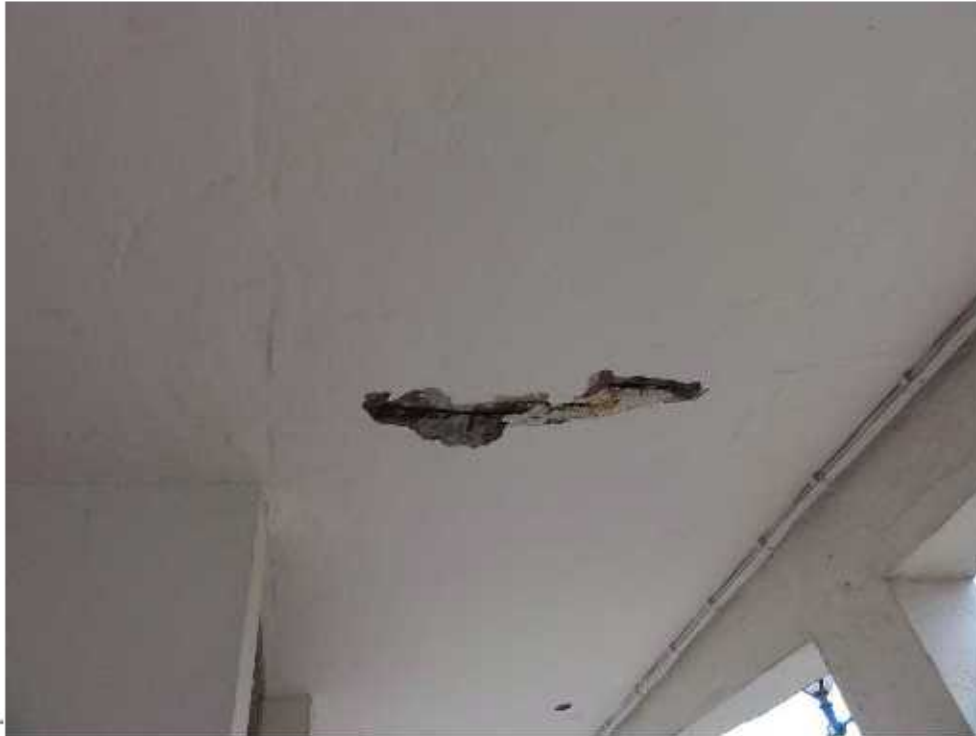
Visual inspection of the first floor soffit slab between GLs 1-2, C, along a previously identified crack and previous concrete repair revealed some hollow concrete which on further investigation cracked and was removed as a precautionary safety measure. This crack appeared to be slightly damp suggesting that the repaired cracks on the upper surface may be starting to deteriorate or retained moisture from earlier leak. At the spalled concrete locations the reinforcement had suffered severe rusting but no significant loss of cross section to bar diameter.

Photo no 11. Soffit of slab at crack GL D, 1-2, concrete crack and spalling.

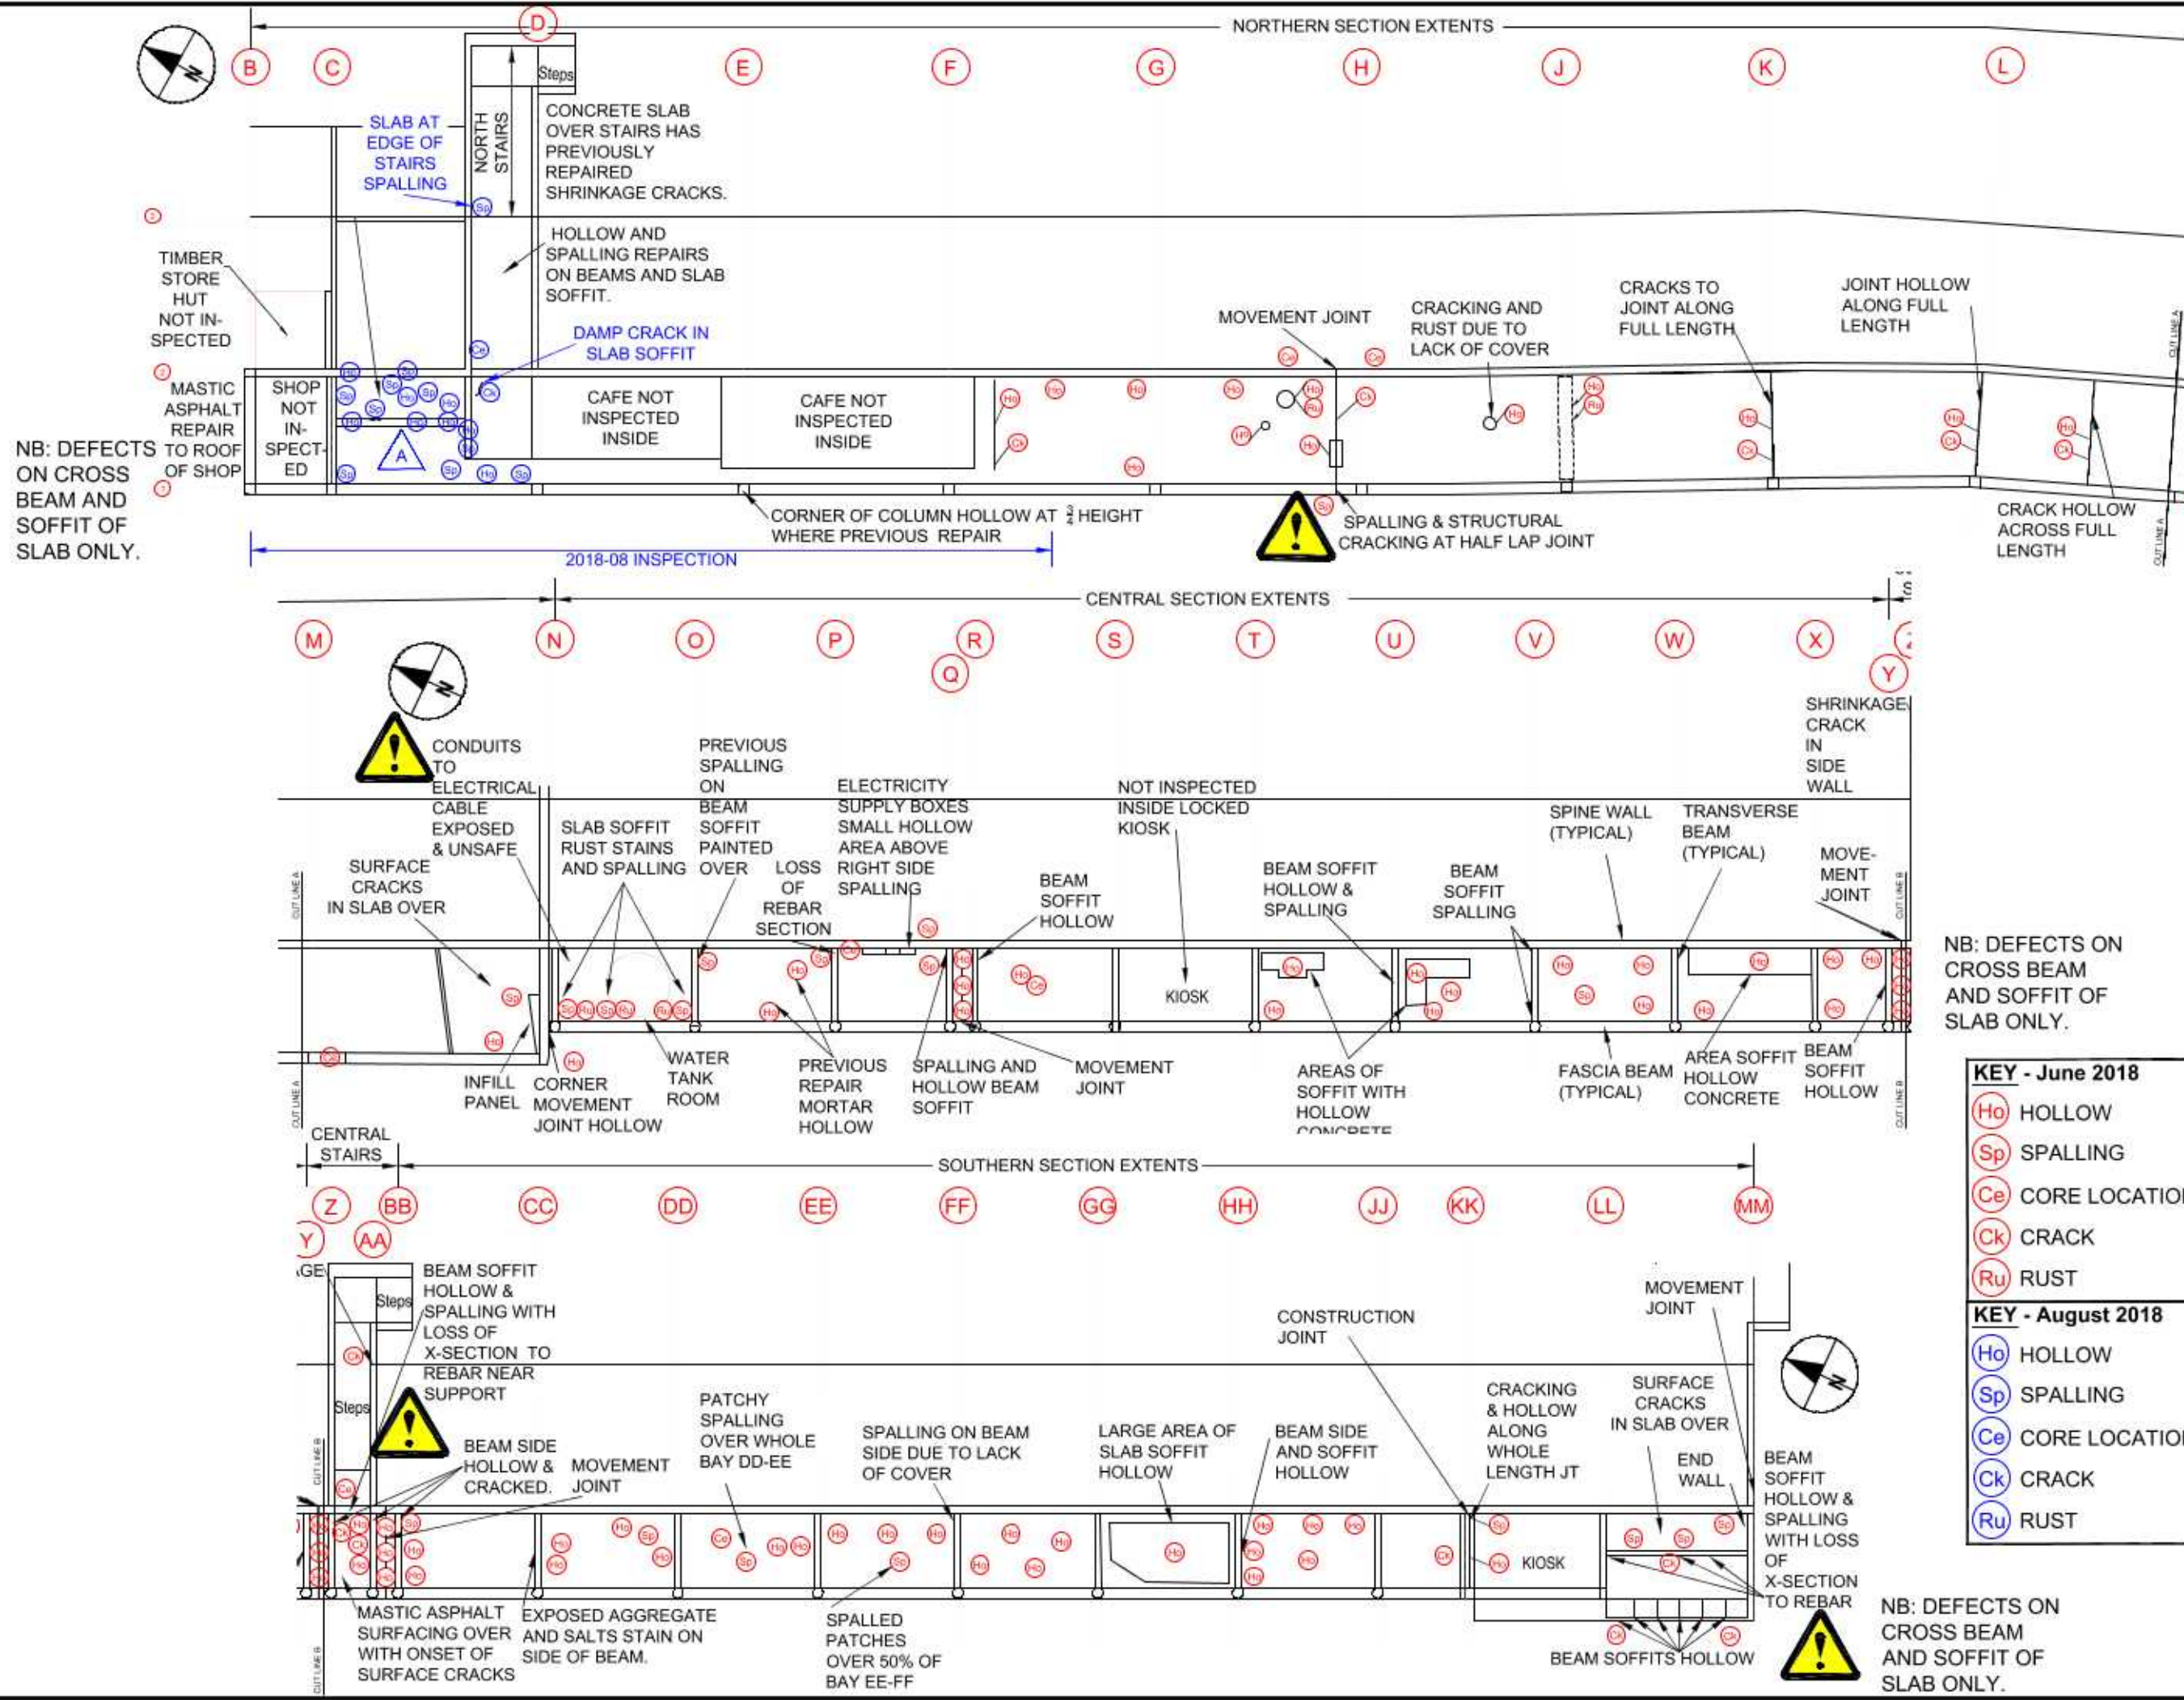
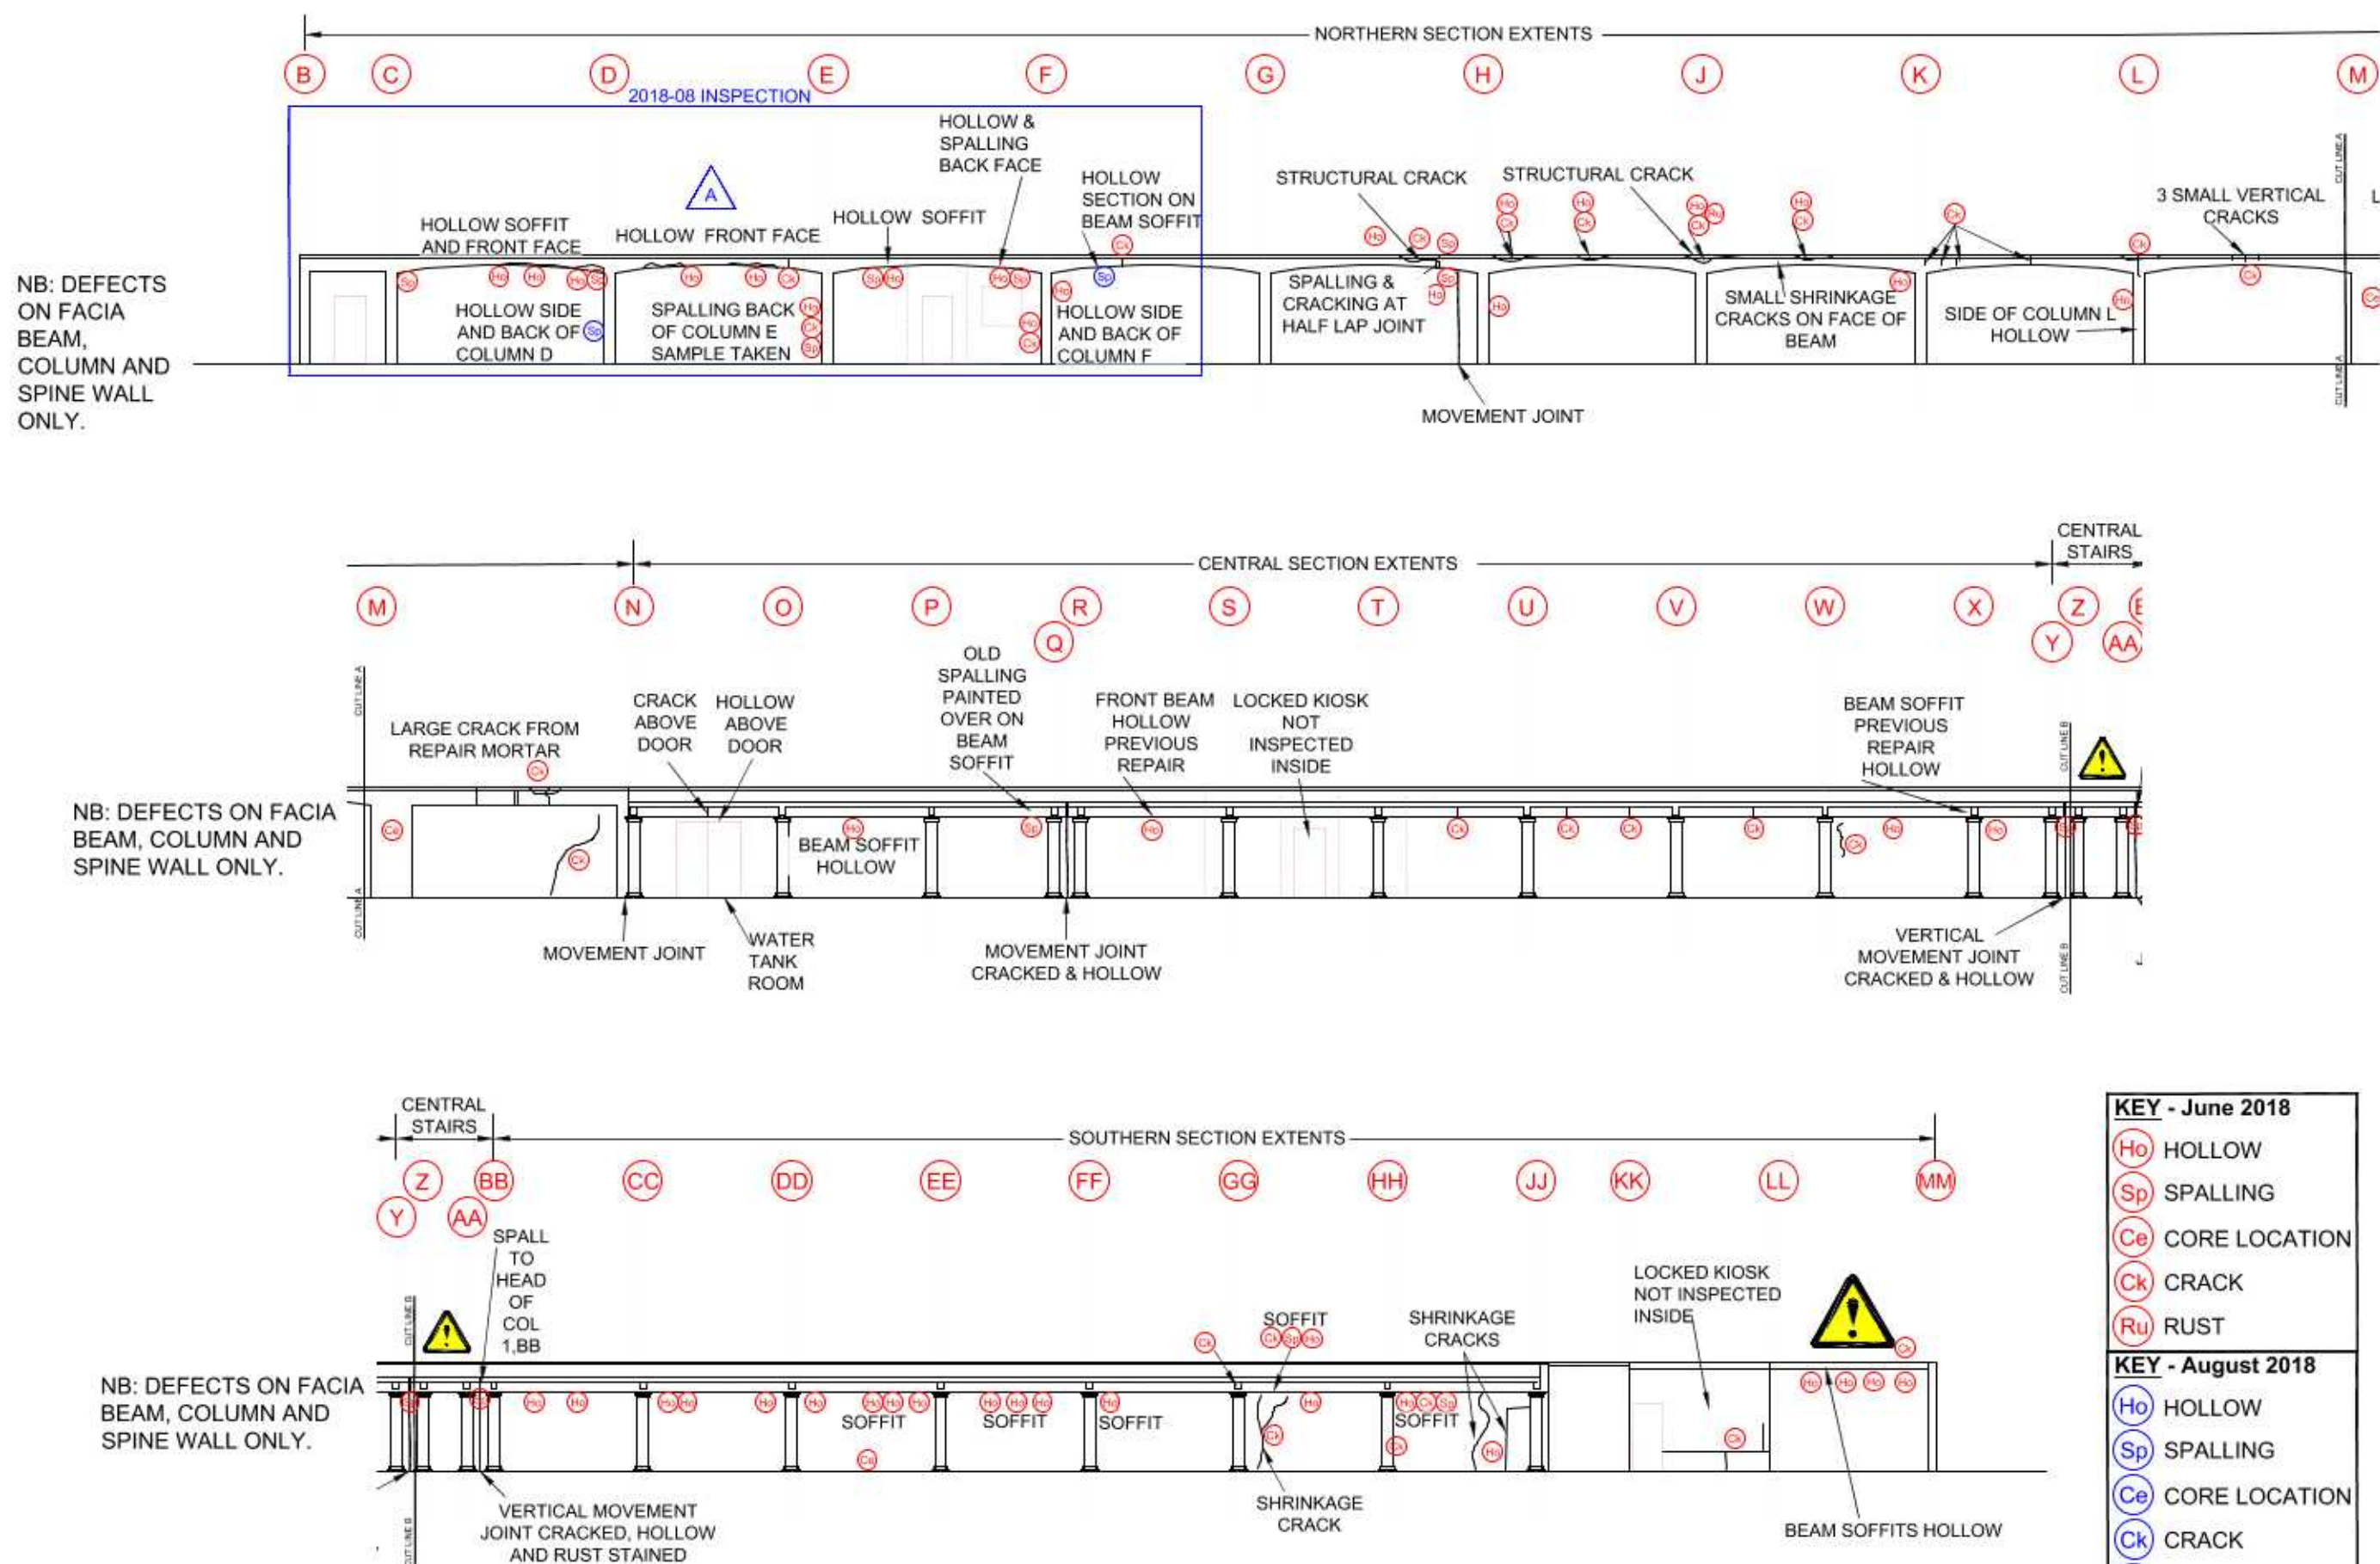
The current visible concrete defects to the structural elements in the concrete structure leading to the North staircase have been added to the defect sketches included in AECOM's earlier Condition Report and a copy included in Appendix B.
