Sutton-on-sea

# Follow-Up Structural Inspection Report 02 on North Colonnade

For East Lindsey District Council

Project number: 60586167  
60586167-ELDC-ACM-REP-0002-P2

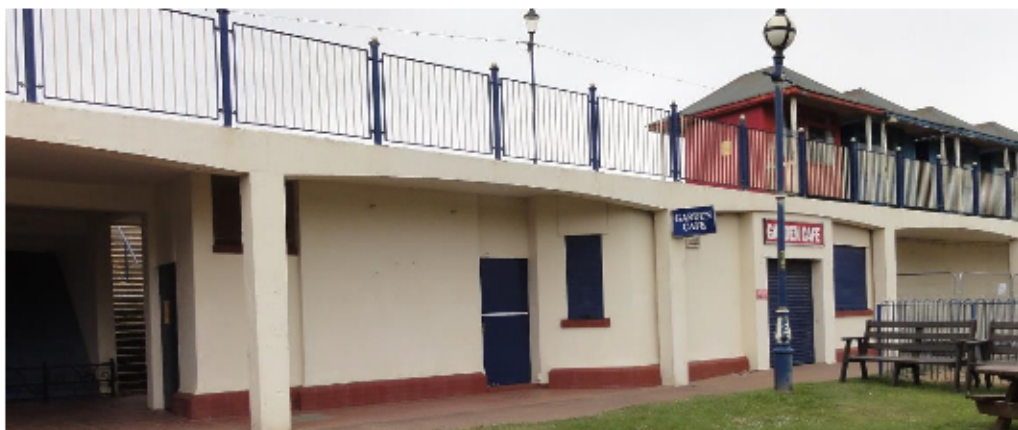
Photo no 01: North West Elevation of Colonnade

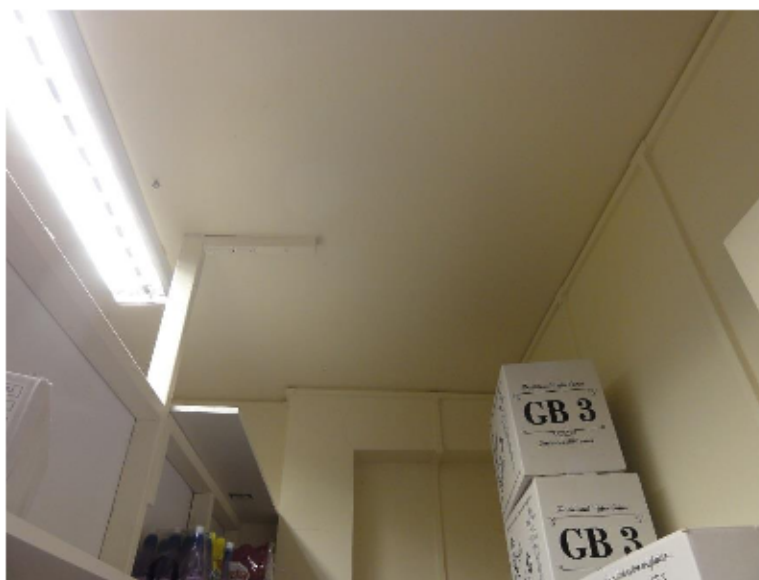
Photo no 2. Ice cream kiosk showing plasterboard ceiling, prior to exposure (near GLs C, 1-2).

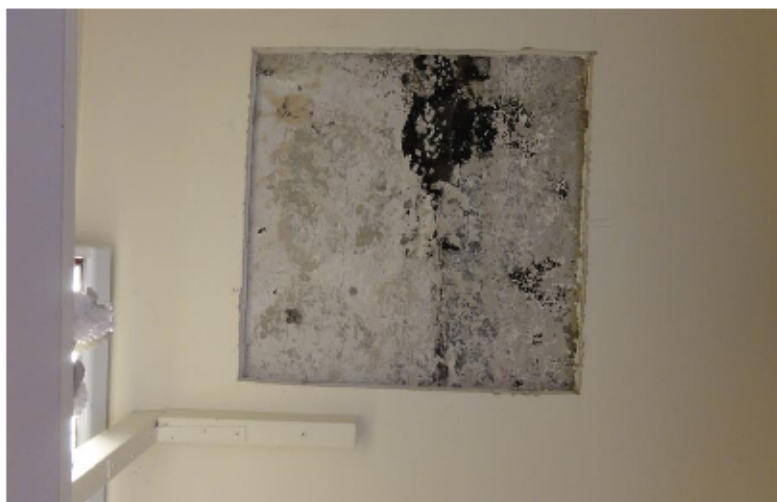
In the small exposure (0.6m square) through the direct bonded, insulated plasterboard ceiling, above the rear entrance door inside the ice cream kiosk, revealed a hairline crack in the soffit of the roof slab, but no significant spalling or water staining. Black stains from the reported earlier fire in the café, (circa 2008), were still present on the slab soffit, but no evidence was observed of significant heat damage to the concrete.

**Photo no 3. Exposure in insulated plasterboard ceiling near GL C, 1-2 of ice cream kiosk showing hairline crack in soffit of roof slab.**

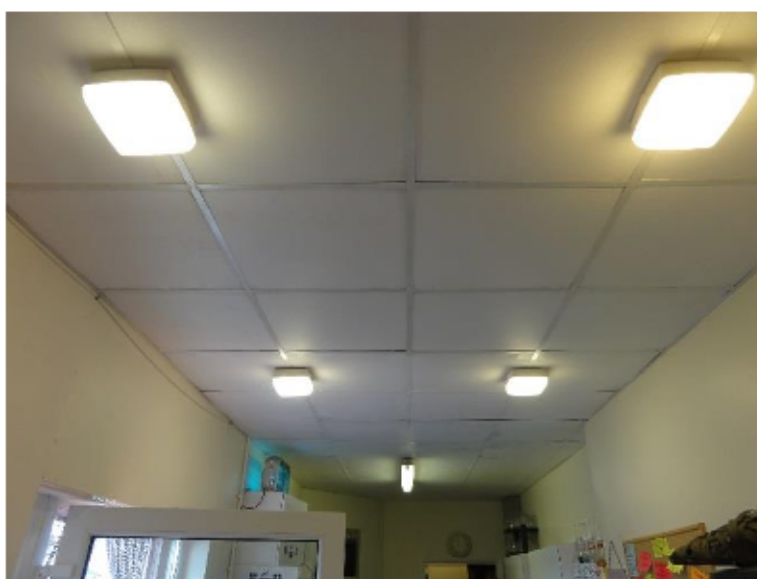
**Photo no 4. Suspended Ceiling in Café prior to exposures.**

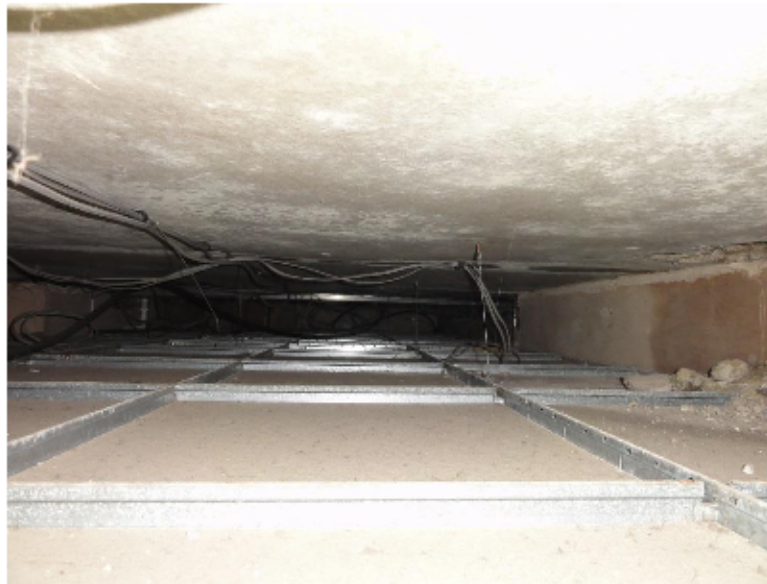
**Photo no 5. Slab soffit above suspended ceiling in Cafe showing spalled concrete to the RHS.**

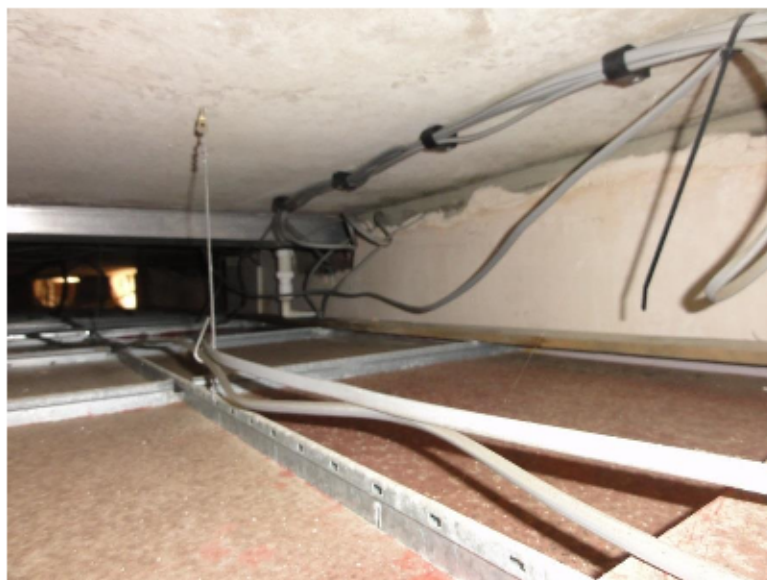
The inspection inside the suspended ceiling of the café revealed four hairline cracks in the soffit of the roof slab, across the full width of the café, which were leaking water into steel drip trays that had been fixed to the underside of three of the cracks. The fourth crack directly across from the main front doors was showing, damp patches on the ceiling with globules of water. No preformed construction joints observed in the soffit of the roof slab over the café.

**Photo no 6. Slab soffit above suspended ceiling in Cafe showing services & steel drip trays fixed under leaking cracks through roof slab.**

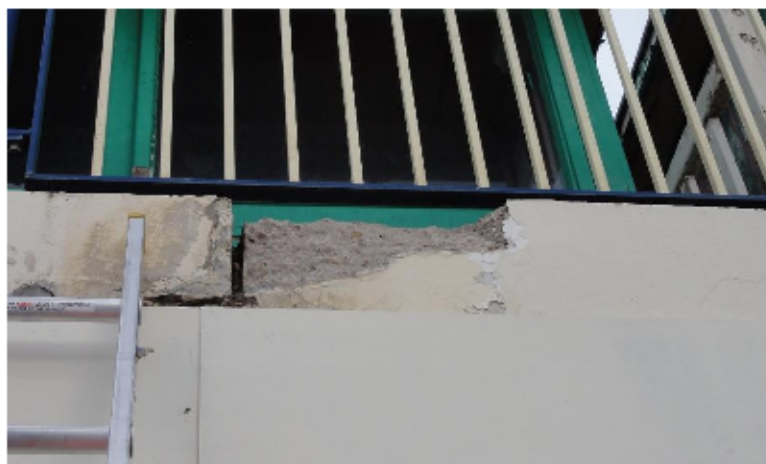
Visual and hammer test of the spalled area of the half-lap joint at GL 1, G-H revealed that the concrete to the right hand side (RHS) of the joint had cracked further and was removed for safety as it was outside the protection barrier.

Photo no 7. Half-lap joint on fascia beam GL 1, G-H, showing area of further spalling on RHS

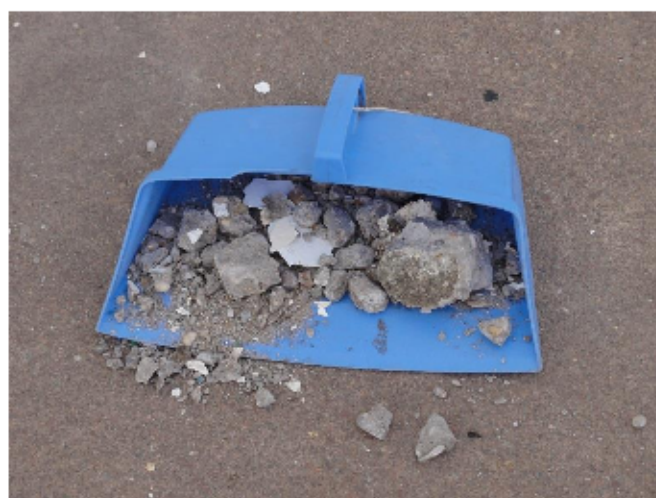
Photo no 8. Close up of spalled concrete from Half-lap joint on fascia beam GL 1, G-H

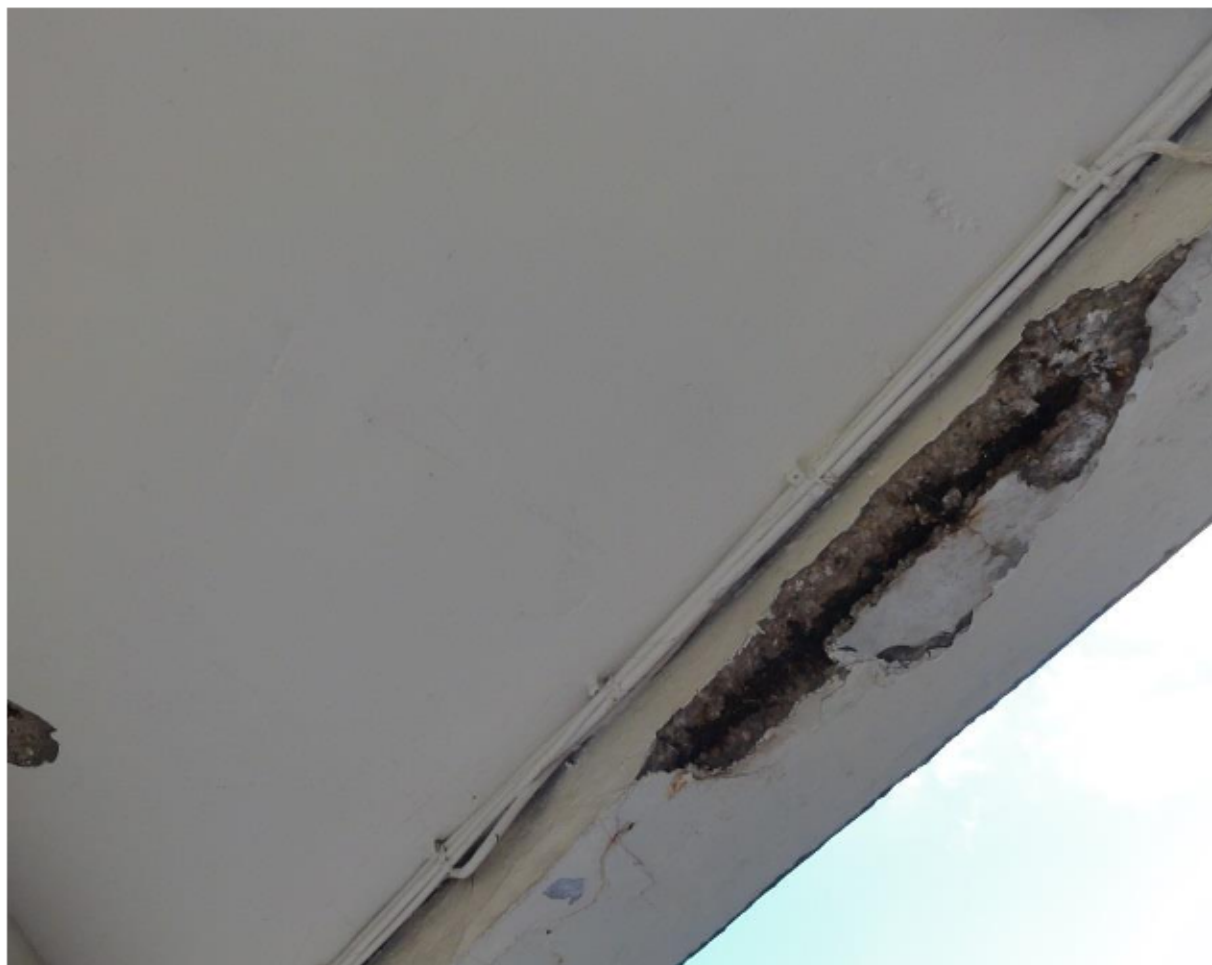
Visual and hammer test inspection of the spalled area on the inside edge of the arched soffit, fascia beam on GL 1, D-E revealed an increase in spalled area of cracked concrete on the soffit edge of the beam, which was removed as a precautionary measure because it was over the access to the north staircase. At the spalled concrete location the reinforcement had suffered surface rusting but no significant loss of cross-section to bar diameter.

Photo no 9. Further spalled concrete cover from down-stand arched soffit fascia beam GL 1, D-E.

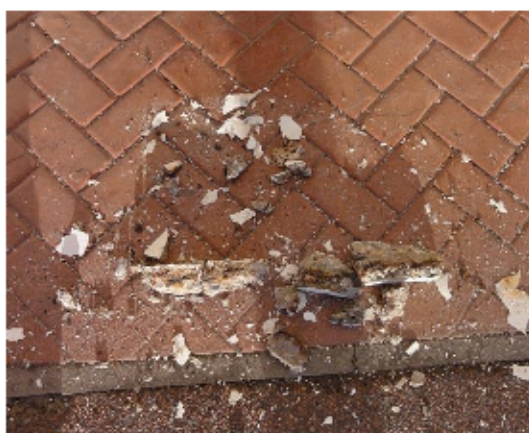
Photo no 10. Close up of spalled concrete from down-stand arched soffit fascia beam GL 1, D-E

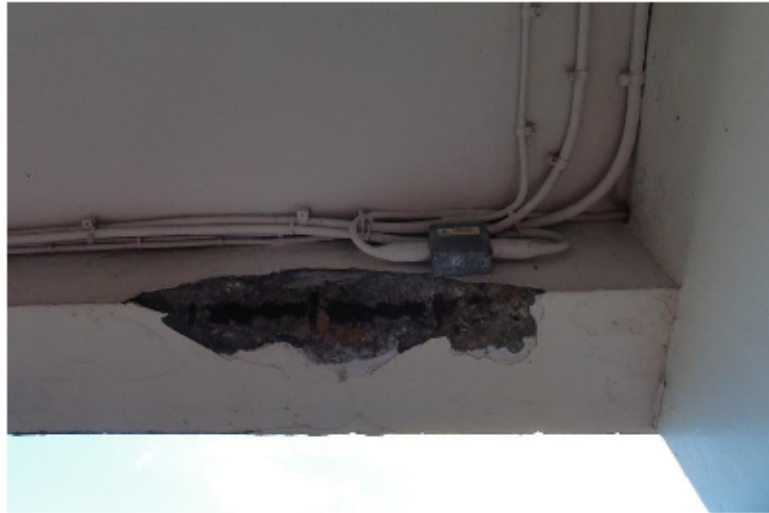
Visual and hammer test inspection of the spalled area on the inside edge of the arched soffit fascia beam on grid line 1, C-D revealed a small increase in spalled area of cracked concrete on the lower edge of the beam, which

was removed as a precautionary measure because it was over the access to the north staircase and ice cream kiosk. At the spalled concrete location the reinforcement had suffered surface rusting but no significant loss of cross-section to bar diameter.

**Photo no 11. Small increase in concrete spalling area to edge of down-stand fascia beam at GL 1, C-D near Ice-cream kiosk.**

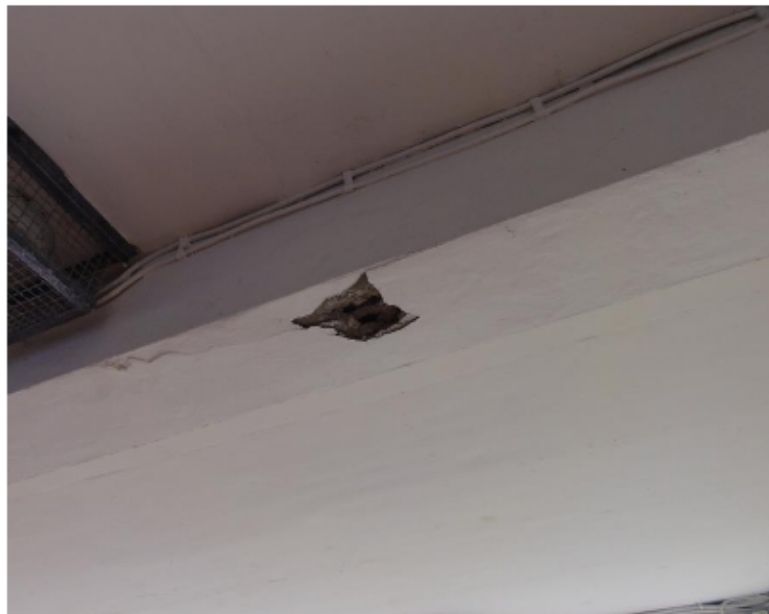
Inspection of the cross beam on GL 2, C-D revealed a further small area of spalled concrete on the soffit which when hammer tested further released some loose aggregate particles from within the cracked concrete, which was removed for safety reasons.

**Photo no 12. Cross beam GL 2 C-D further concrete spalling. Reinforcement corroded with only a slight loss of cross section.**

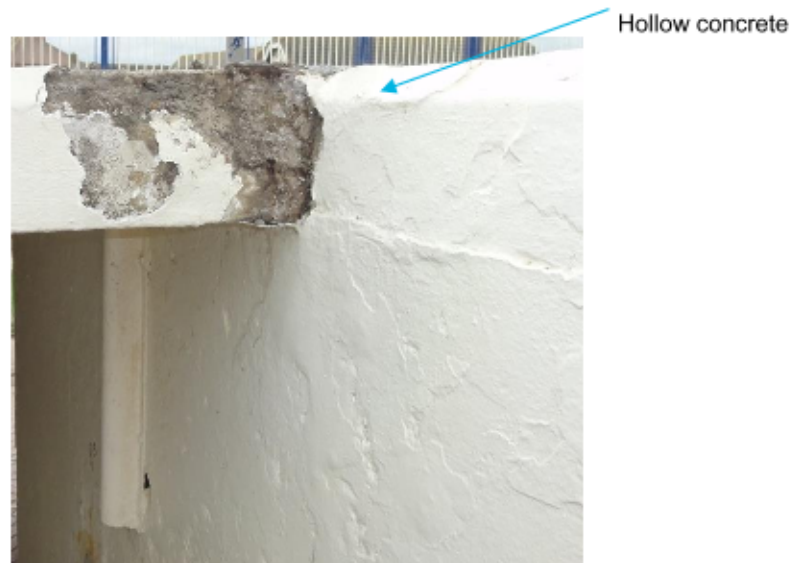
On the top edge of the RC wall to the north staircase (GL 3, C-D), a small area of concrete was tested as hollow adjacent to the spalled area of concrete (near the base of the balustrade standard), on the north east corner.

**Photo no 13. Top of stair wall alongside north staircase (GL 3, C-D), hollow concrete detected adjacent to RHS of concrete spalling.**

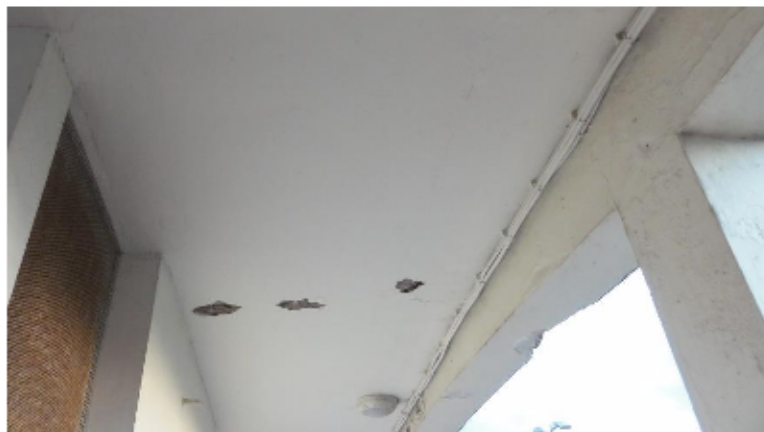
Inspection of the first floor soffit slab between GLs 1-2, D-E, revealed a further small area of hollow concrete which on further hammer testing, cracked and was removed as a precautionary safety measure. The spalled area is on the line of a hairline crack between two existing spalled areas. At the spalled concrete locations, the bar reinforcement had suffered some rusting but no significant loss of cross-section to bar diameter.

**Photo no 14. Soffit of slab GLs 1-2, D-E, further shallow spalling on a hairline crack. Reinforcement corroded with a small loss of cross sectional area.**

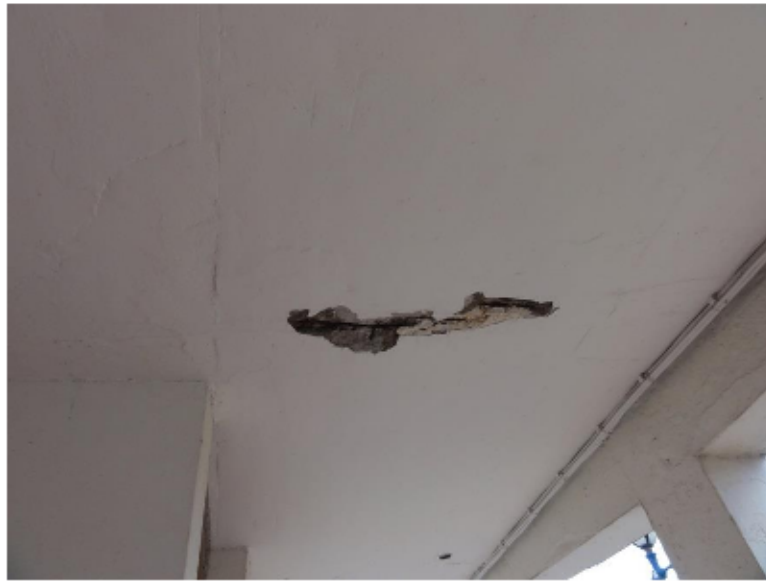
Inspection of the first floor soffit slab between GLs 1-2, D, revealed a further area of hollow concrete, adjacent to a spalled area, which on further hammer testing cracked and was removed as a precautionary safety measure. The spalled area is on the line of a hairline crack between an internal wall and the fascia beam GL 1. At the spalled concrete locations, the bar reinforcement had suffered some rusting but no significant loss of cross-

section to bar diameter. This crack appeared to be slightly damp suggesting that the repaired cracks on the upper surface may be starting to be ineffective.

Photo no 15. Soffit of slab at crack GLs D, 1-2, concrete crack and spalling.

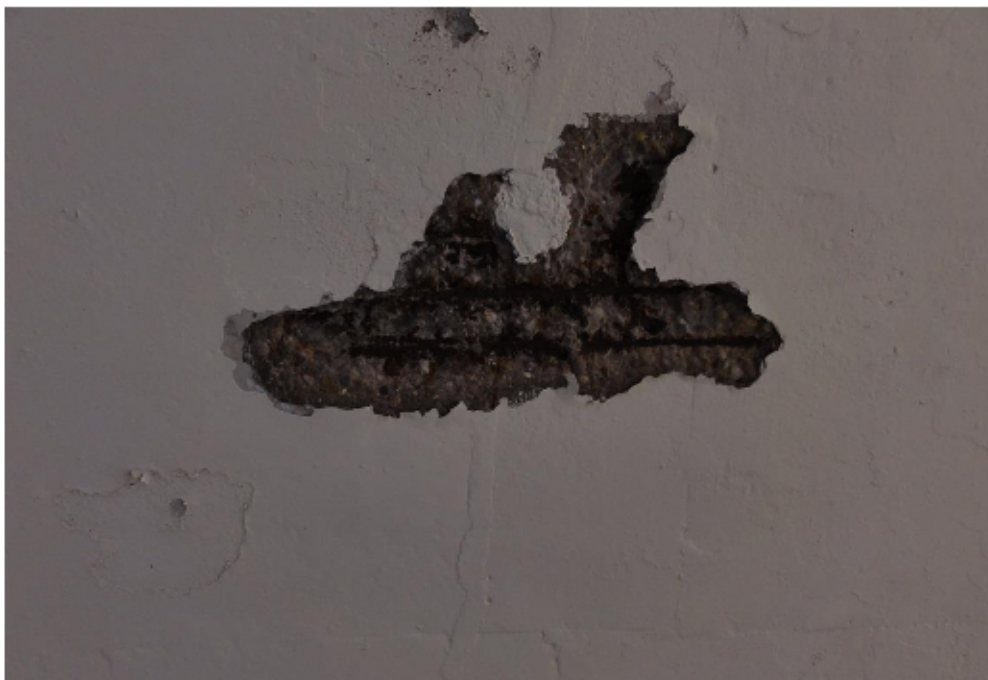
Visual and hammer test inspection of the first floor soffit slab between GLs 1-2, C-D, along a previously identified crack and previous concrete repair, revealed some further hollow concrete which on further investigation cracked and was removed as a precautionary safety measure. At the spalled concrete location the reinforcement had suffered corrosion and detectable loss of cross section to bar diameters.

Photo no 16. Soffit of slab at GLs 1-2, C-D showing spalled concrete, corroded reinforcement with loss of cross section.

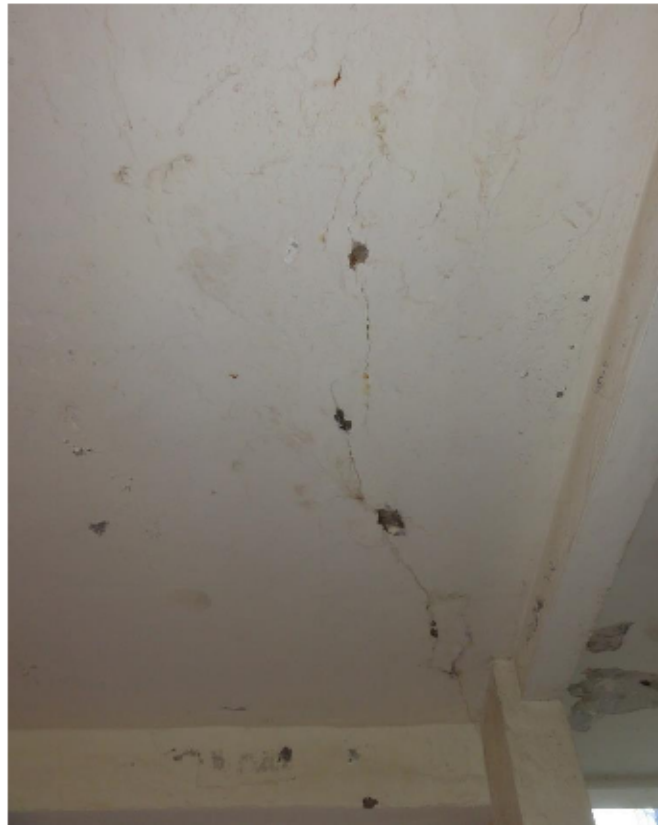
Visual and hammer test inspection of the first floor soffit slab between GLs 1-2, C-D along a previously identified crack revealed some minor spalling but no damp concrete.

**Photo no 17. Hairline crack in slab soffit at GLs 1-2, C-D with some minor rust stains and spalling.**

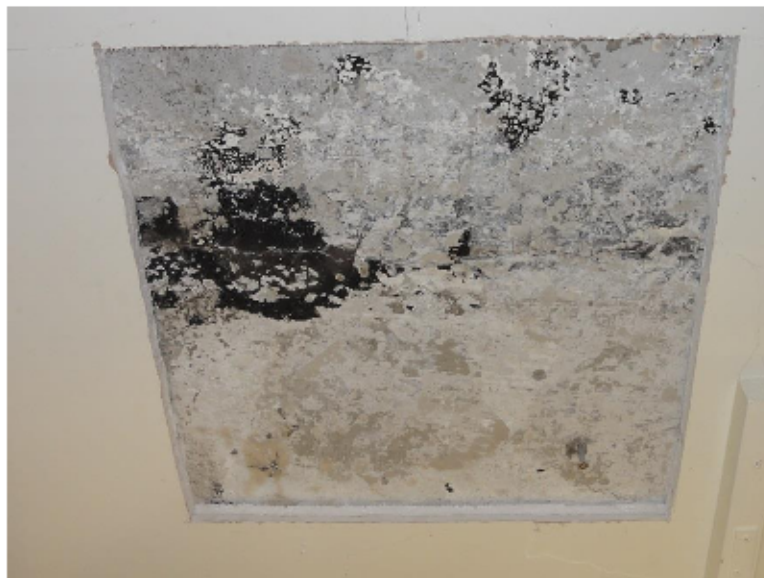
A small exposure through the bonded plasterboard ceiling, inside the ice cream kiosk, revealed a hairline crack in the soffit slab but no significant spalling.

**Photo no 18. Exposure in plasterboard ceiling to ice-cream kiosk showing hairline crack in slab soffit at GLs 1-2, B-C with some minor spalling. Black staining damage reported to be from an earlier fire.**

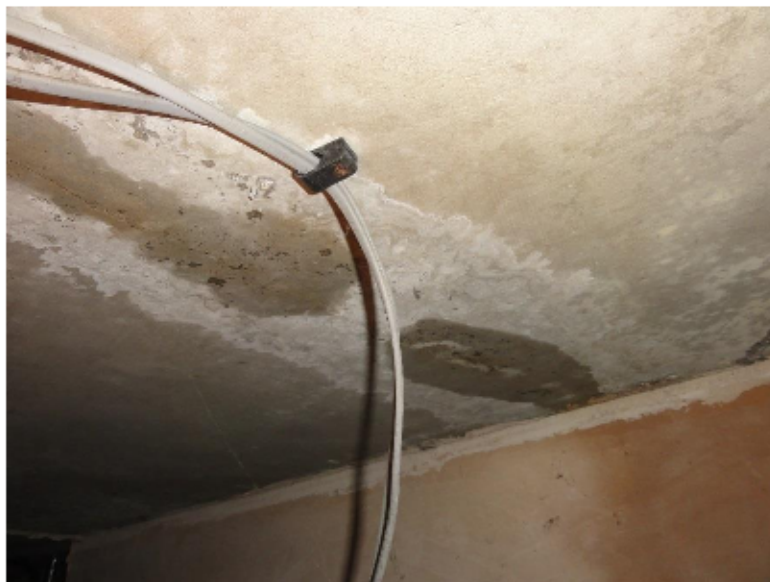
A small exposure through the bonded plasterboard ceiling, inside the ice cream kiosk, revealed a hairline crack in the soffit slab but no significant spalling or dampness. The inspection inside the suspended ceiling in the café

revealed four hairline cracks in the roof slab, across the width of the café, which had reportedly leaked water (raining at time of inspection). A steel drip trays that had been fixed to the underside of three of the cracks to collect and drain off the water to overflows. The fourth crack, directly across from the front door of the Café, was displaying damp patches with globules of water on the surface. Three of the four cracks reflected the repaired cracks on the roof slab at promenade level that were observed during the May 2018 inspections. The drip trays under three of the roof slab cracks prevented close inspection and the assessment of concrete degradation.

**Photo no 19. Crack through roof slab above Café with damp patches at GL 1-2, E-F.**

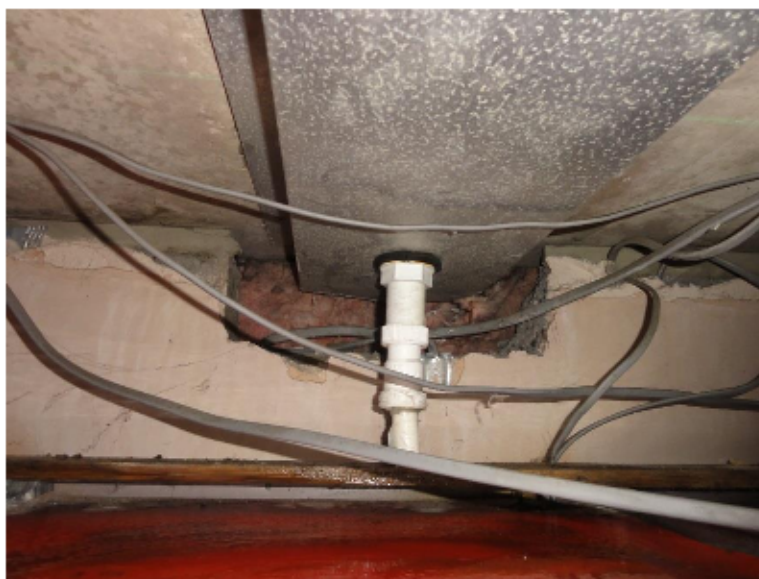
One of the drain pipes to the drip tray on GL E, 1-2, was leaking such that water was pooling on a ceiling tile situated over the electric deep fat fryers. Although AECOM mopped up the water, on day, the concession manager Mr Brown reported a safety incident to ELDC which was responded to within 3 hours. Since the Café continues to be leased to the concession the waterproofing to these defects should be considered for improvement in the short term. Should the water ingress continue it will cause additional structural problems over time.

**Photo no 20. Crack through roof slab above Café with steel drip tray at GL 1-2, E-F. Drain pipe from drip tray leaking water onto ceiling tile above electric deep fat fryer.**

**Potential safety hazard unless resolved by ELDC.**

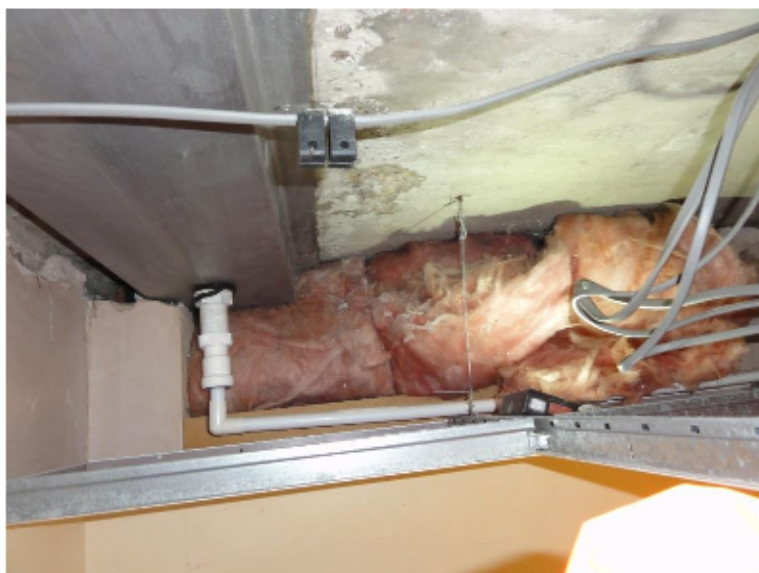
**Photo no 21. Crack through roof slab above Café freezer with steel drip tray at GL 1-2, D-E.**

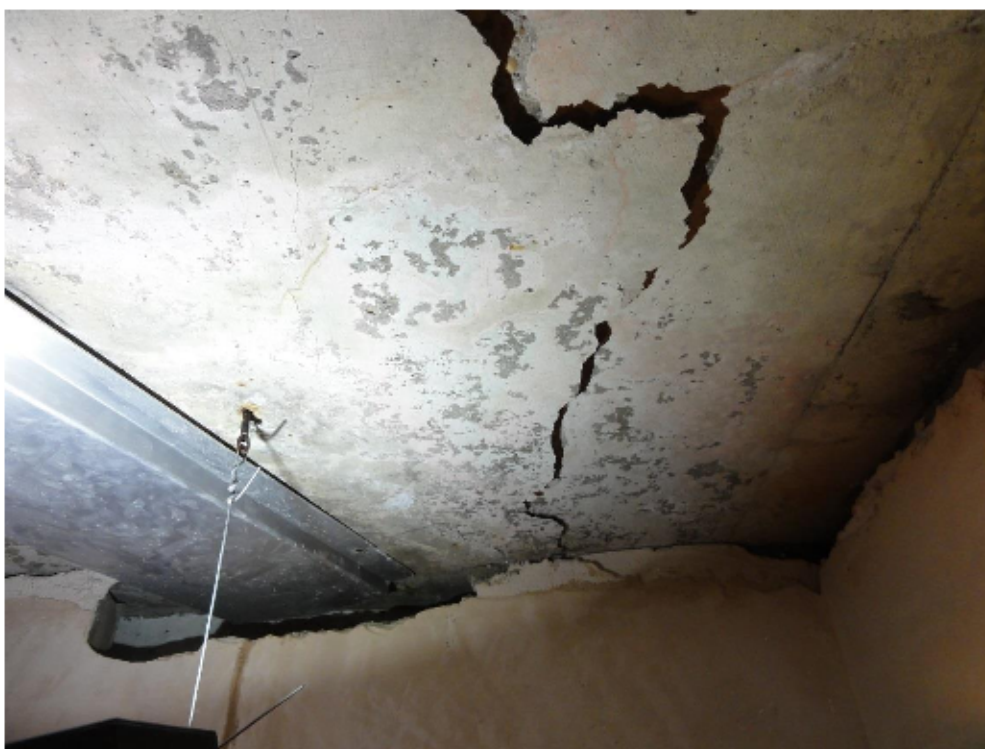
In the toilet, at the back of the Café, a large piece (0.5m square) of spalled concrete on the soffit of the roof slab was being held in place by the steel drip tray and its small fixings. This piece of concrete was too large for AECOM to safely remove on the day and was referred to ELDC to remove this safety hazard, so that the toilet could be used safely. AECOM requested ELDC to take photos after the spalled concrete had been removed so that the structural condition of the slab could be reviewed.

**Photo no 22. Crack through roof slab above Café internal toilet, with steel drip tray (approx. GL 1-2, D-E.)**

**Potential safety hazard unless resolved by ELDC.**

In the toilet, at the back of the Café, a large piece (0.5m square) of spalled concrete from the roof slab was being held in place by the steel drip tray and its small fixings. This piece of concrete was too large for AECOM to safely remove on the day and was referred to ELDC to remove this safety hazard so that the toilet could be safely used. AECOM requested ELDC to take photos after the spalled concrete had been removed so that the structural safety condition of the roof slab could be reviewed.

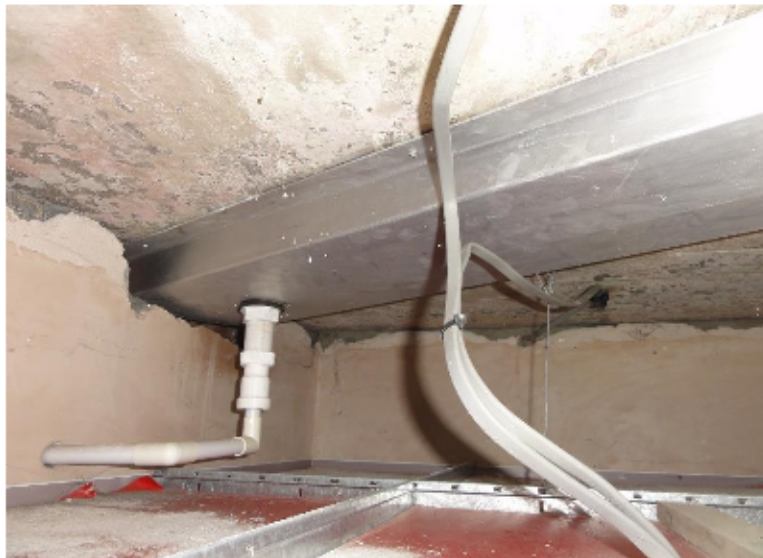
**Photo no 23. Spalling and a dripping water leak in ceiling void of Café at GL 2, E-F**

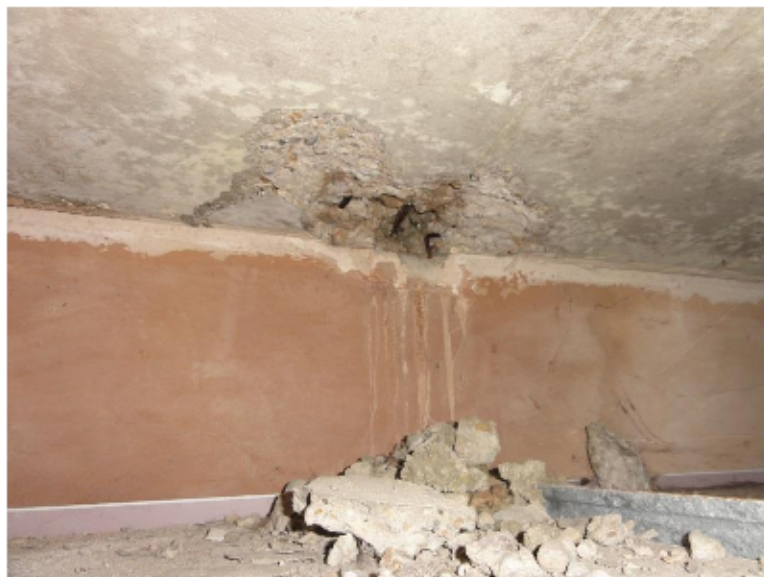
A spalled area of concrete on the roof slab soffit situated under chalet no 2 (GL 2, E-F) was also dripping water (raining at time of inspection) onto a pile of previously spalled concrete (approx. 1.5kg) resting on the existing fibre ceiling tile.

**Photo no 24. Spalling and a dripping water leak in ceiling void of Café at GL 2, E-F above internal block wall and under chalet no 2.**

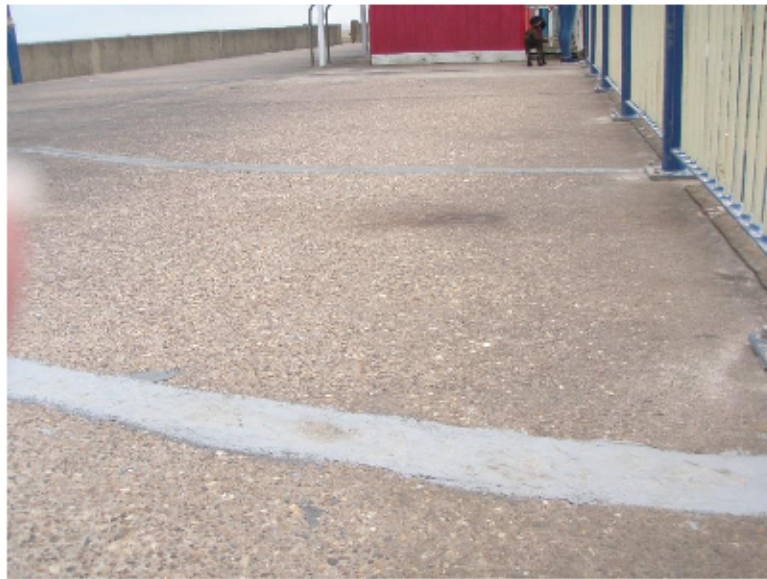
**Photo no 25. Repaired cracks in slab at promenade level which approximately correspond with cracks in Garden Café ceiling below. (GL 1-2-3, D-F).**

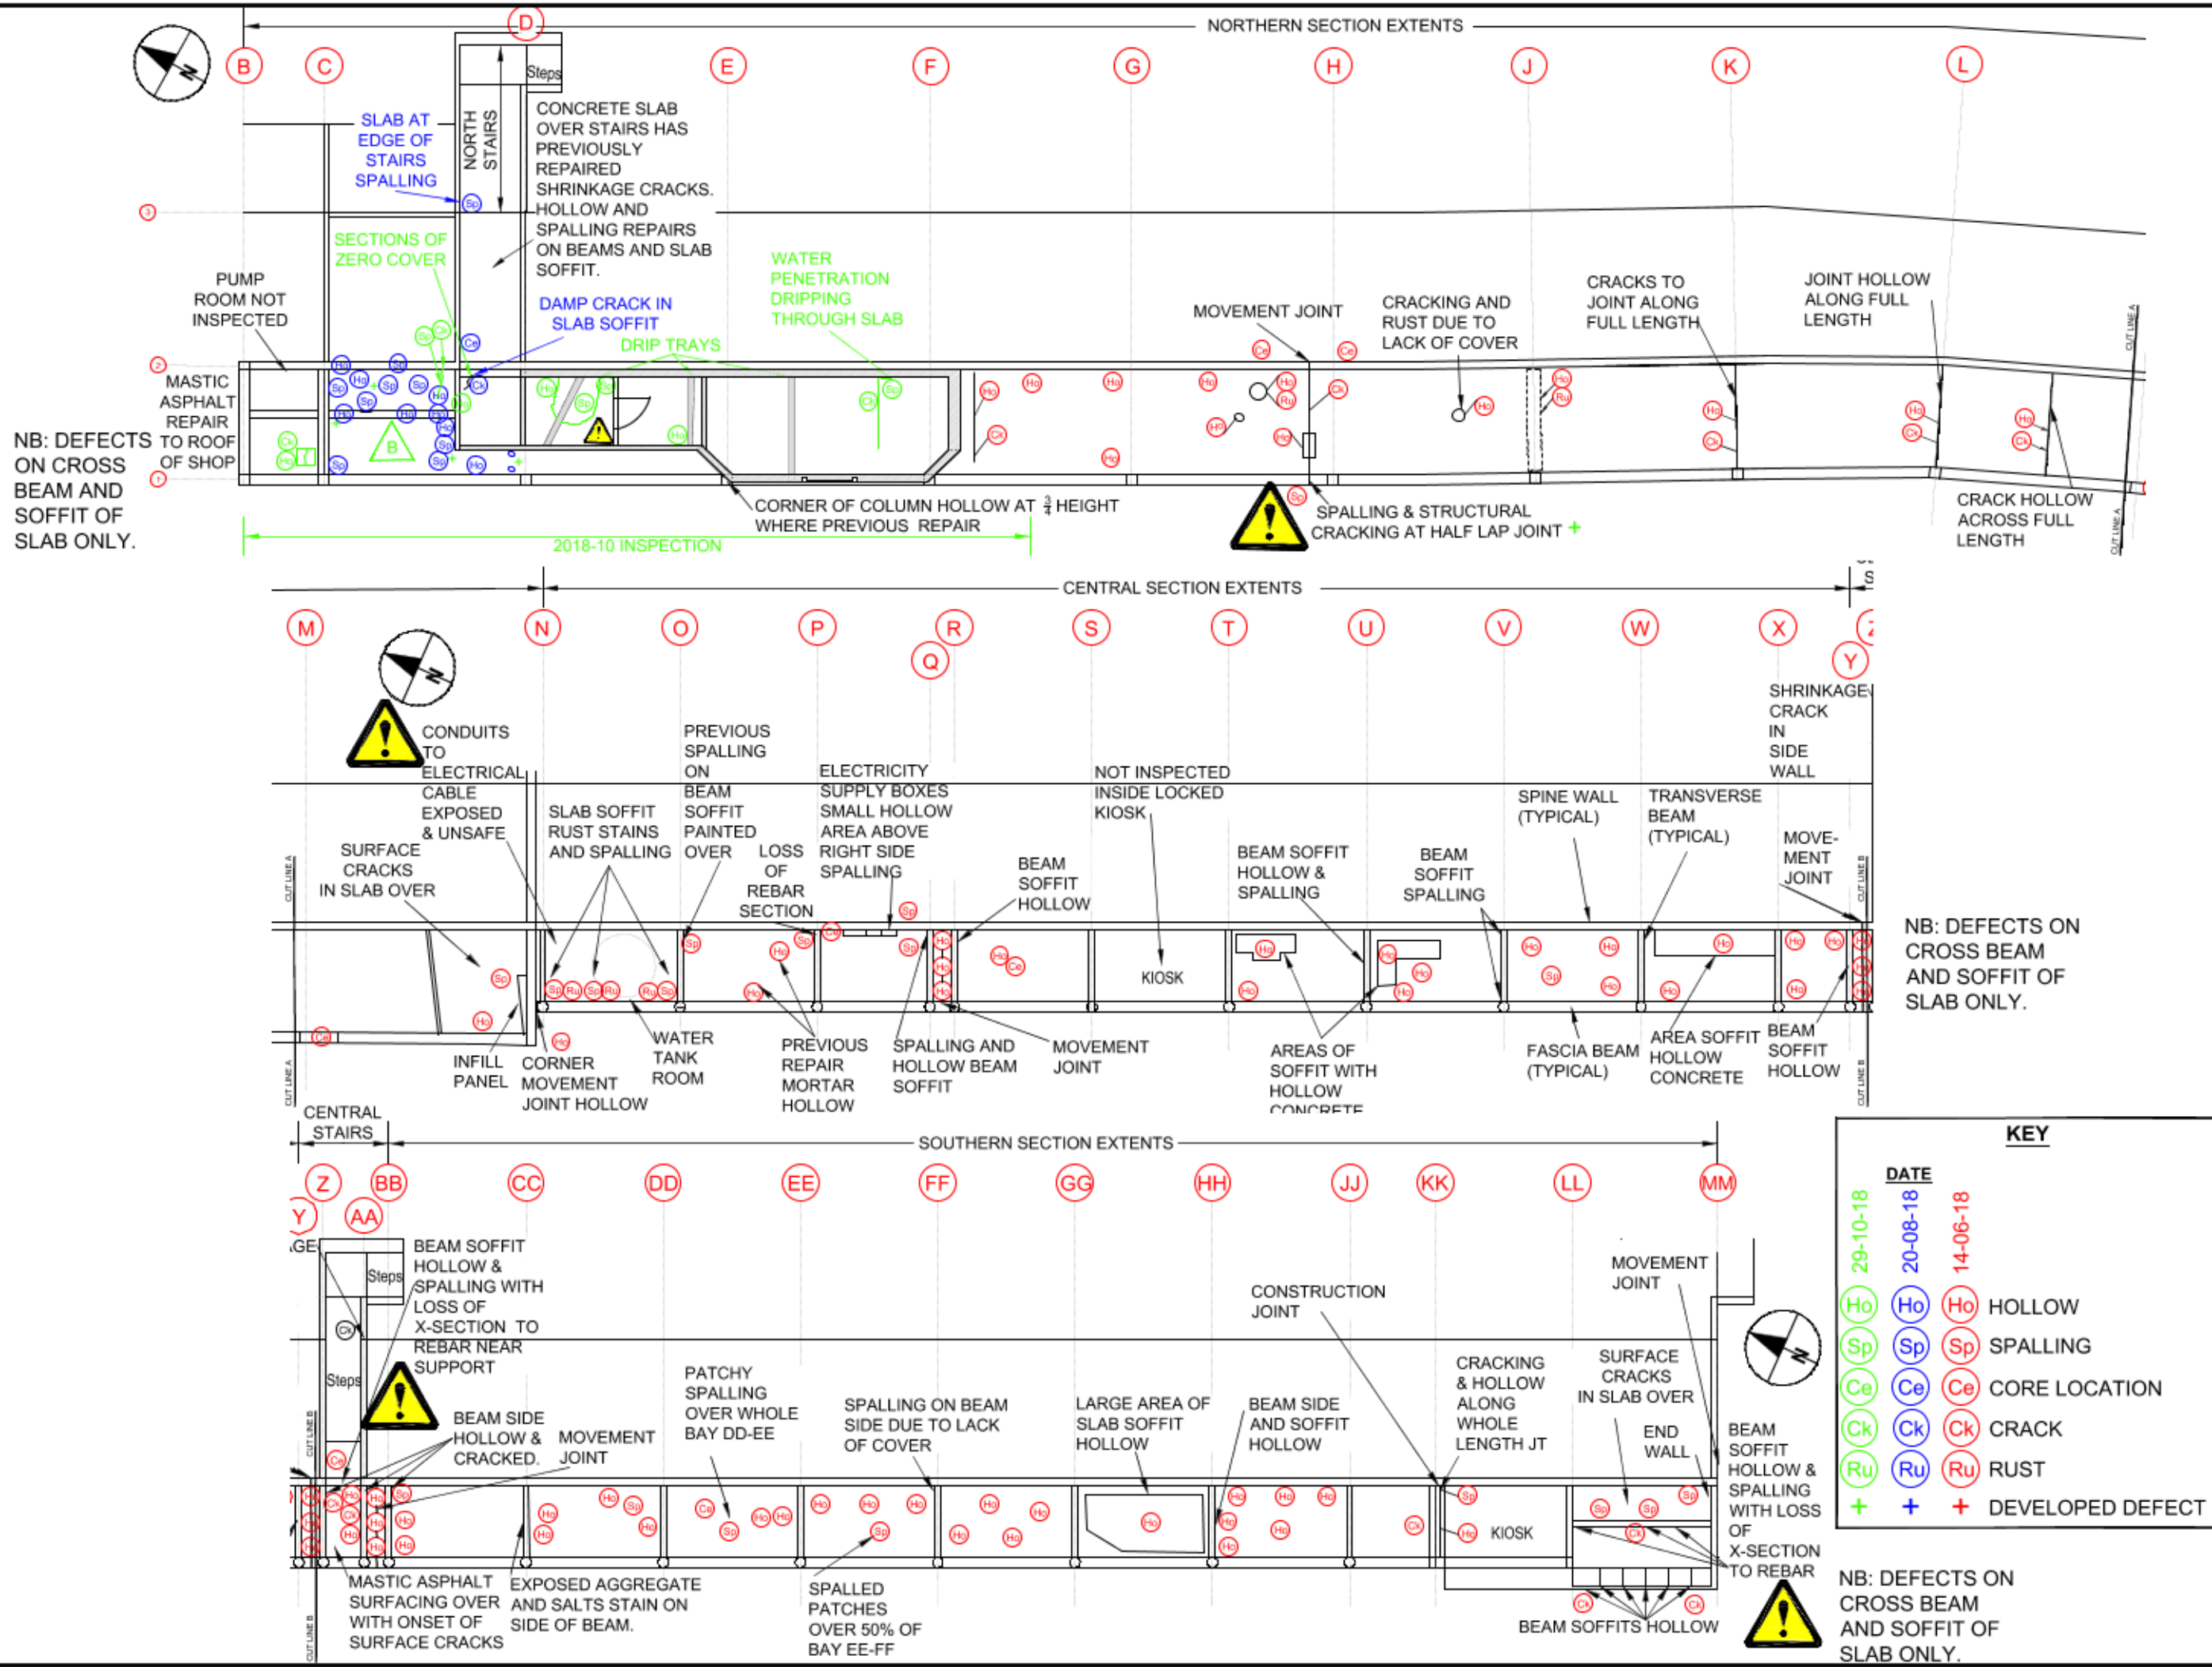
Plan Figure 3 Rev B

The second inspection, of the north stair promenade access revealed that three small areas, of previously identified hollow concrete cover, had deteriorated so that it could become detached along the lower rear edge of the front down-stand beams GLs 1, C-G and these were removed for safety reasons. There were another two small areas of hollow concrete identified on column 1F and on the rear face of down-stand beam, (GLs 1-2, C-D). Four small areas on three different soffit slabs on the route to the stairs had deteriorated such that there were small sections of concrete cover that could become detached and were removed for safety reasons. One cross beam side face and one stair wall top face had an additional area of hollow concrete. Refer to Sketch of visual defects in Appendix B.
