Sutton on Sea Colonnade

Concrete Testing

East Lindsey District Council

May 2018

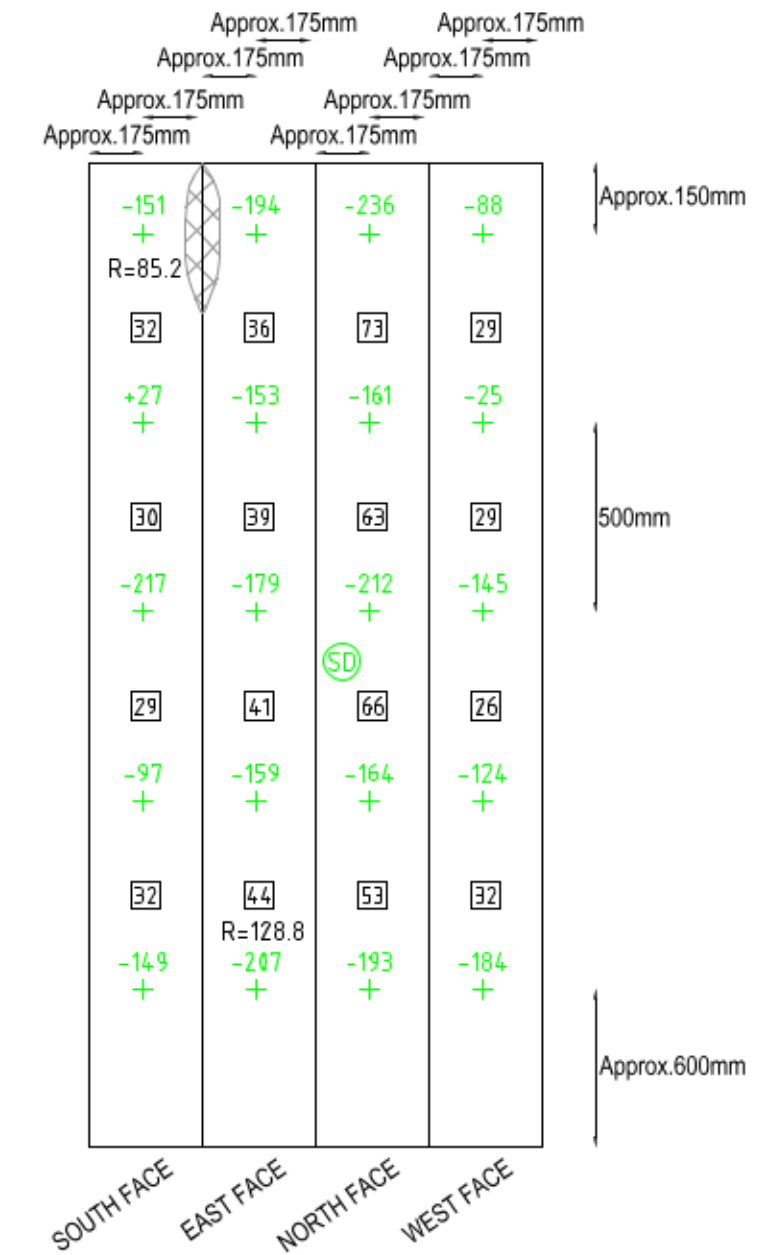
LOCATION 4 - COLUMN K

There are medium chloride levels at reinforcement depth (0.071% by weight of concrete), half-cell readings are low but there are steep gradients at the top of the column suggesting that corrosion maybe occurring, as confirmed by the spalling at the top of the column.

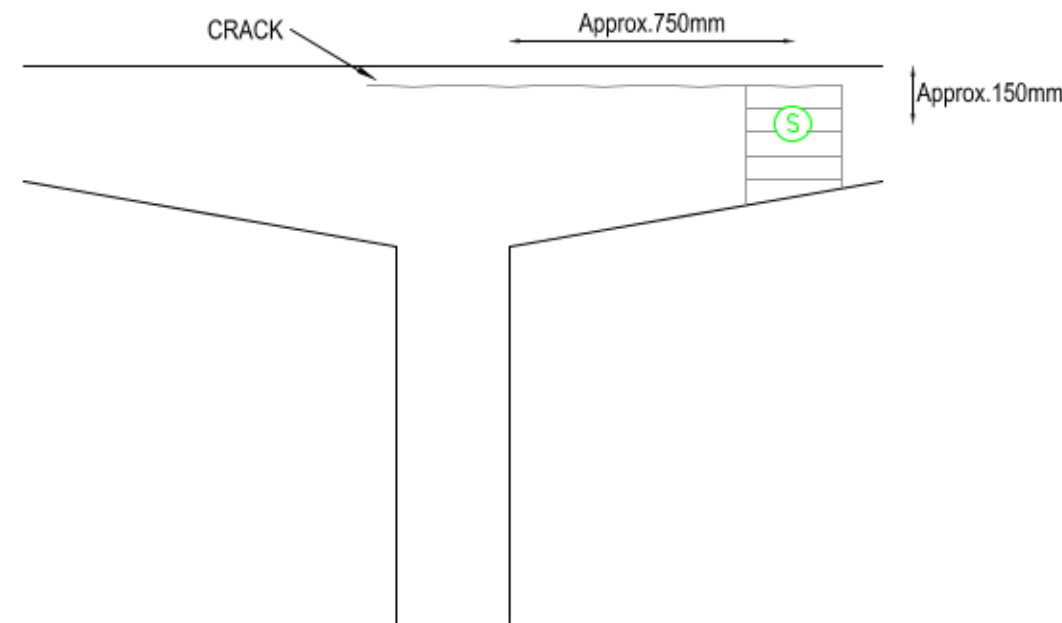
AREA OF RUST STAINING ON FRONT
BEAM, BETWEEN COLUMNS J-K
