# Sutton-on-sea

## Structural Condition Report on Concrete Colonnade

For East Lindsey District Council

Project number: 60578623  
60578623-ELDC-ACM-REP-00010

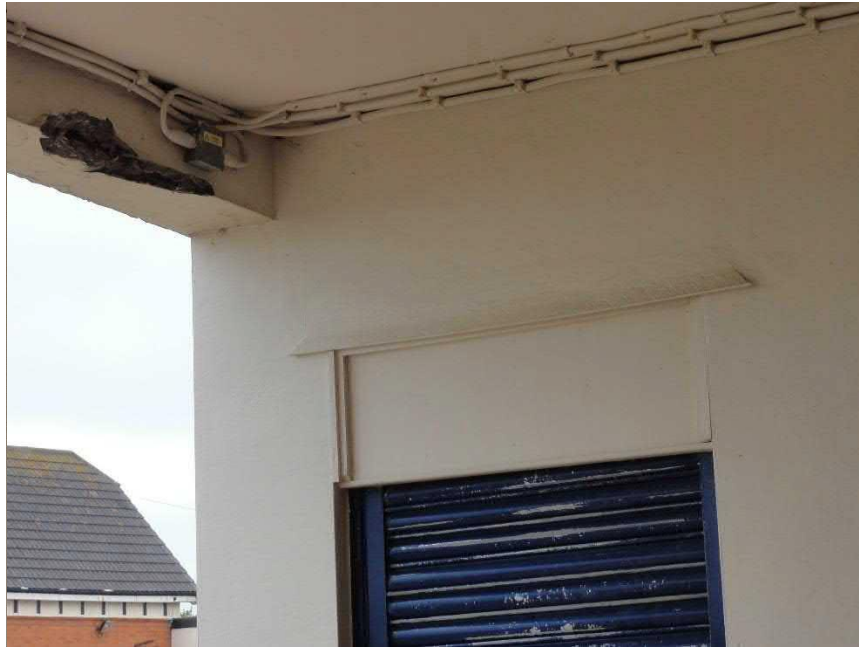
Visual inspection of the rectangular and arch profiled fascia beams on the Northern section revealed hollow sounding concrete to sides and soffits, rust staining to outside faces, structural cracking over heads of columns 1J and 1L and tops of beams. A number of vertical hairline historic shrinkage cracks were observed on the front face of three beam spans. The fascia beam over the access to the North staircase and seating area of the ice cream kiosk (GL 1, C-D) was exhibiting extensive hollow sounding concrete and will need regular structural inspections so the access to the stairs and kiosks could be kept open to the public. Some of the damage to the top face and edges of the beams can have resulted from previous (rusting) and current fixings to balustrade standards. At spalled concrete locations the reinforcement has suffered advanced laminated corrosion with significant loss of cross section.

Photo no 02: Showing spalling to fascia beam on GL 1, C-D near Ice Cream Kiosk.

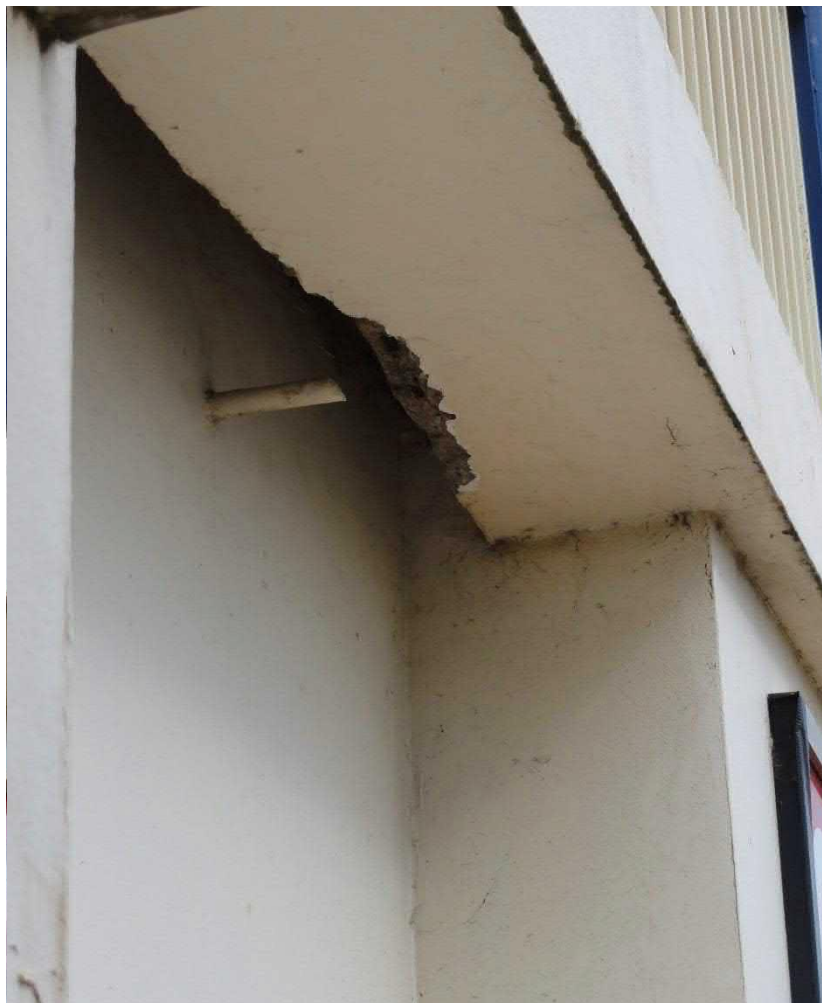
Photo no 03: Showing spalling to fascia beam on GL 1, D near Café.

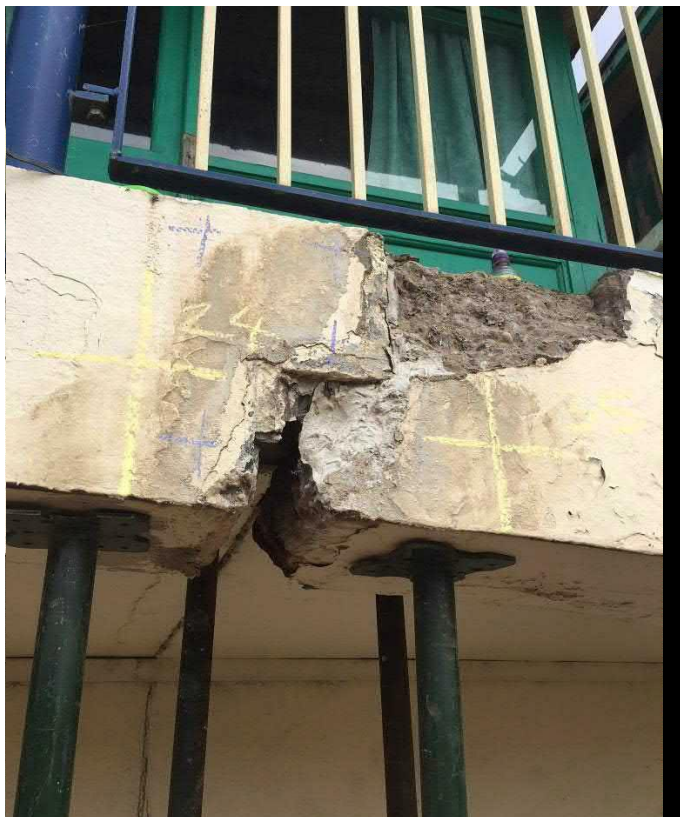
The half lap joint within the fascia beam spanning between columns 1G and 1H had suffered significant structural cracking to the top part of the half lap detail, along with concrete spalling and loss of reinforcement section due to corrosion that it was considered structurally at risk so was left propped for safety. The corresponding transverse movement joint from GL 1 to 2 across the slab exhibiting extensive hollow sounding concrete will require patch repairs and resealing. The corresponding vertical joint in the spine wall is showing only minor defects requiring patch repairs and resealing.

**Photo No 05. Half-lap Joint Fascia Beam GL 1, G-H**

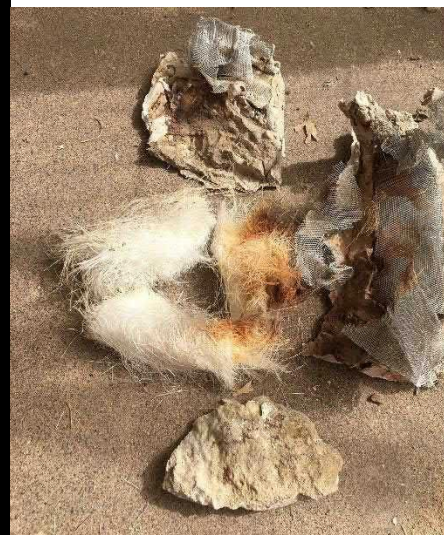
**Photo No 06. Debris from previous repair to Half-lap Joint Fascia Beam GL 1, G-H**

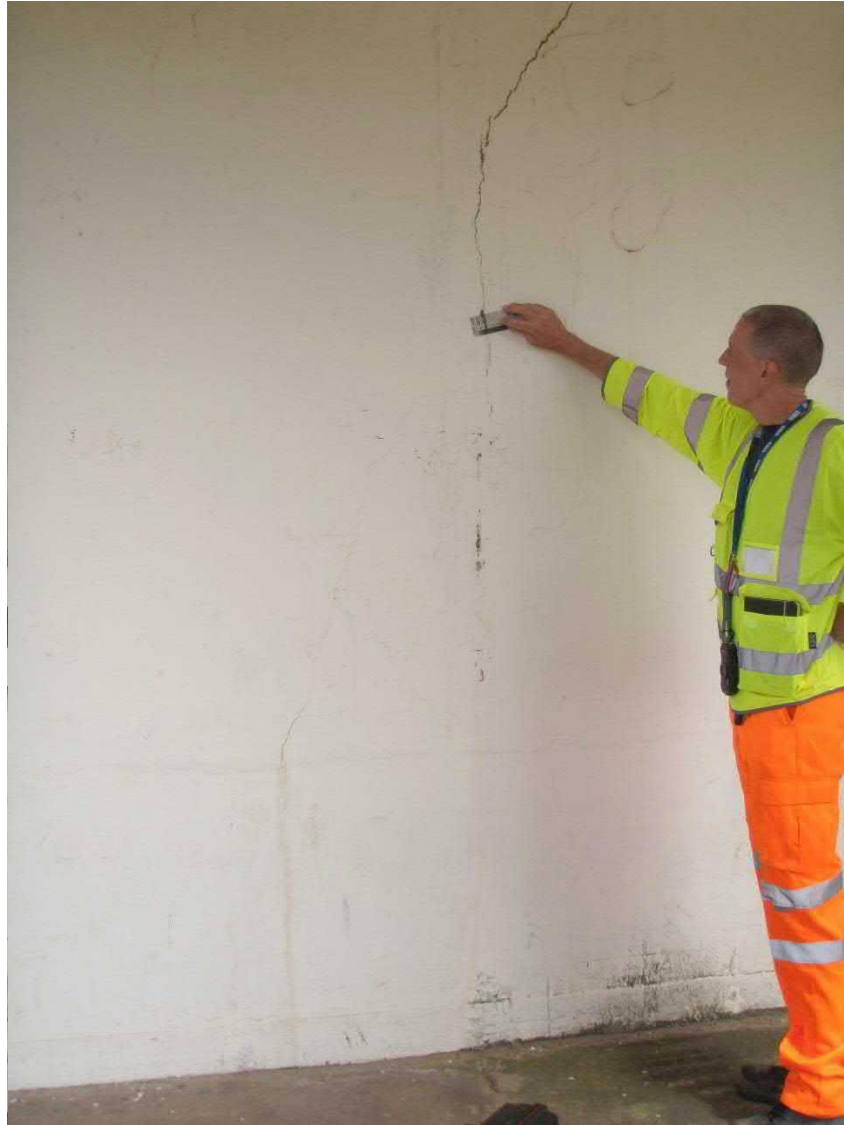
A bay of the spine wall at GL 2, M-N was exhibiting a hairline crack over its full height at an inclined angle to the vertical. The cause of the crack was not readily identified but believed to be shrinkage. A large number of the weep holes on the spine wall were blocked with weak concrete on the far face, as proved by a concrete core.

**Photo no 07: Shrinkage crack in spine wall near GL N 2.**

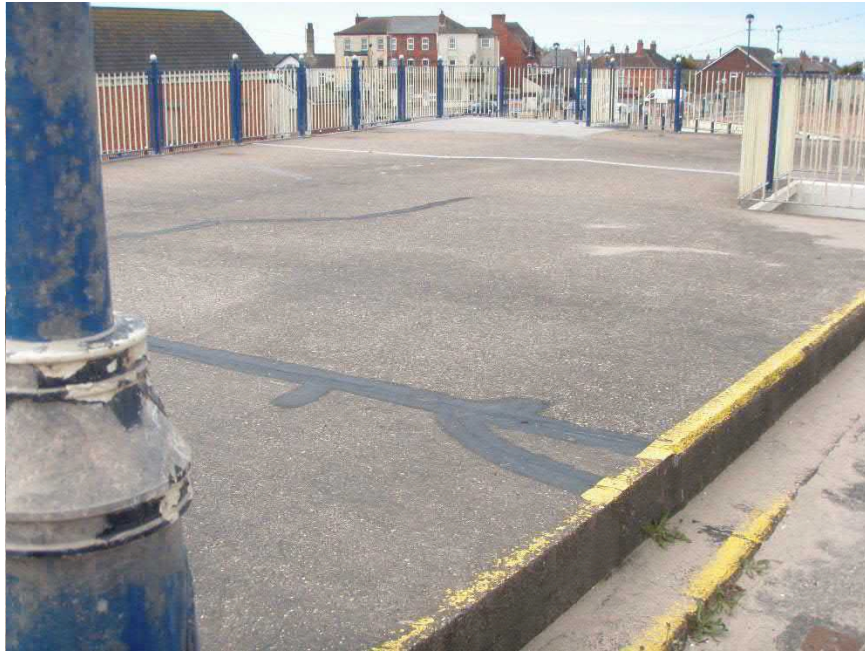
**Photo no 08: Floor slab at promenade level GL B-D, 1-3 North end showing shrinkage cracks and mastic asphalt remedials to kiosk roof in distance.**

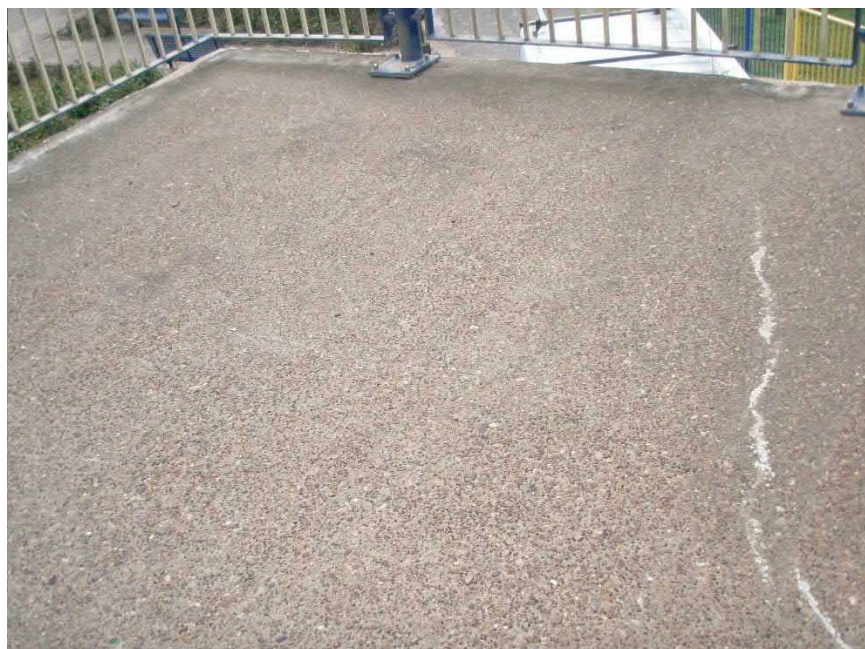
**Photo no XX: Slab at promenade level showing shrinkage cracks GL 1-2, M-N.**

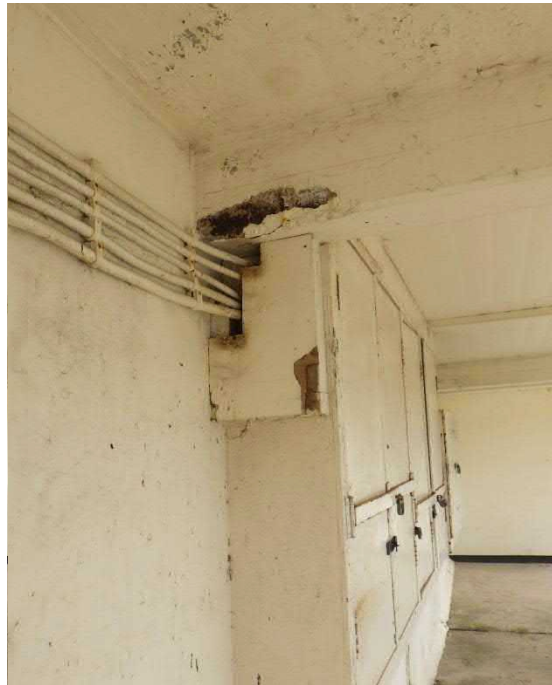
Inspection of the first floor slab down stand, cross-beams revealed spalling, hollow beam soffits to six spans. At spalled concrete locations the reinforcement had suffered advanced laminated corrosion with significant loss of cross section in four locations.

**Photo no 09: Cross beam GL P1-2 showing spalled concrete and loss of section to rebar and electrical meter boxes**

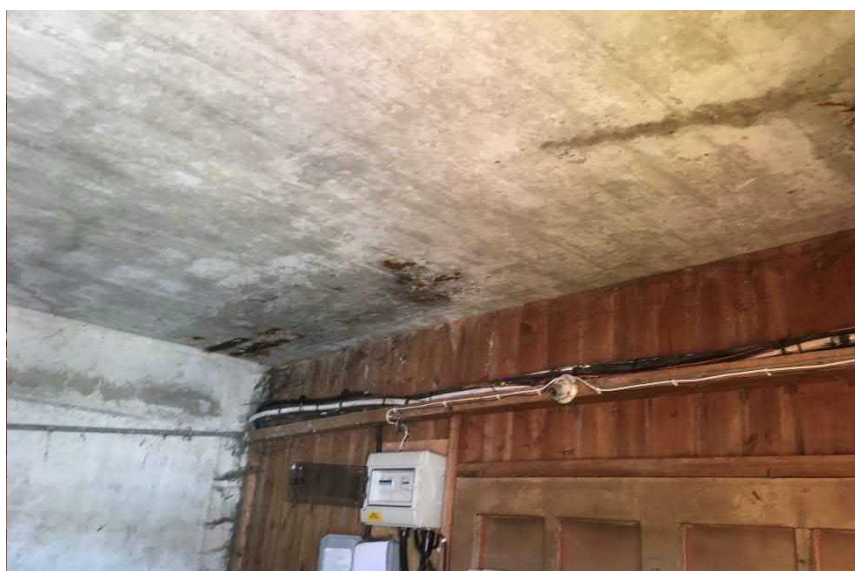
**Photo no 10: Slab soffit inside tank room showing spalling, cracks and rust stains. Also a detached electrical services (far wall) [Safety Hazard].**

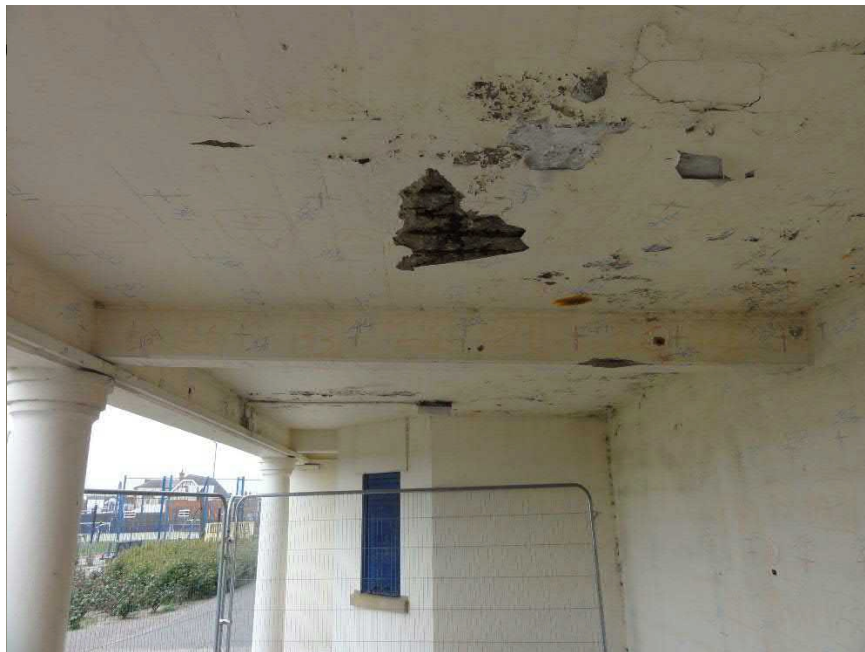
Large areas of the soffit to the first floor slab were found to have rust staining and hollow sounding concrete indicating extensive ferrous oxide corrosion jacking presence.

**Photo no 11: Slab soffit rust stains, cracks and spalled concrete GL 1-2, U-V.**

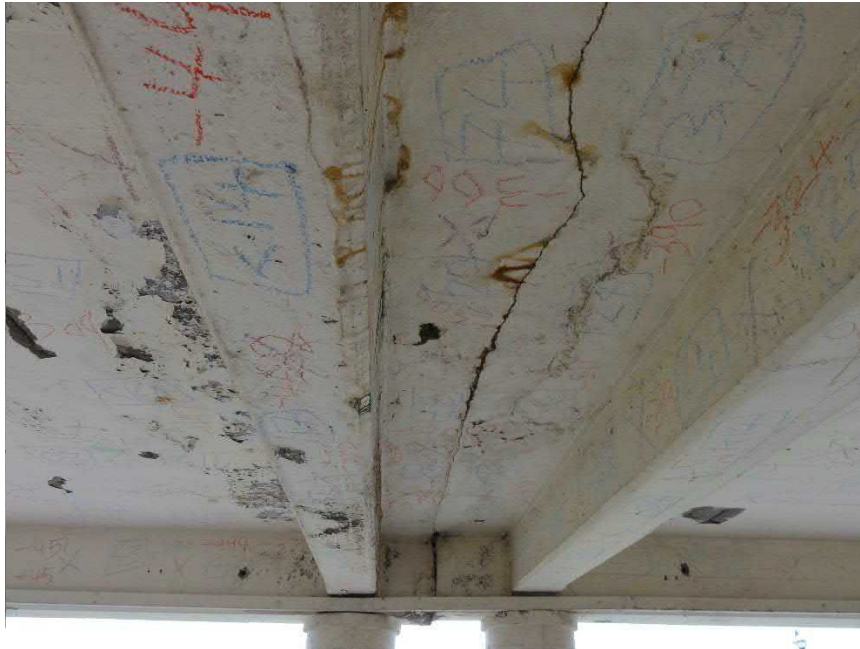
Inspection of the first floor slab down-stand cross-beams revealed spalling, hollow beam soffits to two spans. At spalled concrete locations, the reinforcement had suffered advanced laminated corrosion with significant loss of cross section in two locations. The down stand beam on GL BB, 1-2 had hollow concrete and extensive cracks on the side faces of the beam with one area of spalling.

**Photo no 12: Down stand transverse beams and movement joint GL 1-2, AA-BB showing spalled and hollow concrete, along with NDT testing chalk notes.**

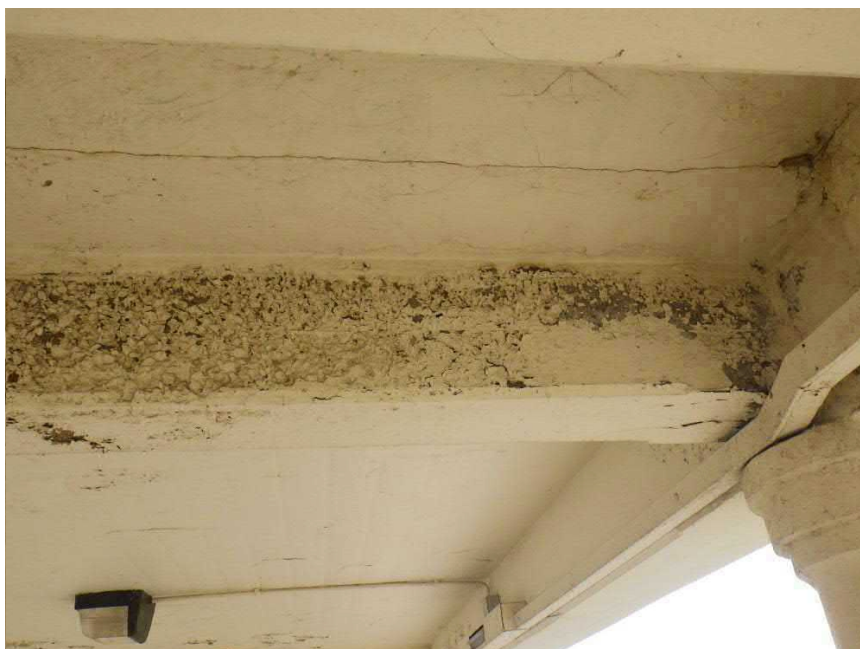
Exposed aggregate was evident on cross beam at GL 1-2, CC and extensive deposits of a white salt was present in the peeling edges of the various coatings of decorative finishes on the beam.

**Photo no 13: Transverse beam GL CC, 1-2 with exposed aggregate on side of beam**

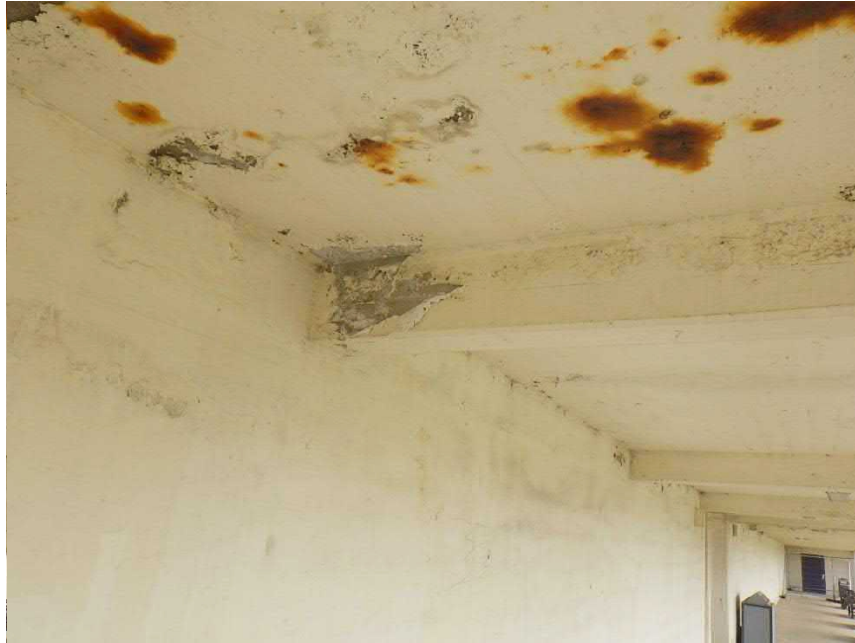
The first-floor slab soffits were exhibiting large areas of hollow sounding concrete, a large number of narrow cracks (generally tracking slab reinforcement bars) and numerous areas of spalled concrete exposing rusty reinforcement affecting seven bays. At spalled concrete locations the reinforcement had suffered advanced laminated corrosion with significant loss of cross section in all locations. The exposed top surface, at promenade level, was protected with a mastic asphalt layer which was exhibiting early signs of degradations and potential water leaks on to the timber substructure and colonnade slabs below. At bay GL 1–2, KK–LL a hairline horizontal crack extended across the full width of the slab GL 1 to 2.

**Photo no 14: Slab soffit GL 1-2, CC-MM showing cracks, spalling and rust staining.**

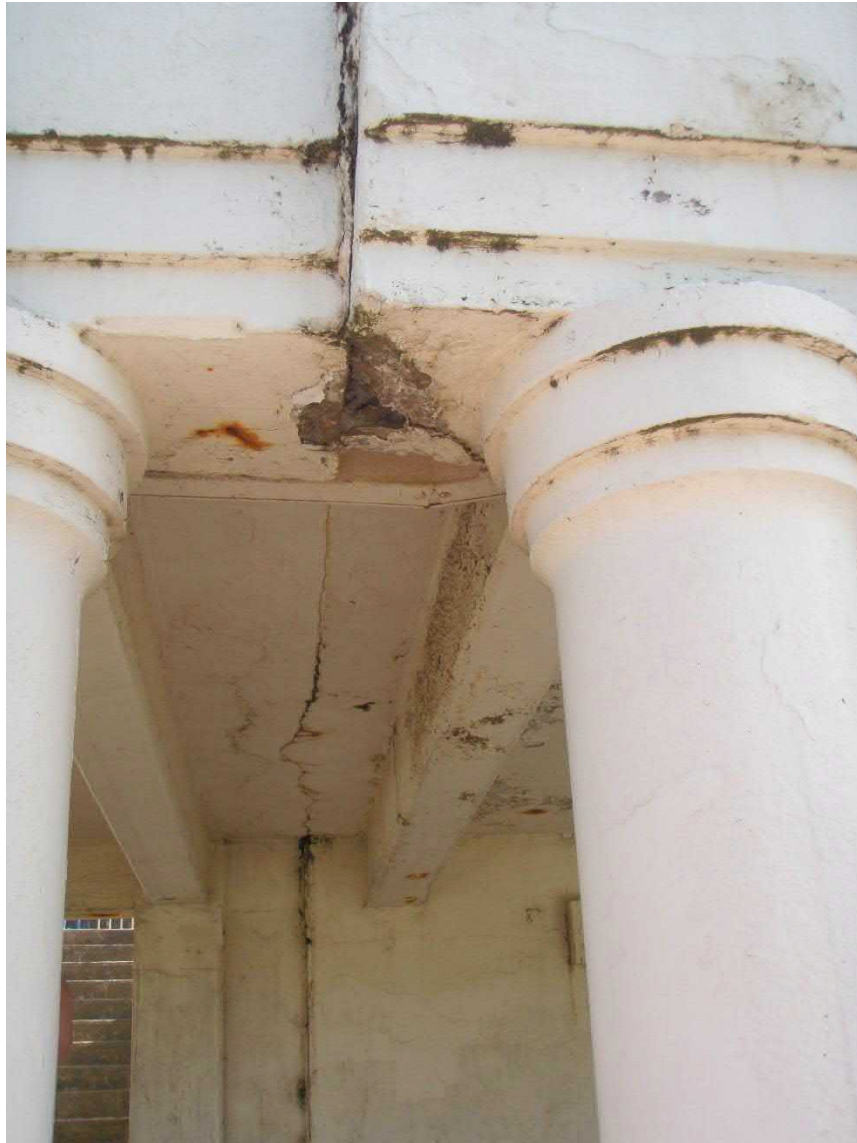
**Photo no 15: Spalling at head of column GL 1BB, and exposed aggregate to transverse beam GL BB and movement joint to central stairs**

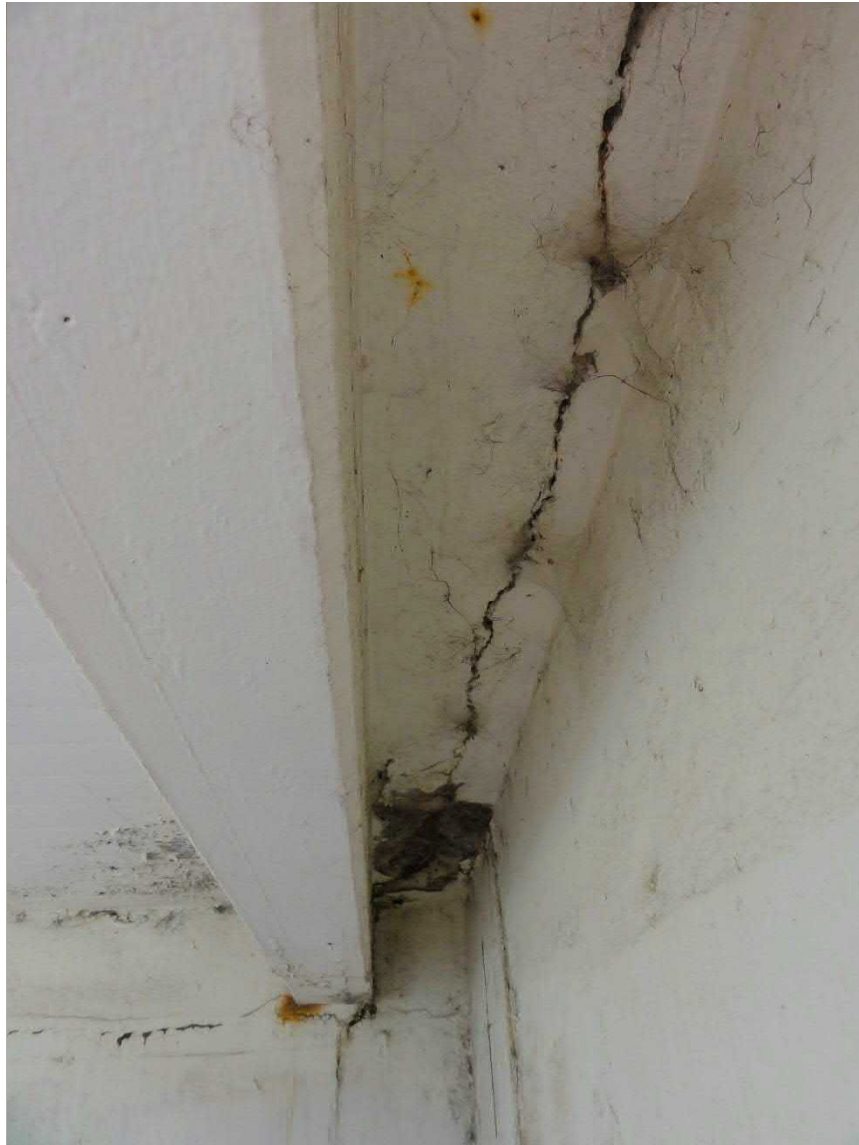
**Photo no 16: Movement Joint in slab soffit GL KK, 1-2 showing rust stains and cracking.**

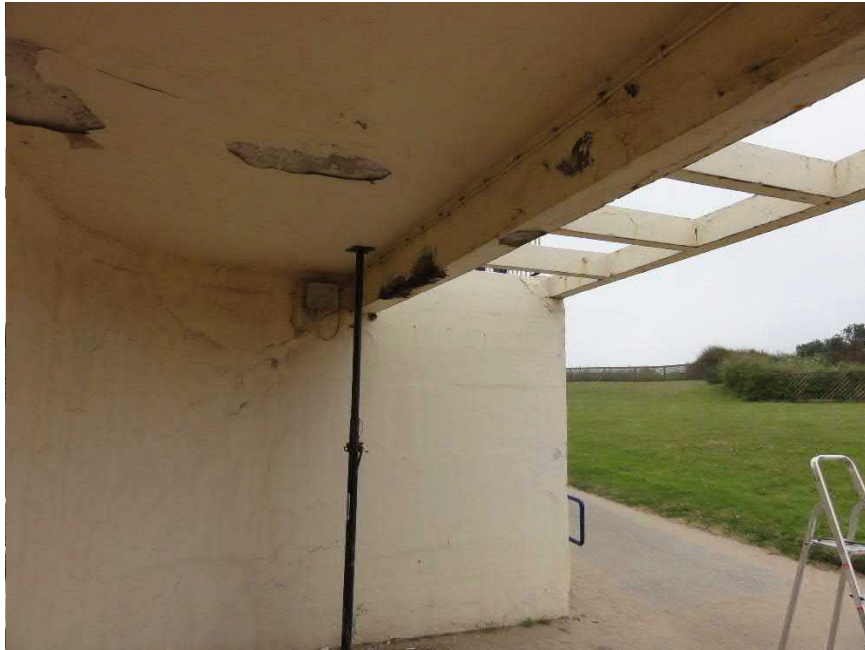
The bay GL 1-2, LL-MM was of a different construction arrangement at first floor level to the rest, as the first floor slab and fascia was set back approximately 1200mm. In the recessed area, the free spanning feature open grid of small cross section RC beams (no slab) had suffered extensive cracking, rust stains, hollow sounding concrete and some spalling. The recessed fascia beam had extensive spalling with advanced laminated corrosion and significant loss of cross section of the reinforcement steel to both the main tension steel and shear stirrups. The damage was so extensive to the small sections it was considered that grid of beams and the adjacent recessed fascia beam (supporting first floor slab) was a structural risk from falling concrete, and should be barriered off to the public until remedial measures implemented. The cross beams in Bay GL 1-2, LL-MM have suffered severe corrosion spalling and cracking and require replacement insitu, to a new structural design, if section retained for public use.

Photo no 17 Cross beams GL 1-2, LL-MM showing severe cracking and spalling necessitating temporary structural support.

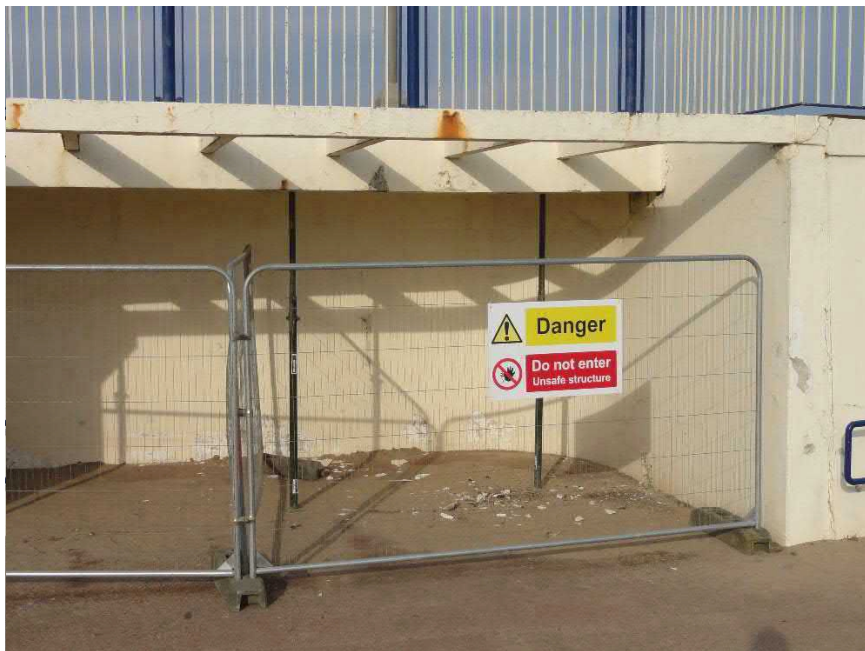
Photo no 18 Cross beams GL 1-2, LL-MM showing severe cracking and spalling and temporary structural support.

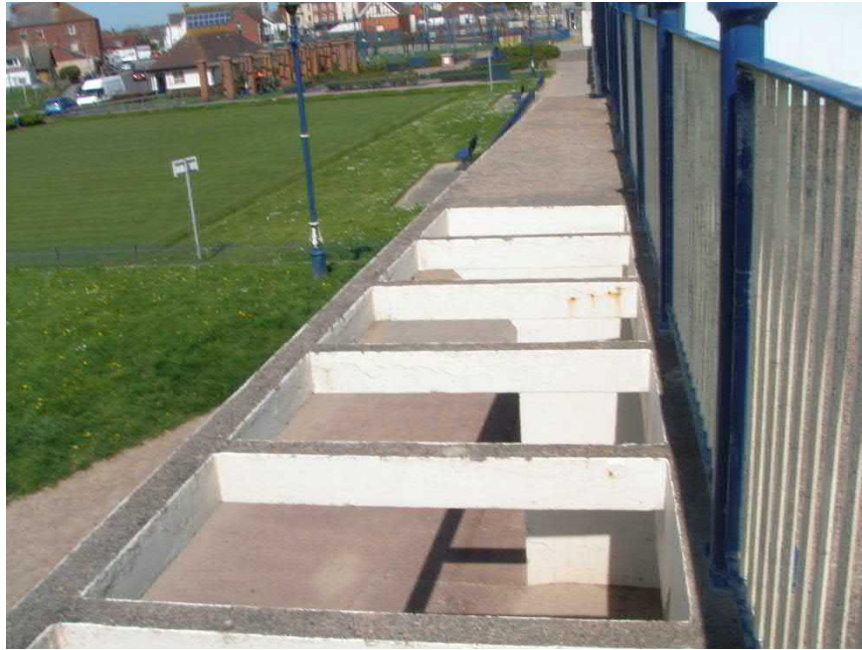
**Photo no 19 Small cross beams to fascia beam GL 1, LL-MM showing severe cracking and spalling.**

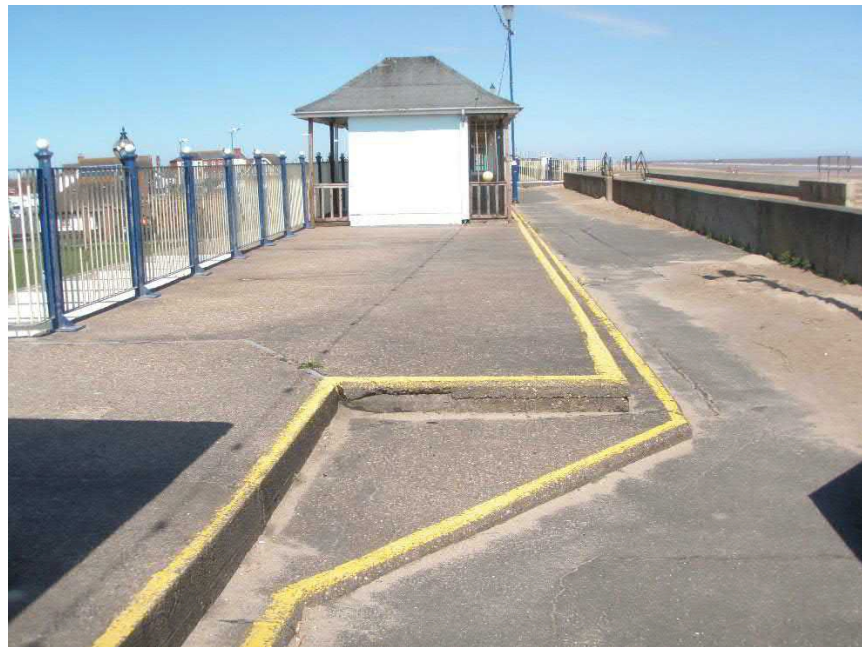
**Photo no 20: Promenade slab at GL 2-3, LL-MM showing shrinkage cracks.**

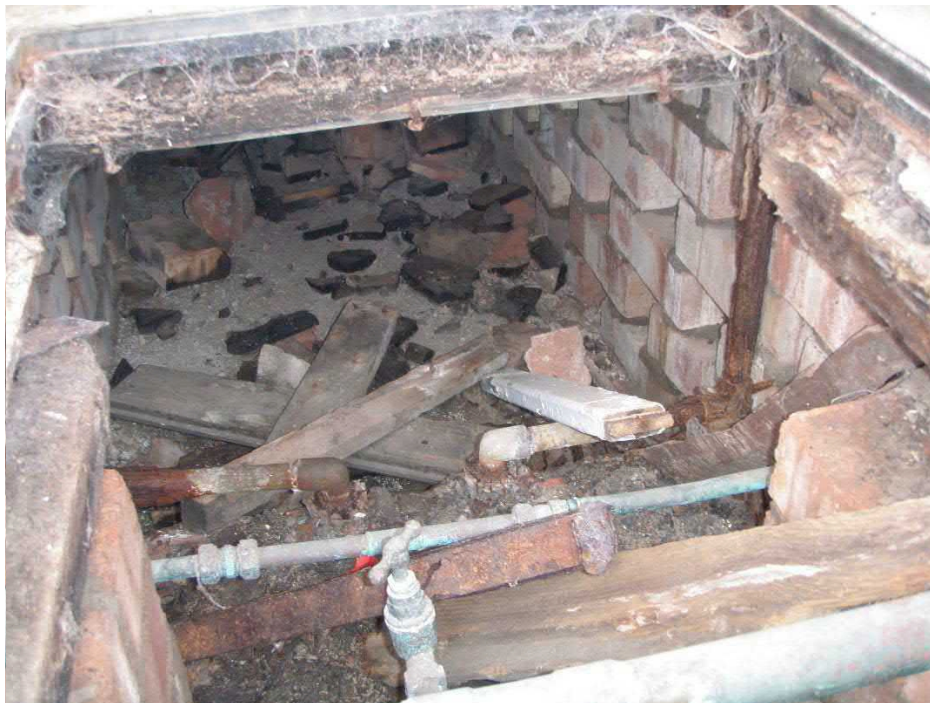
**Photo no 21: Under croft to huts nos 23-24 in central section showing water and drainage services.**

It is recommended that the under-croft below the timber floor to all the beach huts on the central and southern sections should be cleaned out of all heavy debris (old asphalt waterproofing and builder's debris) to reduce the dead load on the structure on weakened first floor slabs. The water leaks into the under-croft should also be sealed so the degradation to the RC concrete structure is not exacerbated. In addition, the drifting of washed up beach sand during the winter months from in front of the beach huts should also be closely controlled to mitigate overloading of suspended slabs not necessarily within the direct control of East Lindsey DC.

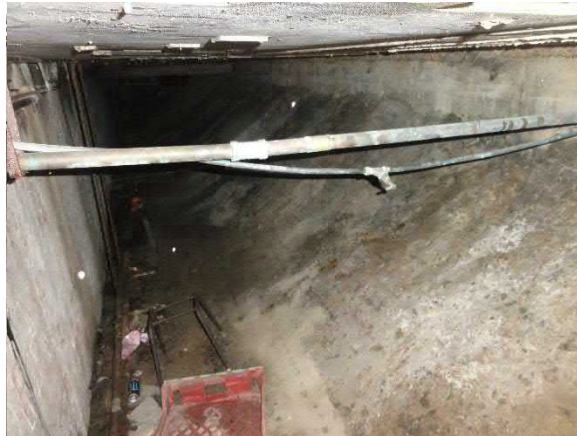
**Photo no 22: Confined space behind spine wall North section (May be in EA ownership).**

- a) Break out defects and patch repair with repair mortar complying with BS EN 1504. Reconstruct expansion joint with filler core and salt-water resistant sealant both sides where ever possible. This will

involve making new safe personal accesses, into the confined spaces, on the coastal side of the spine wall. This may involve consultation with the adjacent landlord, the Environment Agency as the ownership boundary is unclear.

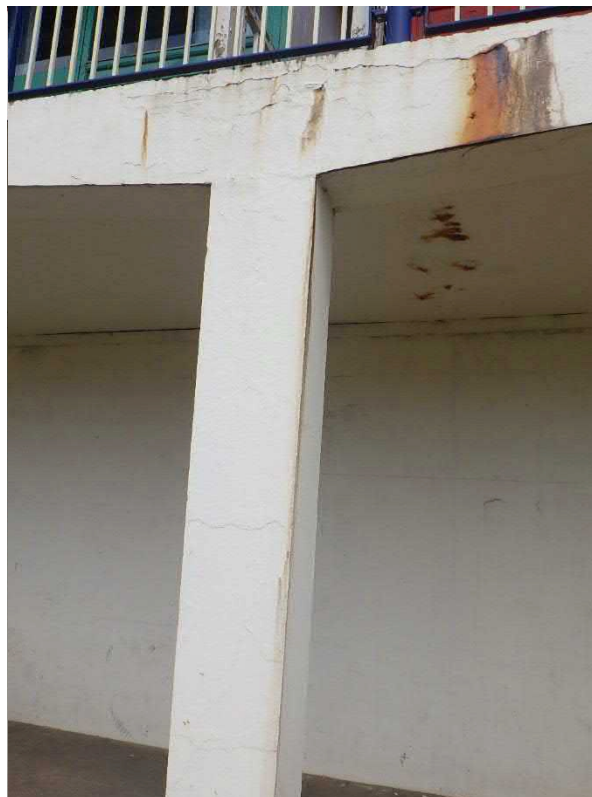
**viii) Fascia Beam over Column J1. (North section)**

**Photo no 23: Fascia beam over column J1 showing rust area and structural crack over column.**

- a) The fascia beam over the column has suffered severe reinforcement corrosion and a structural crack has occurred across the head of the column which needs investigating further and remediating insitu to a new enhanced structural design and detail.

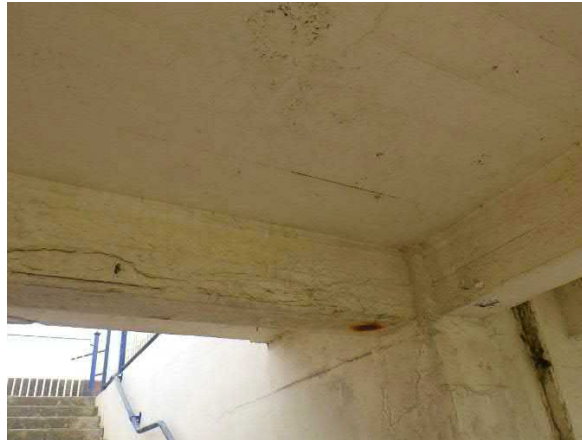
ix) **Cross beams in Bay GL 2, Z-AA.** (Central Stairs)

**Photo no 24: Cross beam over central stair access GL 2 Z-AA showing rust staining, cracking and hollow concrete.**

- a) The cross beam over the stairs has suffered severe reinforcement corrosion and structural cracking which needs investigating further and remediating insitu to a new enhanced structural design and detail.

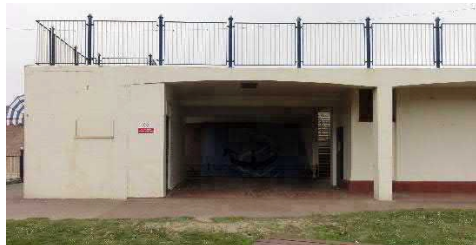
**Photo no 25: Showing area where first floor beams over access to North stairs which need regular structural inspections for public safety.**

Since the fascia and transfer beams which span over the public access to the North stairs to the promenade are not currently closed off from the public, are showing advanced signs of degradation we would recommend that these are inspected for safety, by an engineer with appropriate structural experience, at least every 10 weeks starting from 1<sup>st</sup> June 2018.

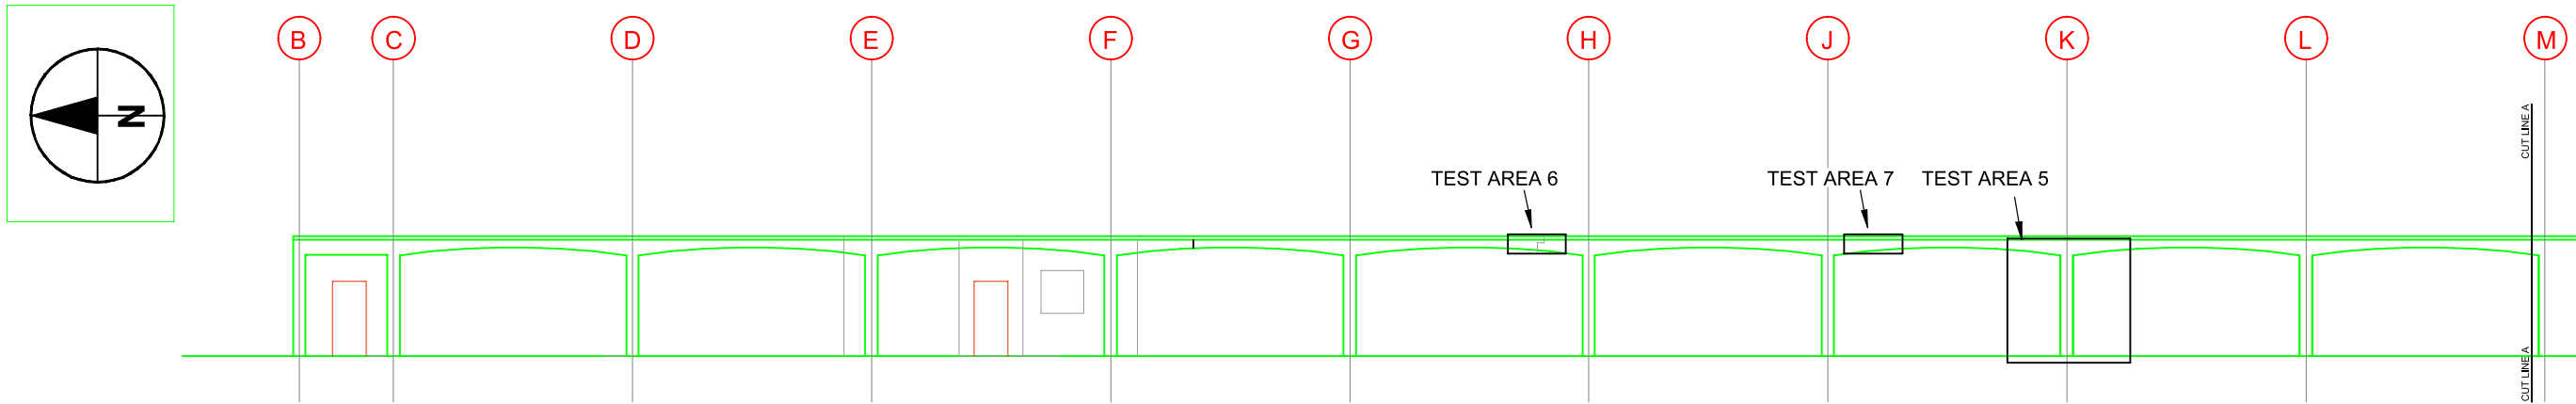
**NORTH SECTION ELEVATION**

ELEVATION OUTLINE SHOWING VISUAL STRUCTURAL DEFECTS
