# Sutton-on-sea

# Follow-Up Structural Inspection Report 03 on North Colonnade

For East Lindsey District Council

Project number: 60586167 60586167-ELDC-ACM-REP-0001-P1

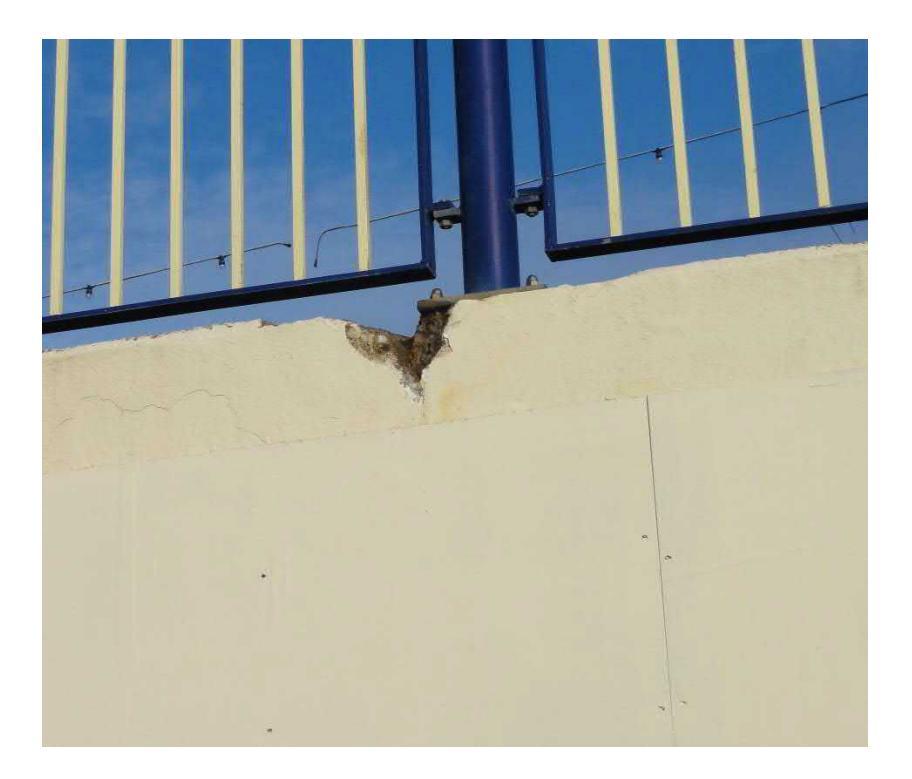
Photo no. 02: Concrete spall from first floor fascia beam GL 1K adjacent to balustrade fixing bolt. Bolt fixing still tight on day of inspection but now partly exposed and needs periodic monitoring.

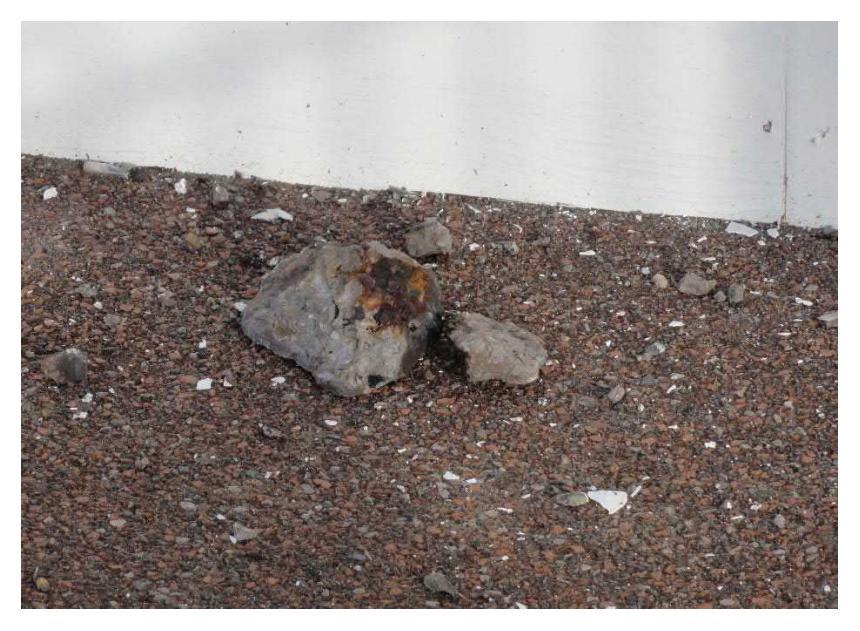
Photo no. 03: Close up of spalled concrete from Fascia beam GL 1K.

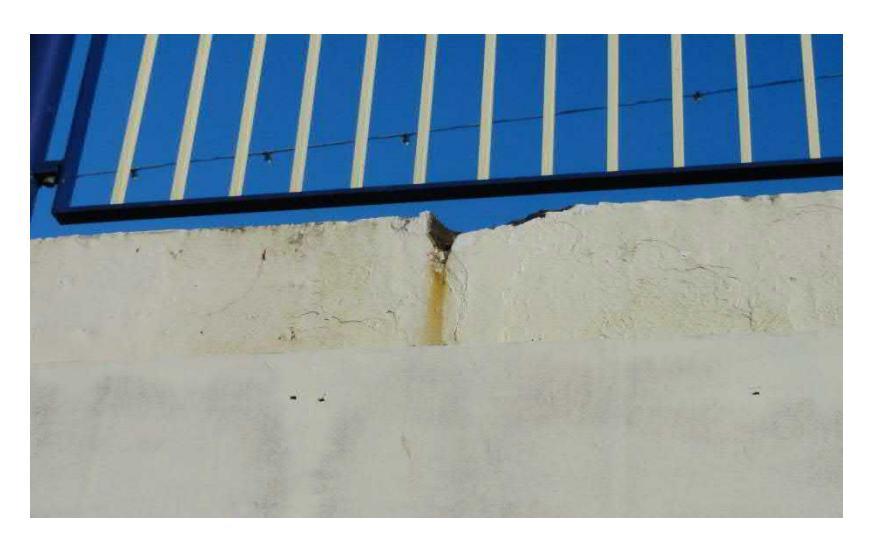
Photo no. 04: Spall and rust stain at Fascia beam GL 1, J-K.

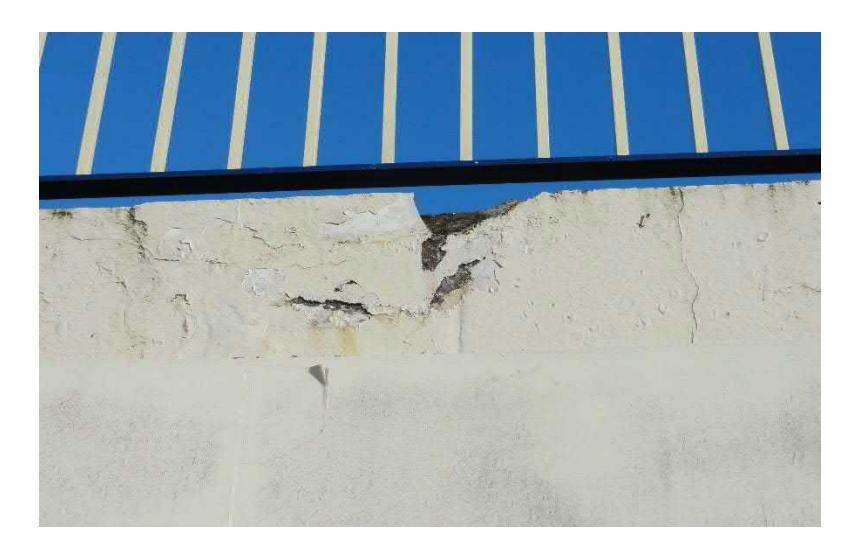
Photo no. 05: Additional concrete spall at Fascia beam GL 1K.

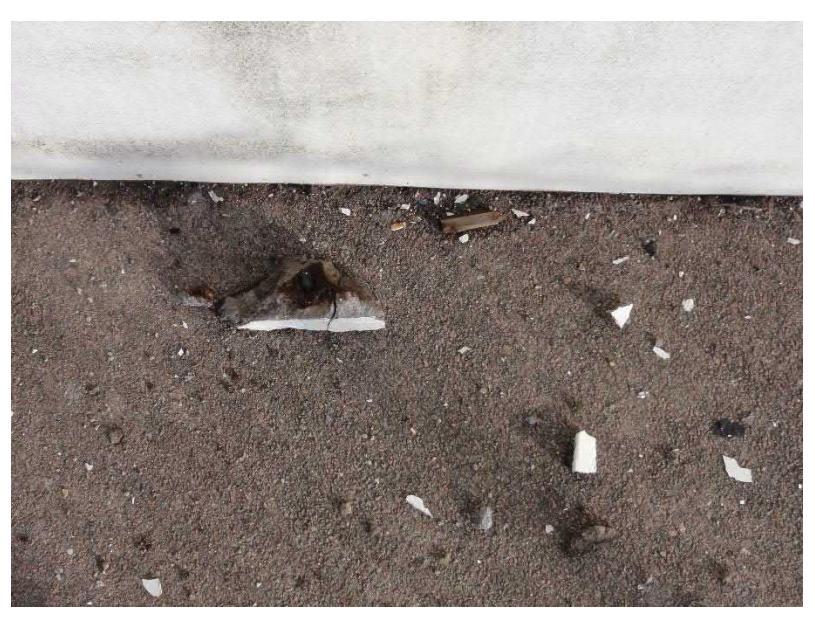
Photo no. 7: Close up of concrete spall at fascia beam GL 1K.

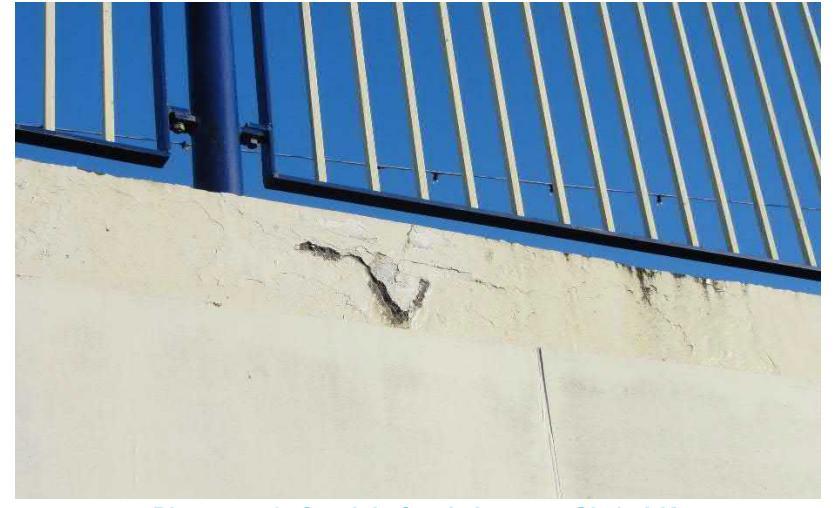
Photo no. 8: Crack in fascia beam at GL 1, J-K.

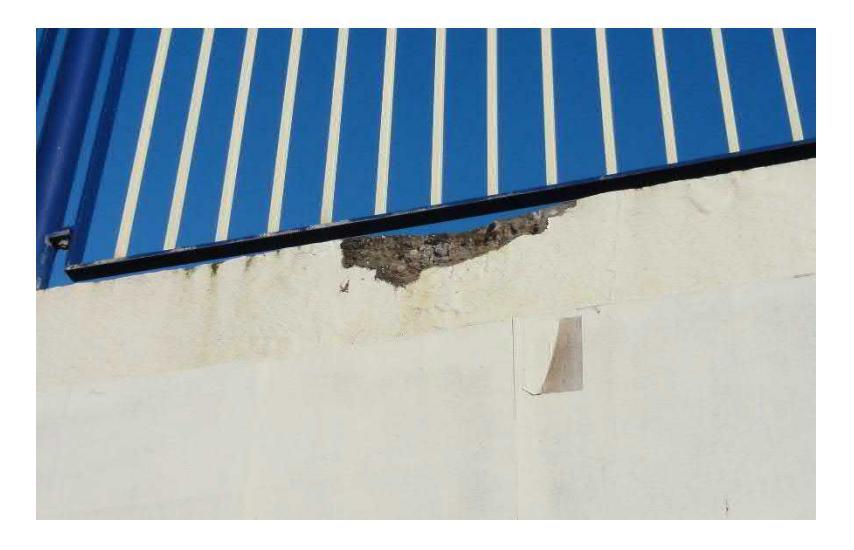
Photo no. 9: Additional concrete spall at fascia beam GL 1H.

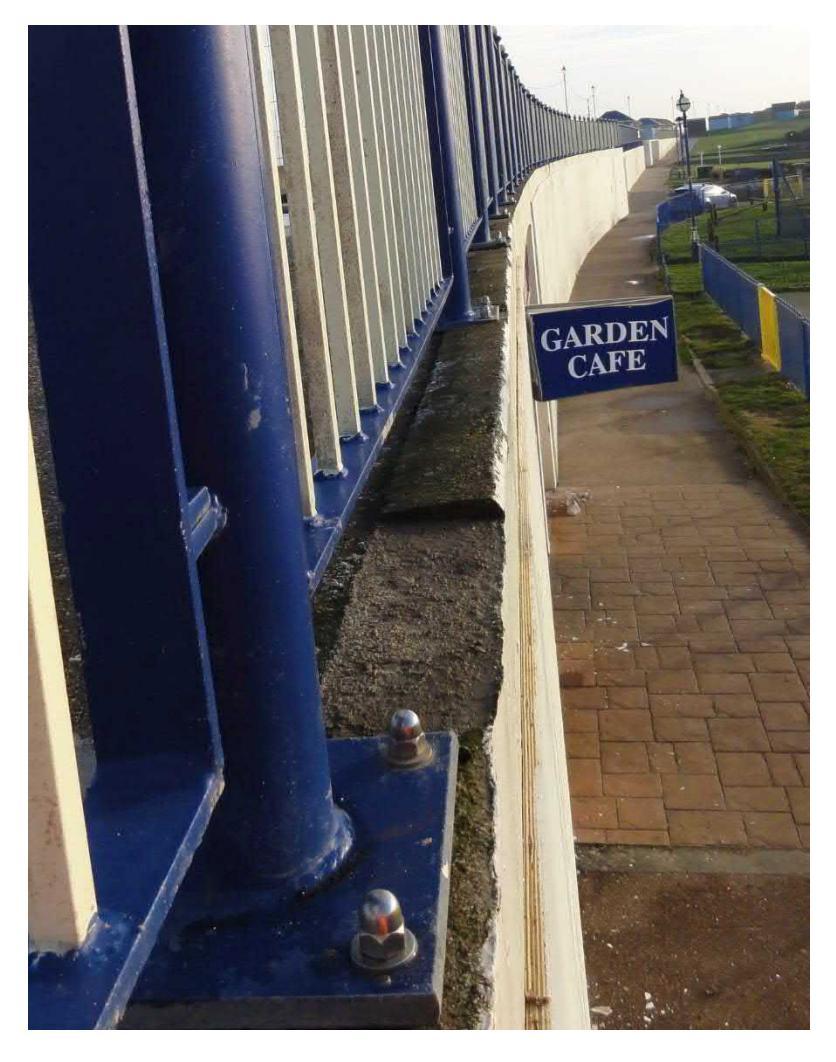
Photo no. 10: Close up of a thin mortar upstand spalling from the top face of fascia beam at first floor level GL 1, C-D.

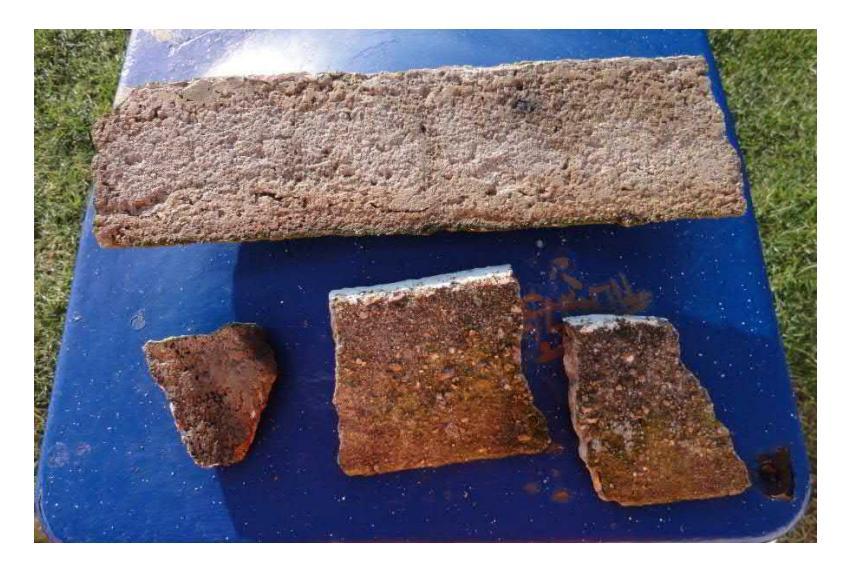
Photo no. 11: Close up of mortar spalled from top face of the fascia beam at first floor level GL 1, C-D.

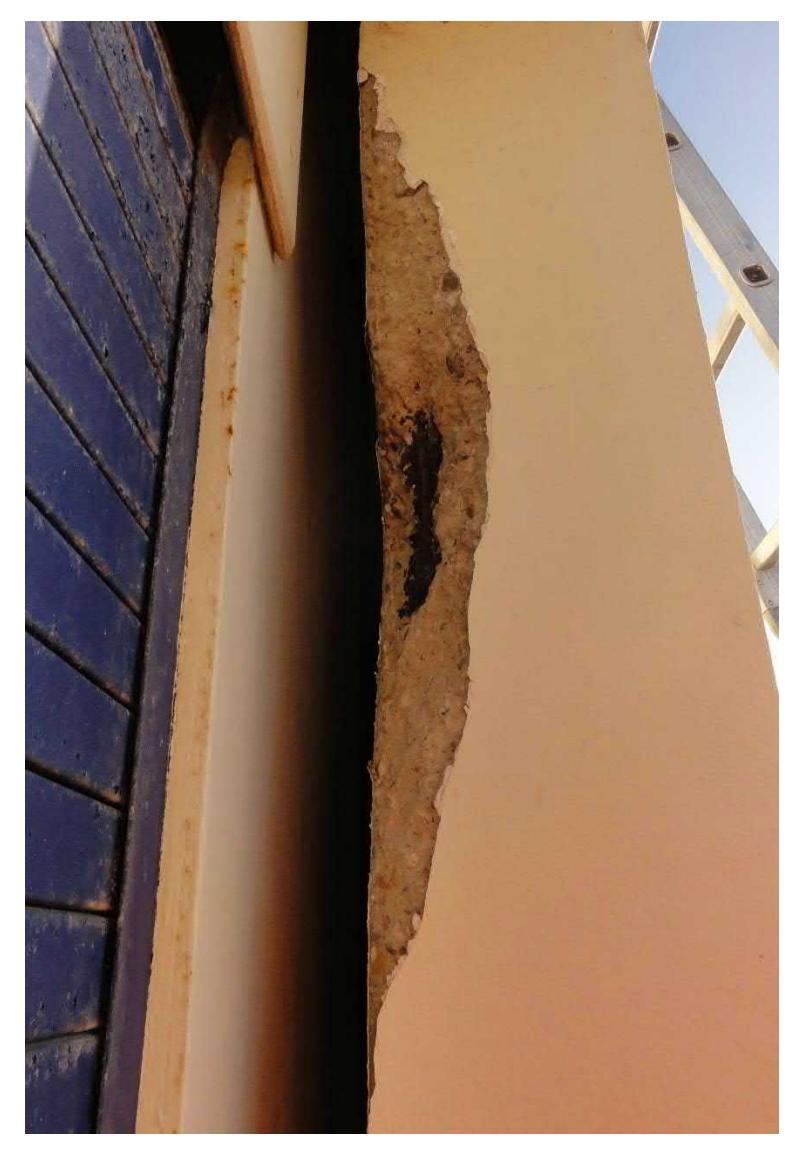
Photo no. 12: Concrete spall on corner of column GL F1 at mid height near café entrance and outside safety barrier.

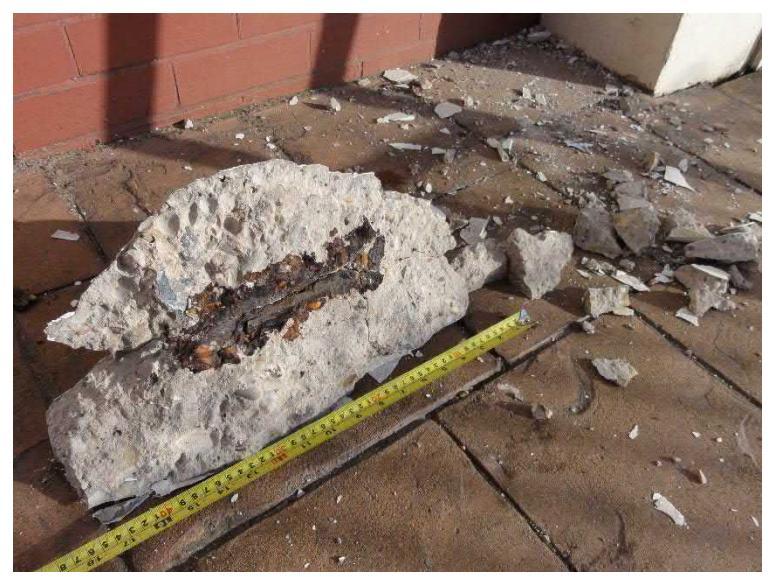
Photo no. 13: Concrete spall approx. 600mm long from corner of column GL F1 (Weight 8kg), removed for safety reasons. The column main steel bar reinforcement had lost some cross section area.

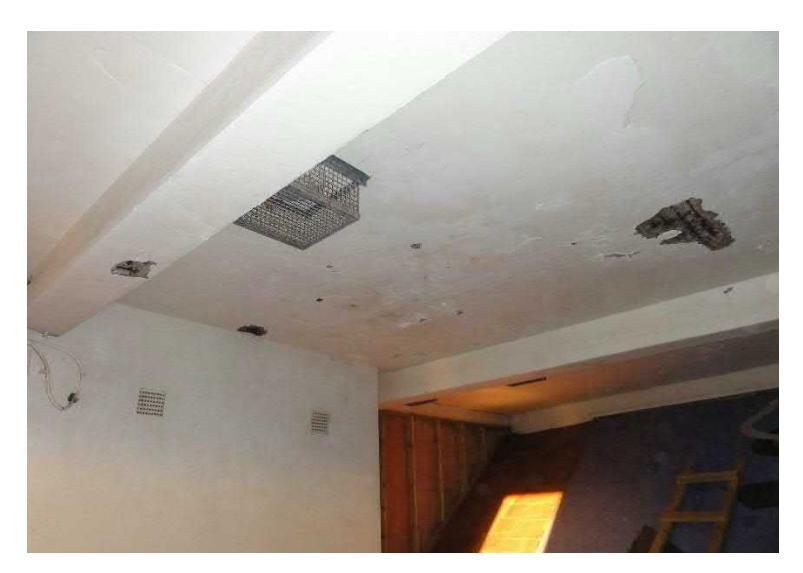
A two metre length of hollow concrete was also detected by hammer testing along the soffit and east side face of the central down-stand beams GL 2, C-G. It is recommended that the beam is supported to soffit and side faces with additional temporary props at 1.5m centres and scaffold boards acting as spreader plates, for safety reasons.

Photo no. 14: Further hollow concrete along cross beam GL 2 C-D. Reinforcement corroded at spalled area with only a slight loss of cross section. Hollow concrete not removed and temporary propping (at 1.5m centres) with scaffold boards acting as spreader plates recommended along soffit and east side of beam.

- c. The down-stand beam on GL 2, C-E should be supported on the soffit and sides with temporary props at 1.5m centres and scaffold boards acting a spreader plates.

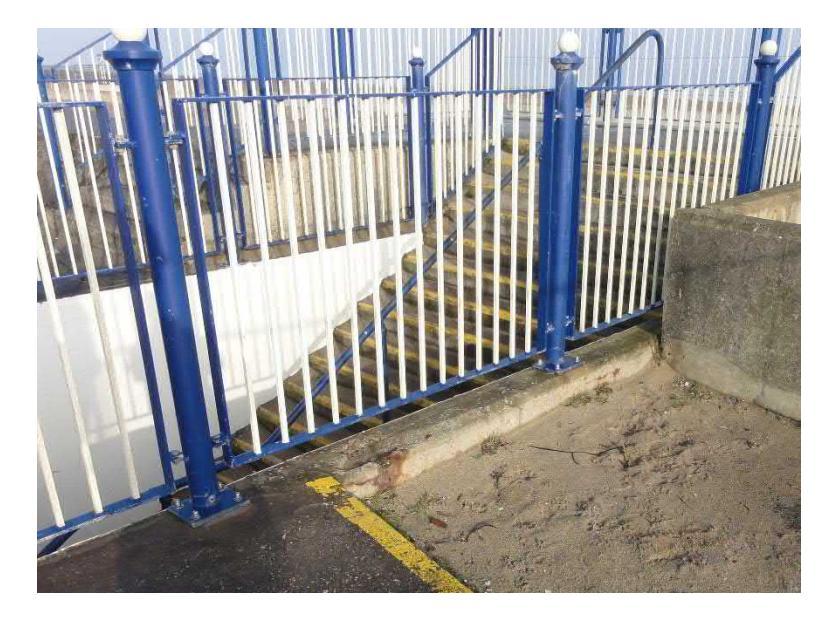
The north staircase, (GL 3, C-D) south side wall, top faces had developed additional hairline cracks. The north side wall had developed a small area of hollow concrete towards the top of the stair flight, since last inspection.

Photo no. 15: Top of north stair south side wall showing cracks with rust stains. On far side wall a small area of hollow concrete near top corner.

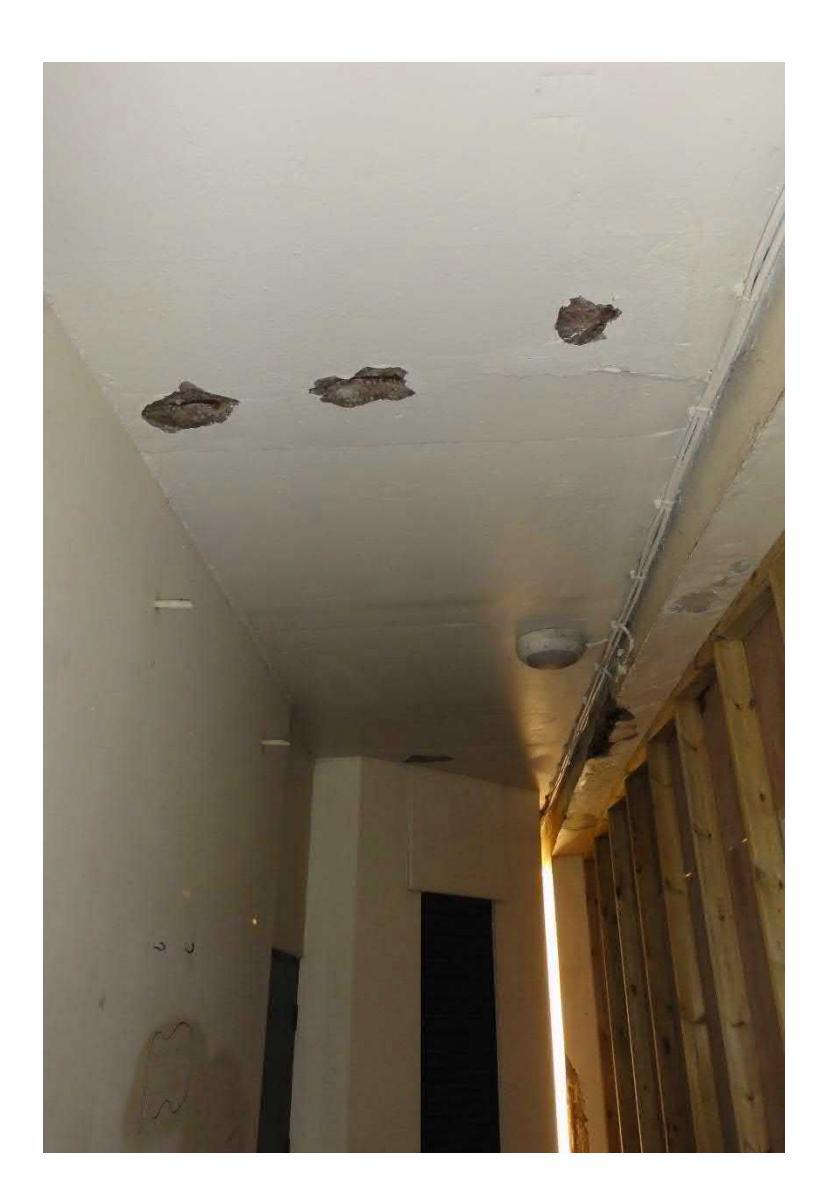
Inspection of the first floor soffit slab between GLs 1-2, D-E, revealed a further small area of hollow concrete which on further hammer testing, cracked and was removed as a precautionary safety measure. The spalled area is on the line of a hairline crack between two existing spalled areas. At the spalled concrete locations, the bar reinforcement had suffered some rusting but no significant loss of cross-section to bar diameter.

Photo no. 16: Soffit of slab GLs 1-2, D-E, shallow spalling on a hairline crack. Reinforcement corroded with no significant loss of cross sectional area. Visual and hammer test inspection of the first floor soffit slab between GLs 1-2, C-D along a previously identified crack revealed some minor spalling and damp concrete with two water droplets. This may have been exacerbated by the cold weather at the time of the inspection.

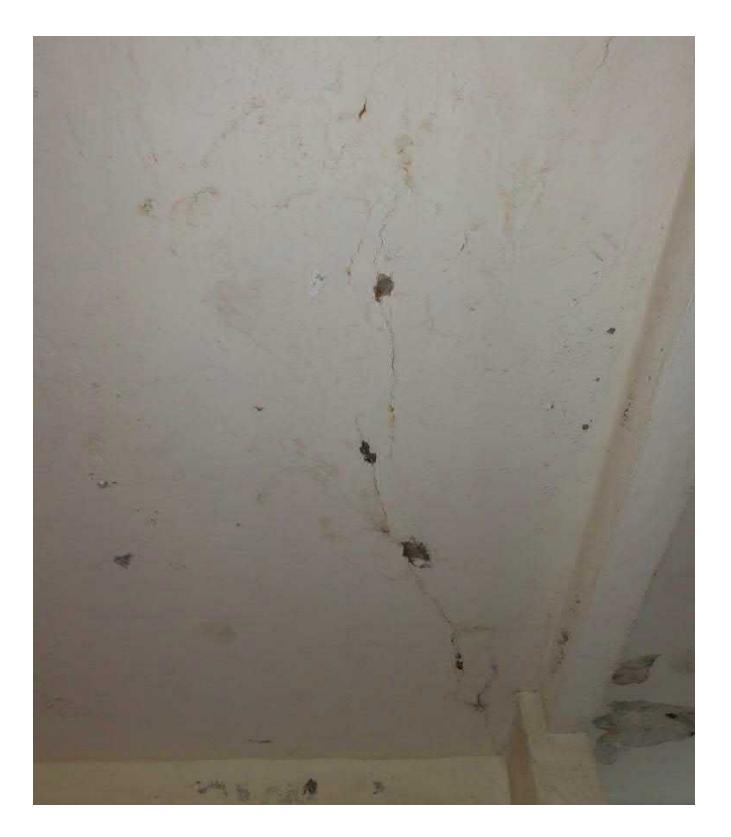
Photo no. 17: Hairline crack in slab soffit at GLs 2-3, C-D with some minor damp patches and spalling.

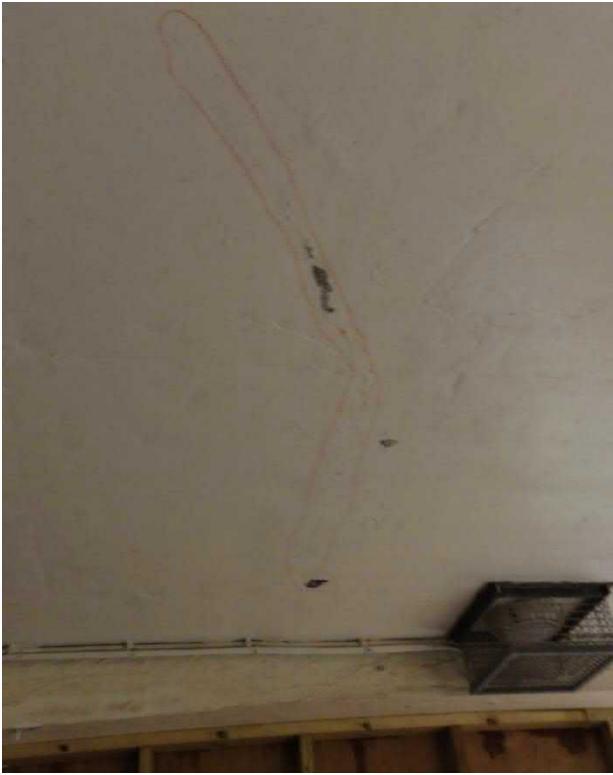
Photo no. 18: Crack in soffit of first floor slab GL 1-2, C-E with some minor spalling.

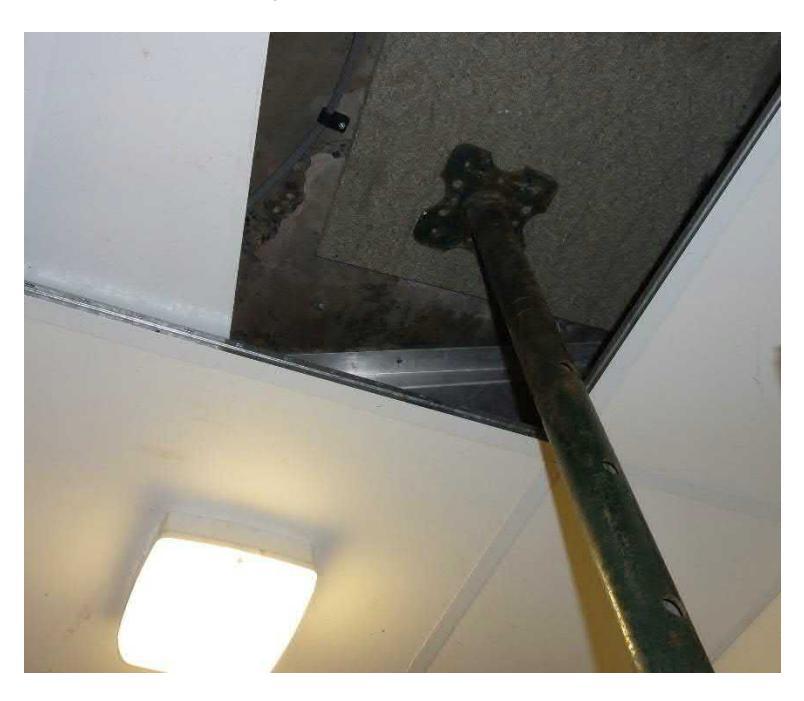
As previously observed, during the last inspection, the large piece (approximately 0.5m square) of spalled concrete on the soffit of the roof slab over the café toilet, was further supported with two additional temporary steel props (erected by Gelders) for safety reasons. The main reason for this precaution was the fact that the exact extent of the defect could not be readily inspected.

Photo no. 19: Spalled area of roof slab above Café internal toilet, with temporary prop and spreader board (approx. GL 1-2, D-E.)

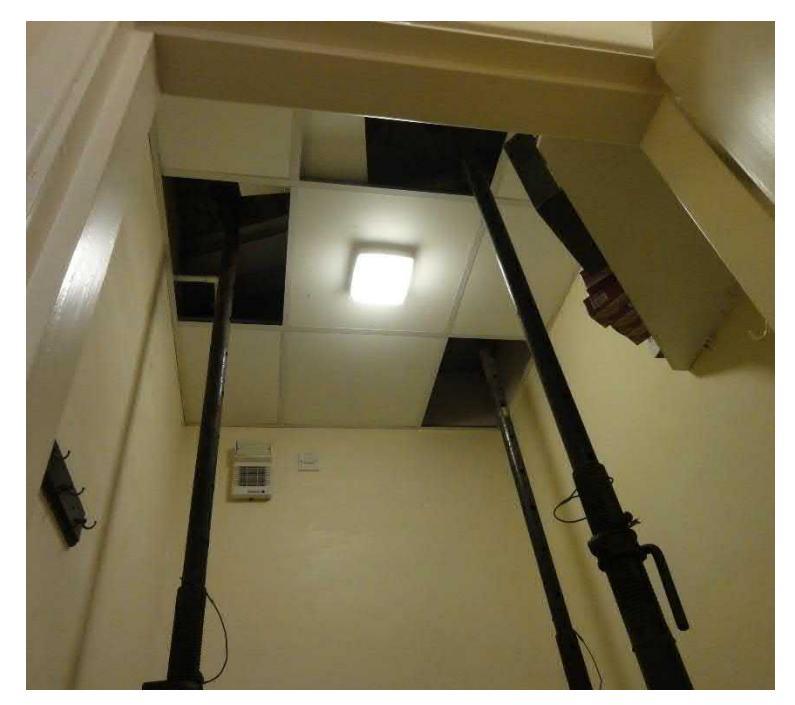
Photo no. 20: Three temporary props to spalled area of concrete at first floor roof slab over the toilet of Café GL 2, E-F

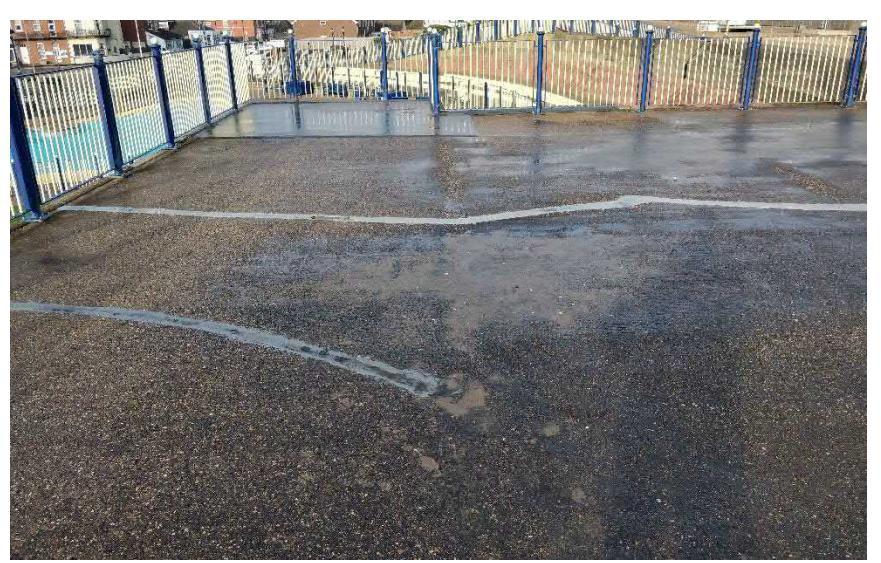
Photo no. 21. Repaired cracks in first floor slab (not preformed construction joints), at promenade level, which approximately corresponds with cracks in the soffit over the access to north stair below. (GL 1-2-3, C-D).

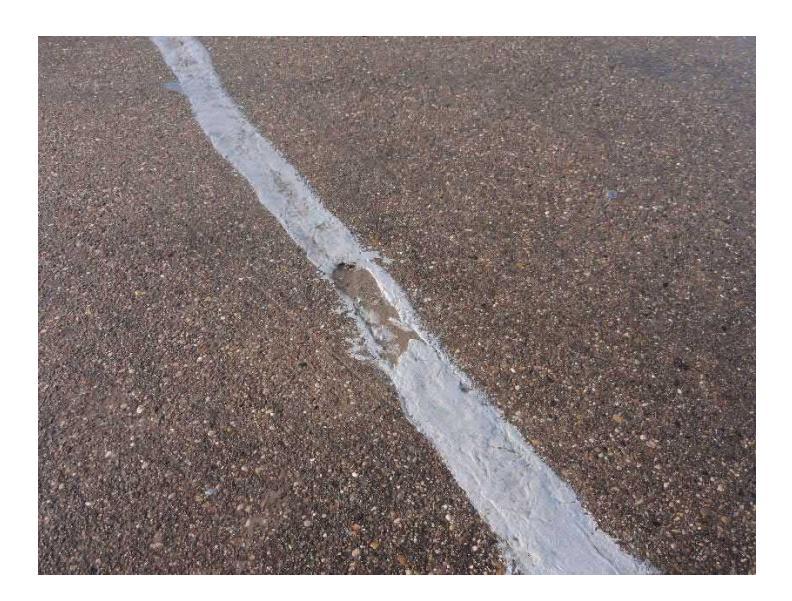
Photo no. 22: Repaired cracks in first floor slab at promenade level with a minor defect corresponds with cracks in soffit to access to north stair below. (GL 1-2-3, C-D).

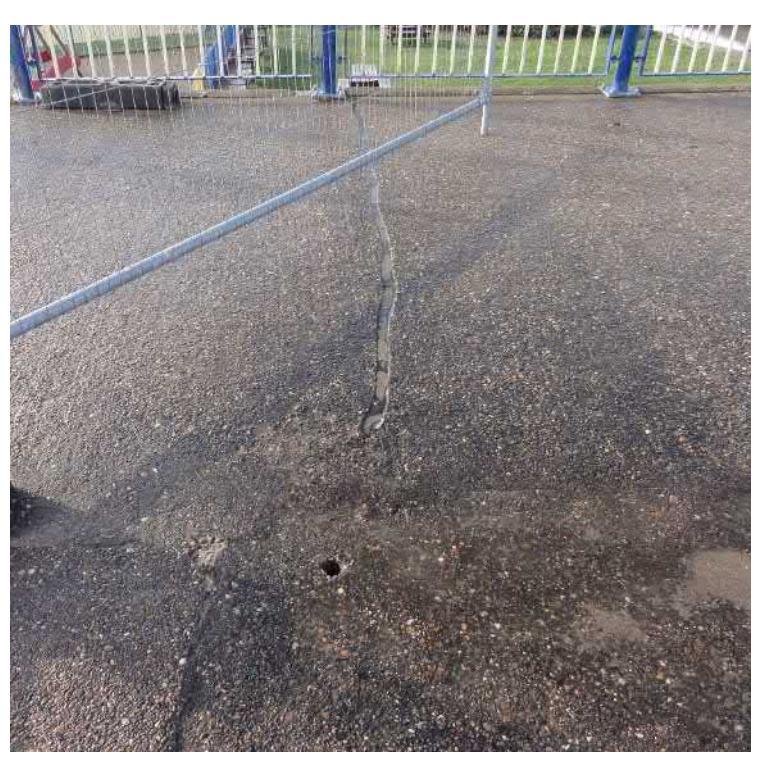
Photo no. 23: Repaired cracks in slab (not construction joint) at promenade level which approximately corresponds with crack across the Garden Café toilet ceiling below. (GL 1-2, D-E). Drilled hole in foreground penetrates through concrete slab.

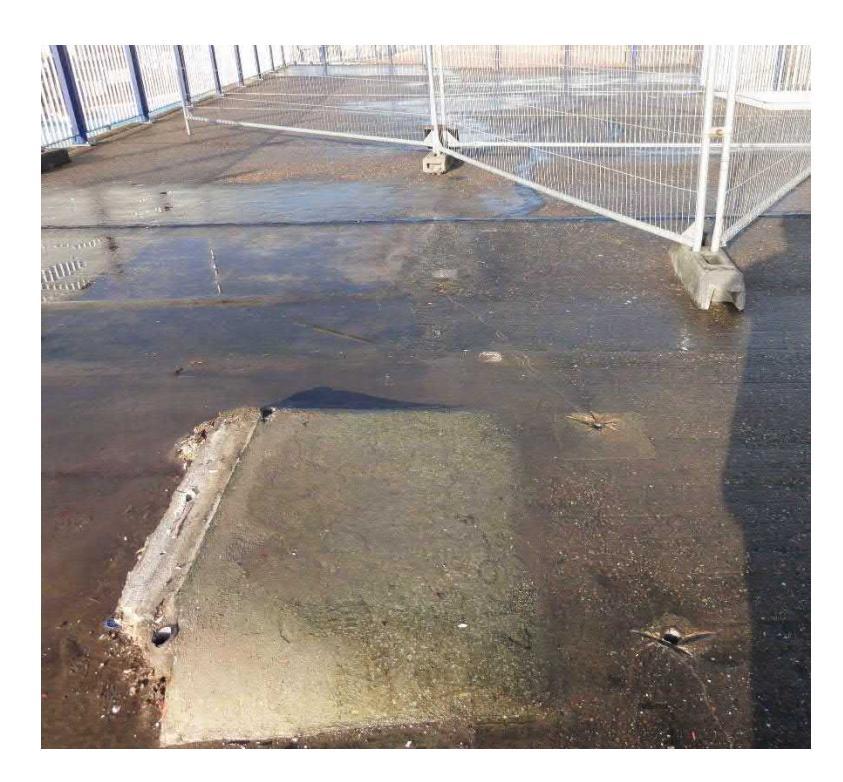
A previously observed spalled opening in the concrete on the roof slab soffit situated under the former chalet no 2 (GL 2, E-F) which was also dripping water was traced to a recent observed opening observed through the first floor roof slab at promenade level (which is shown in the following photo no. 24).

Photo no. 24: In foreground a concrete ramp to former beach hut no. 2 with evidence of cut handrail posts. Circular holes (25mm diameter) through concrete slab (Mid height left photo) at promenade level which approximately corresponds with the hole in Café ceiling, weeping water below. (GL 1-2, E-F). Horizontal repaired crack in top of photo exhibiting damp patches on ceiling in café (to north side of front door).

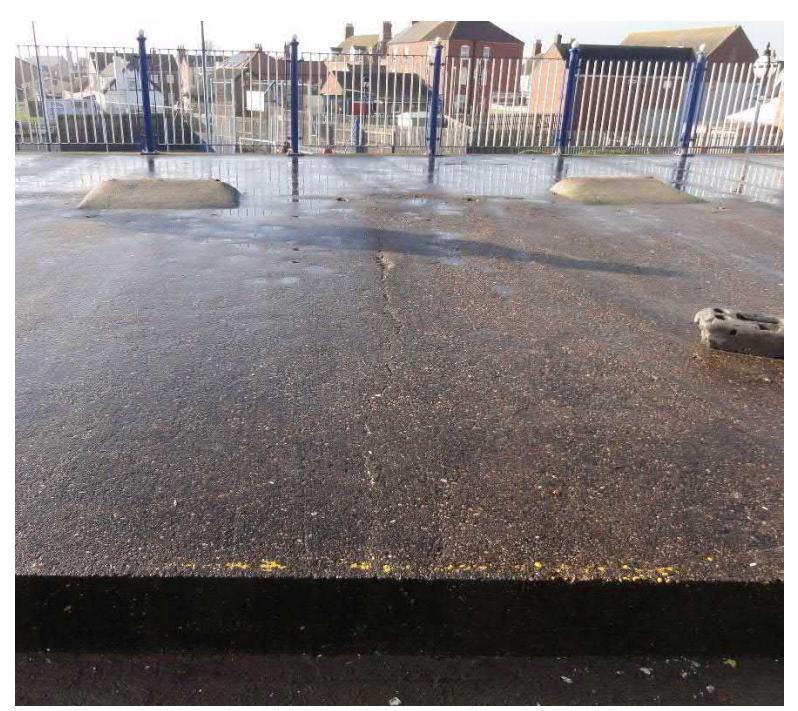
Photo no. 25: Photo showing an example of one of the seven pairs of openings (100 x 75mm) through slab (middle of picture) at promenade level which pass directly through into the confined space void between the spine wall (GL 2) and the sea defence revetment. These are potential leak sites. Also a shrinkage crack in concrete slab joins up with a preformed opening (from bottom to top of photo).

- e. Close off the openings through the first floor slab to mitigate potential leaks into the colonnade structure and adverse structural consequences. Consider repairing the wear to the previous repairs to the cracks on the first floor slab between GLs 1 to 2 and E to Y as leaking water will adversely affect the RC structure below.

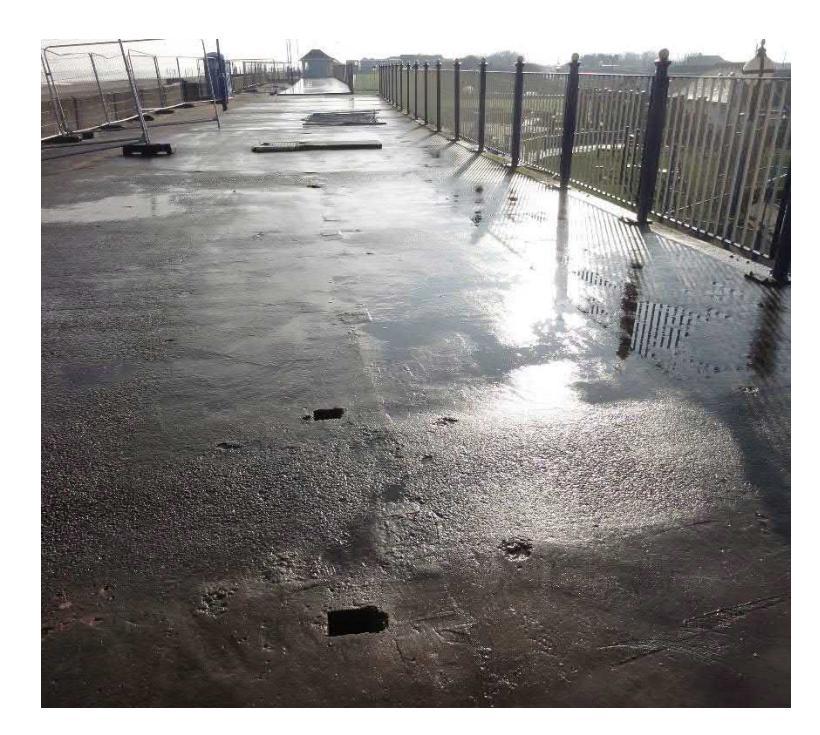
Photo no. 26: Photo showing an example of the seven pairs of formed openings (100 x 75mm) and seven 25mm diameter openings through the 130mm thick concrete slab (middle of picture) at promenade level which pass directly through into the confined space void between the spine wall (GL 2) and the sea defence revetment. These are potential leak sites.

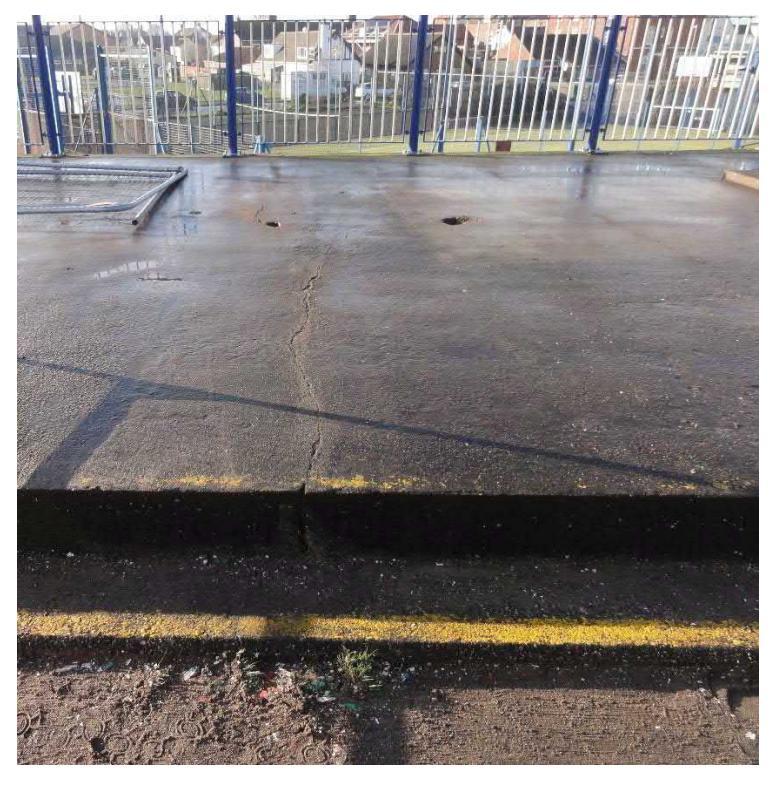
Photo no. 27: A shrinkage crack in first floor concrete slab over colonnade, (from top to bottom of photo) GL 1-3, J-K. Preformed openings also shown.

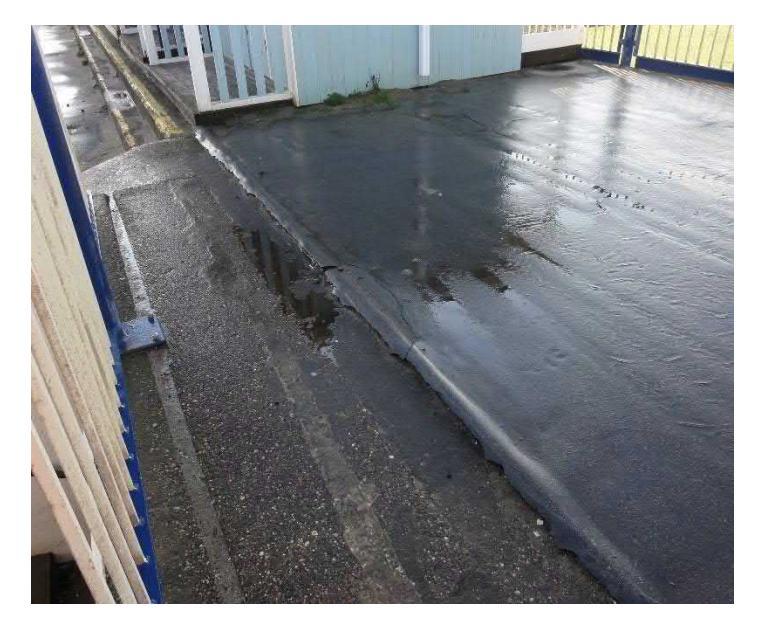
Photo no. 29: Photo of mastic asphalt over first floor slab over central staircase with broken edges and start of crack towards centre of slab (Potential leak).

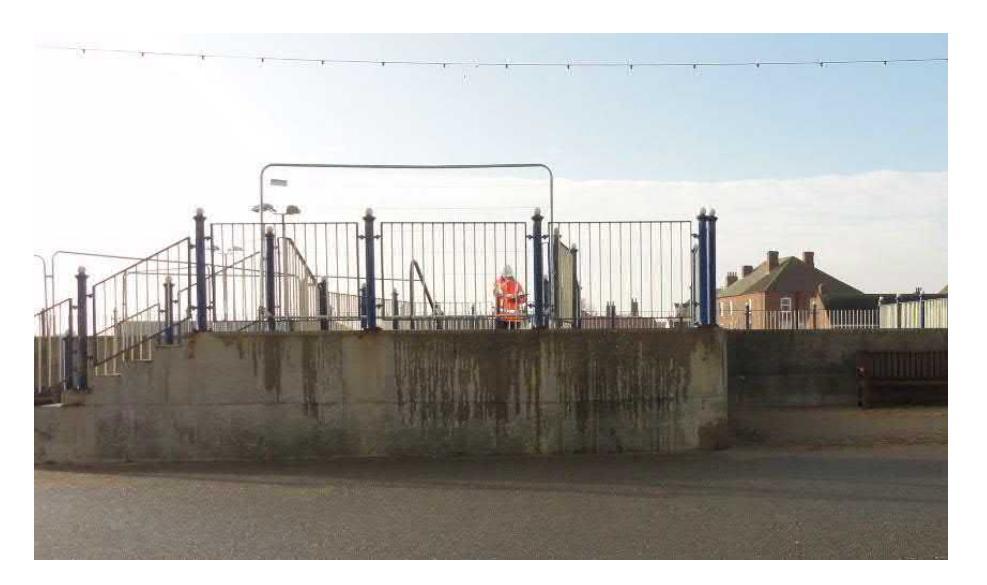
Photo no. 30: Photo from promenade showing the north staircase with public access still available onto the first floor slab at the north end, despite Heras fence panel positioned across the staircase entry.

- d. Restrict access onto first floor slab by extending barrier fence along the promenade across the north stairs access over the flood prevention wall.

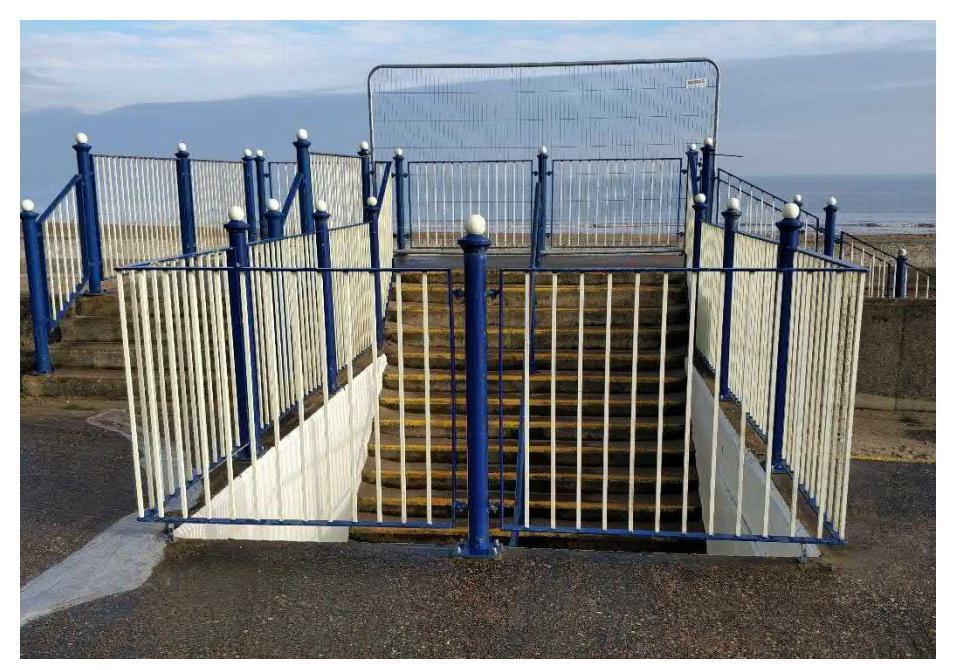
Photo no. 31: Photo from first floor slab showing north staircase with public access still available onto the first floor slab at the north end, despite the single Heras fence panel to the staircase entry.

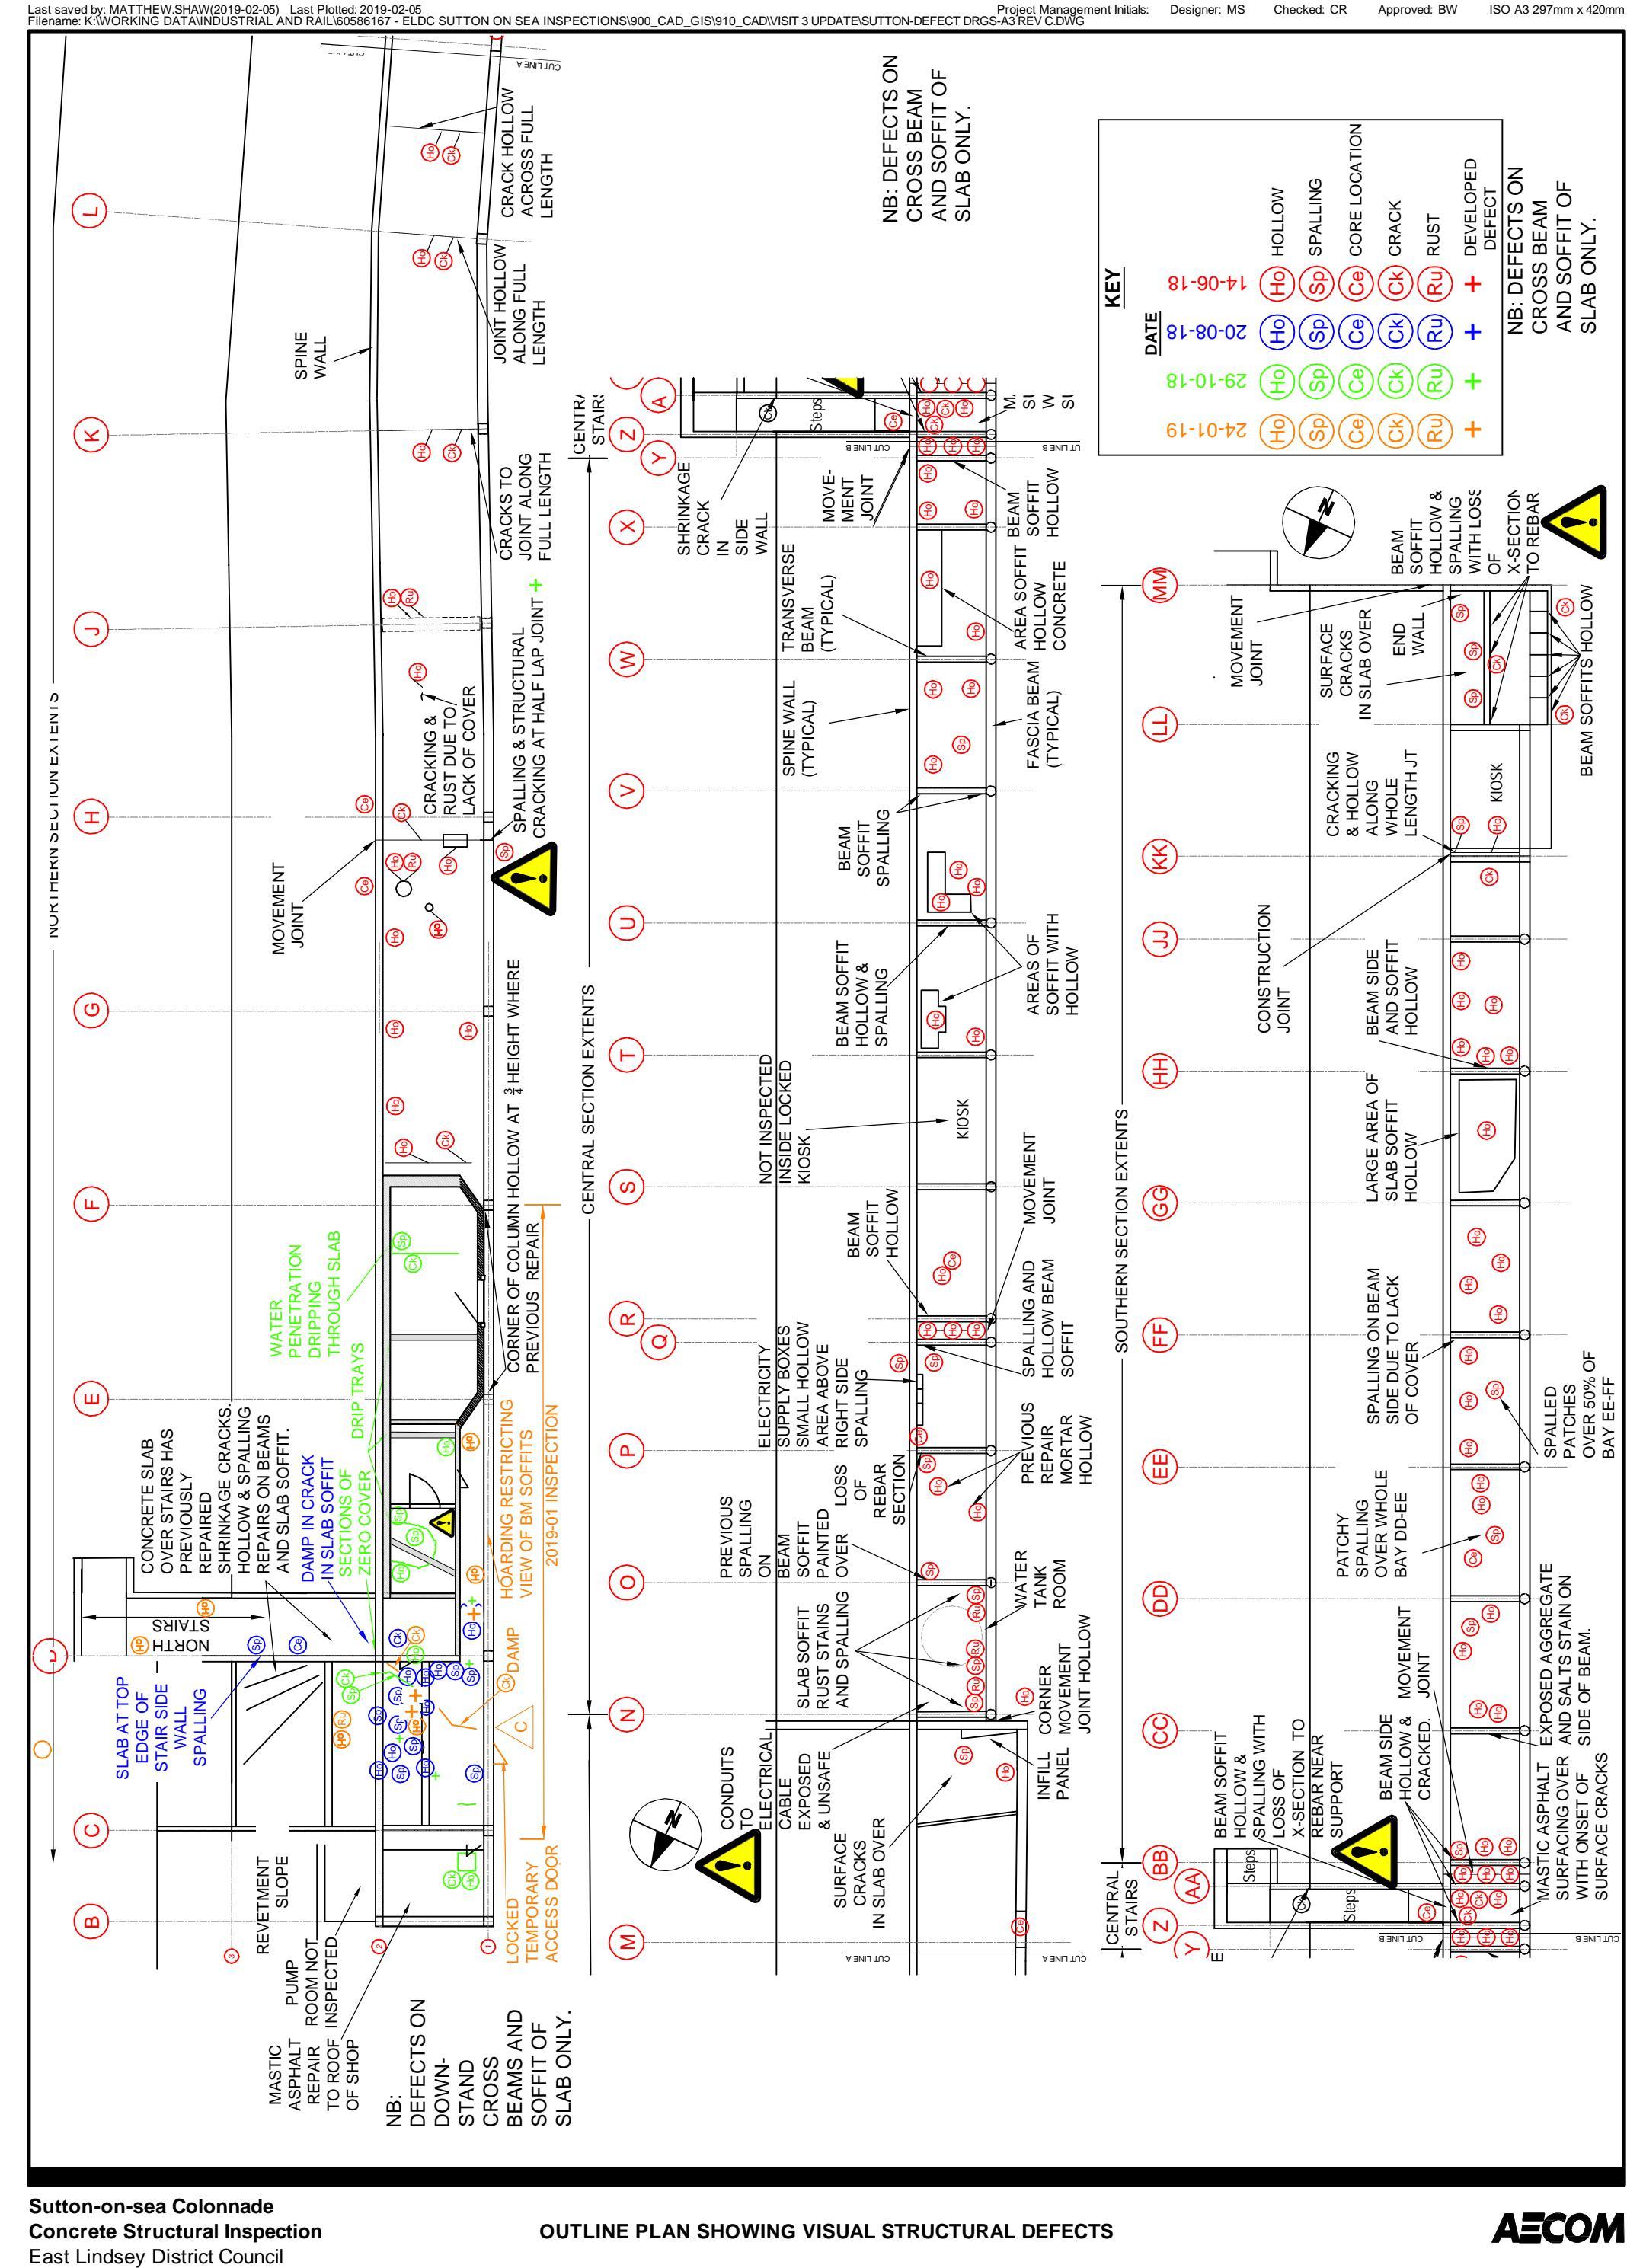
Fig. No. 3

A typical plan and cross-section sketch has been developed for the northern section, and included in Appendix A. The current visible concrete defects to the structural elements in the concrete structure leading to the north staircase have been added to the defect sketches included in AECOM's earlier Condition Report and an updated copy included in Appendix B.
