Kiwa CMT Testing

Report Number 74386/57776

Site: Sutton on Sea

Appendix 1:
Certificates of Chemical Analysis

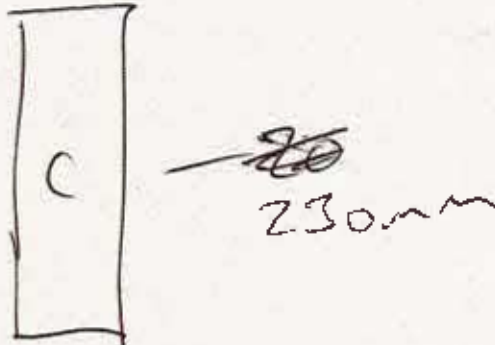
Offset from the: = m			
GPS Coordinates:			
Core Diameter: <u>100</u> mm	Coring type: <u>WET</u> DRY		
Foundation Condition <u>Cracked</u> / Rutted / Settlement / Surface Det'r / OK			
Is the core taken through the crack:			
If so Crack type: <u>Transverse</u> Longitudinal Cracking			
Did the core barrel lock/jam whilst cutting: YES <u>NO</u>			
If Yes, at what depth: mm			
Condition of core: <u>Good</u> De-bonded Shattered Partial Recovery			
Depth cored to: mm	Core length mm		
Nature of material at bottom of core hole:			
Have photos been taken? (general core location before, core on extraction and down core hole) <u>YES</u> NO

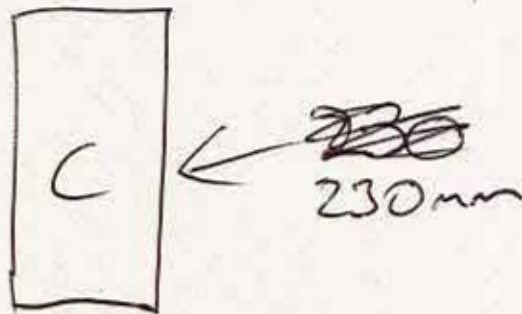
Offset from the: = m				
GPS Coordinates:				
Core Diameter: <u>100</u> mm	Coring type: <u>WET</u> <u>DRY</u>			
Foundation Condition: <u>Cracked / Rutted / Settlement / Surface Det'r / OK</u>				
Is the core taken through the crack:				
If so Crack type: <u>Transverse</u> <u>Longitudinal</u> <u>Crazing</u>				
Did the core barrel lock/jam whilst cutting: YES <u>NO</u>				
If Yes, at what depth: mm				
Condition of core: <u>Good</u> <u>De-bonded</u> <u>Shattered</u> <u>Partial Recovery</u>				
Depth cored to: <u>230</u> mm	Core length <u>230</u> mm			
Nature of material at bottom of core hole:

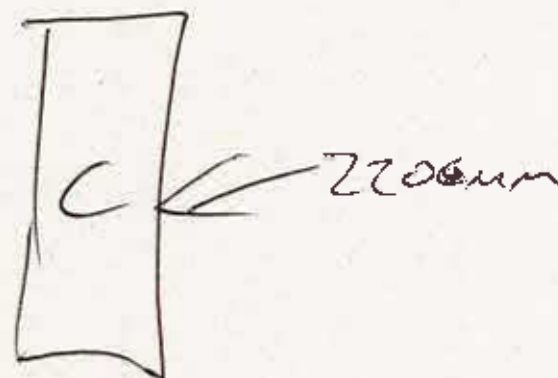
Project:		Job No.	08251017	Core Sketch: (Detail sketch with measurements of extracted sample)
Site:	Sutton on Sea	Date:	24/05/18	
Coring Operator:	BP/CC	Time:		
Weather conditions:			DRY	
Core No./Ref:	Ch/MP/ELR Ref:			
Grid Line 2 PL				
Direction:	Lane:	X Pos: (ns/os etc)		
Offset from the:			= m	
GPS Coordinates:				
Core Diameter:	100 mm	Coring type:	WET DRY	
Foundation Condition: Cracked / Rutted / Settlement / Surface Det'r / OK				
Is the core taken through the crack:				
If so Crack type: Transverse Longitudinal Crazing				
Did the core barrel lock/jam whilst cutting:			YES NO	
If Yes, at what depth:			mm	
Condition of core: Good De-bonded Shattered Partial Recovery				
Depth cored to:	220 mm	Core length	220 mm	
Nature of material at bottom of core hole:				
Have photos been taken? (general core location before, core on extraction and down core hole)			YES NO	
Has sample of sub-base been taken and bagged:			YES NO

(Please detail/comment on any findings during coring)

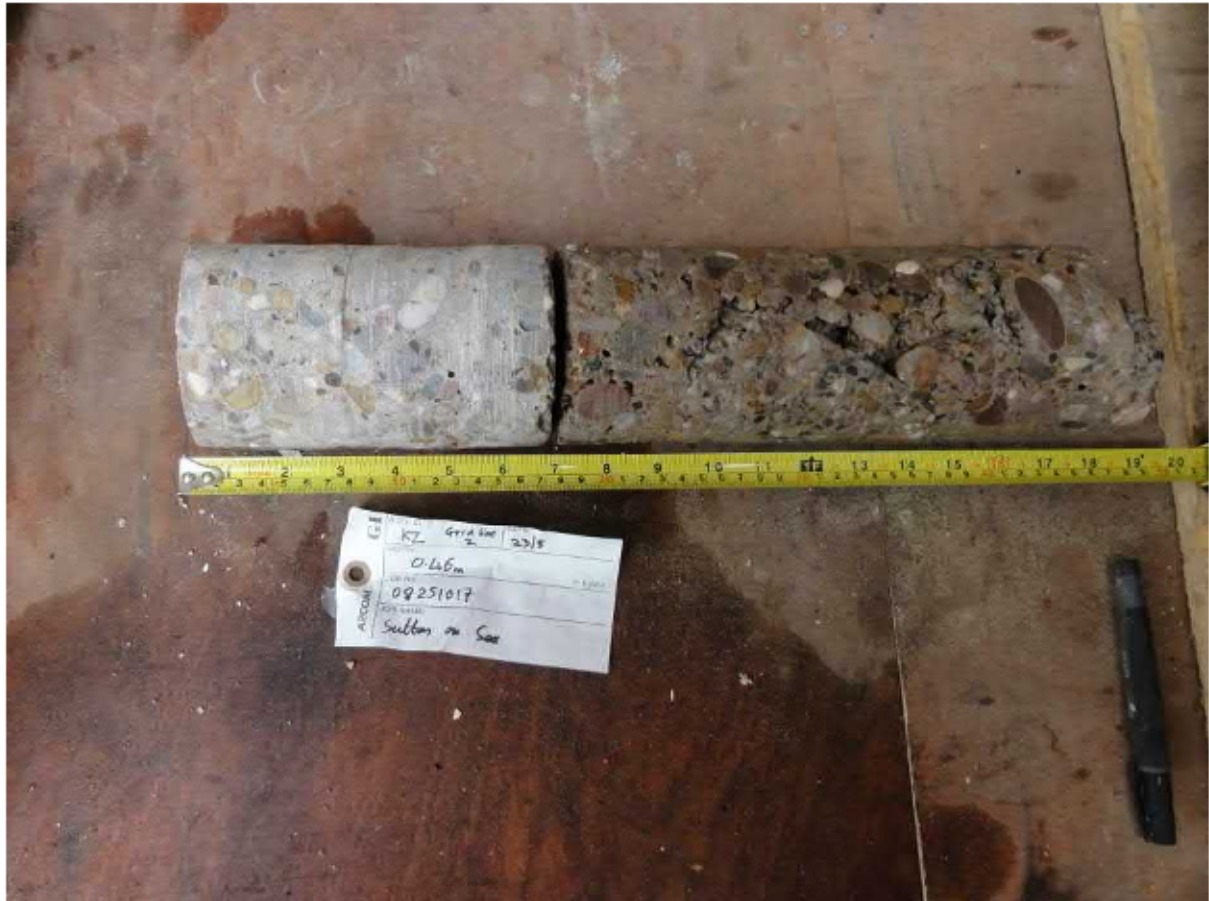
Figure 1 K2 Gridline 1

Laboratory Ref. No.	57776.01	Max Length Received (mm)	160.0								
Client Reference	GL K2 Grid Line 2	Min Length Received (mm)	160.0								
Orientation	Horizontal	Diameter (mm)	98.0								
Site Curing Condition	Average	Saturated density by displacement (Kg/m³)	2428								
Max. nom. size of agg.	14mm	Excess Voidage (%)	1.0								
Date Drilled	23.05.18	Length After Capping (mm)	96.0								
Visual inspection including abnormalities	2 pieces	Length Diameter Ratio	0.98								
Condition Of Storage	Water	Reinforcement									
Date Cast	N/K

Diameter ϕ	d*	0	0	0	0	0	0
Diameter ϕ	d*										
0	0										
0	0										
0	0										
Date Tested	20.06.18	* Distance of bar axis from nearest end									
Moisture condition at test	SSD	Load At Failure (kN)	452.8								
Lab. Water Curing (Days)	6	Core Strength (N/mm²)	60.0

Method of preparation	Sulphur Capping
Condition on receipt	OK
Failure type and observations	Explosive
Mix details	Not Known
Deviation from standard	None

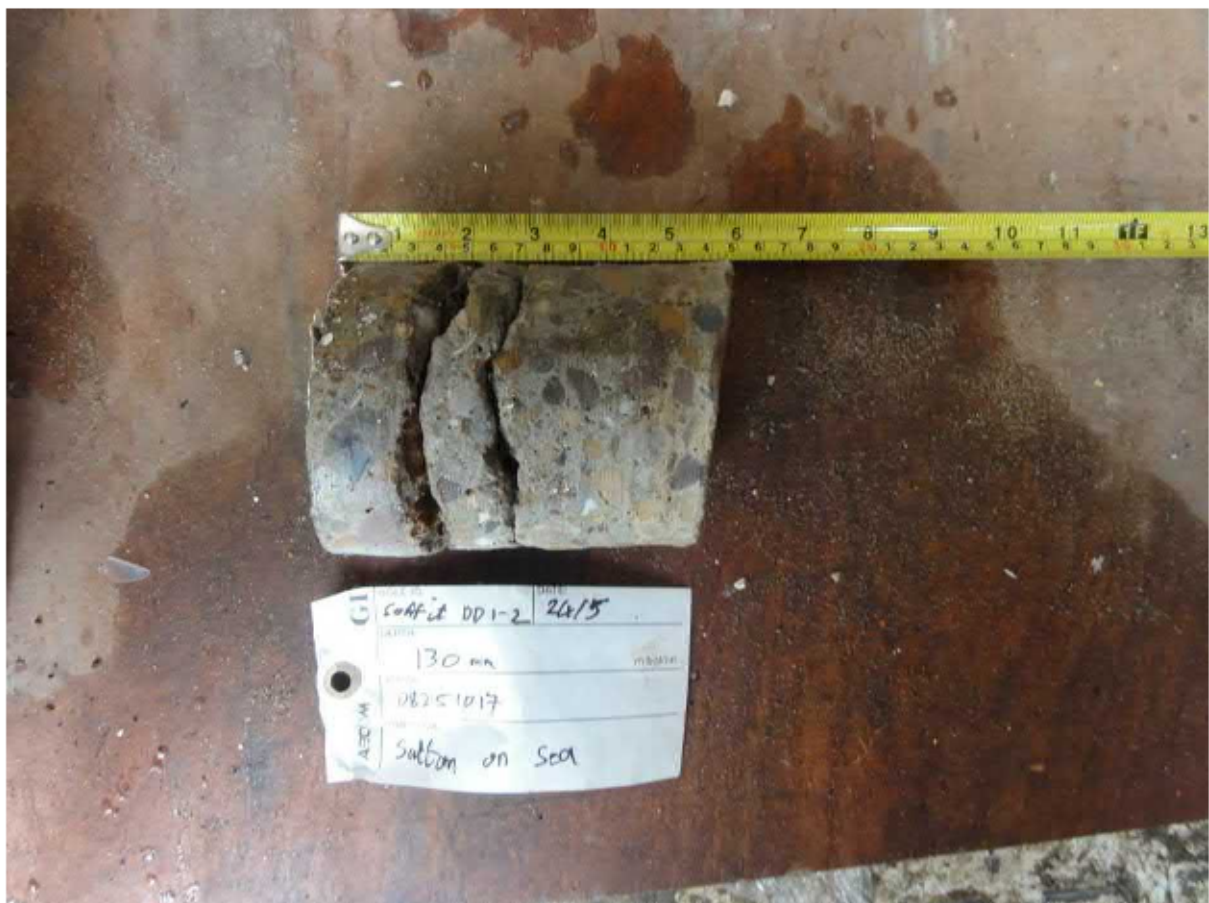
Figure 2: DD1-2

Comments:
The test method used for the lime (CaO) determinations deviates from BS 1881 : Part 124 : 2015 only in terms of the indicator used.
Core DD1-2 could not be tested for compressive strength as this core consisted of three layers 35mm, 20mm and 65mm thick. None of these layers are large enough to be tested.

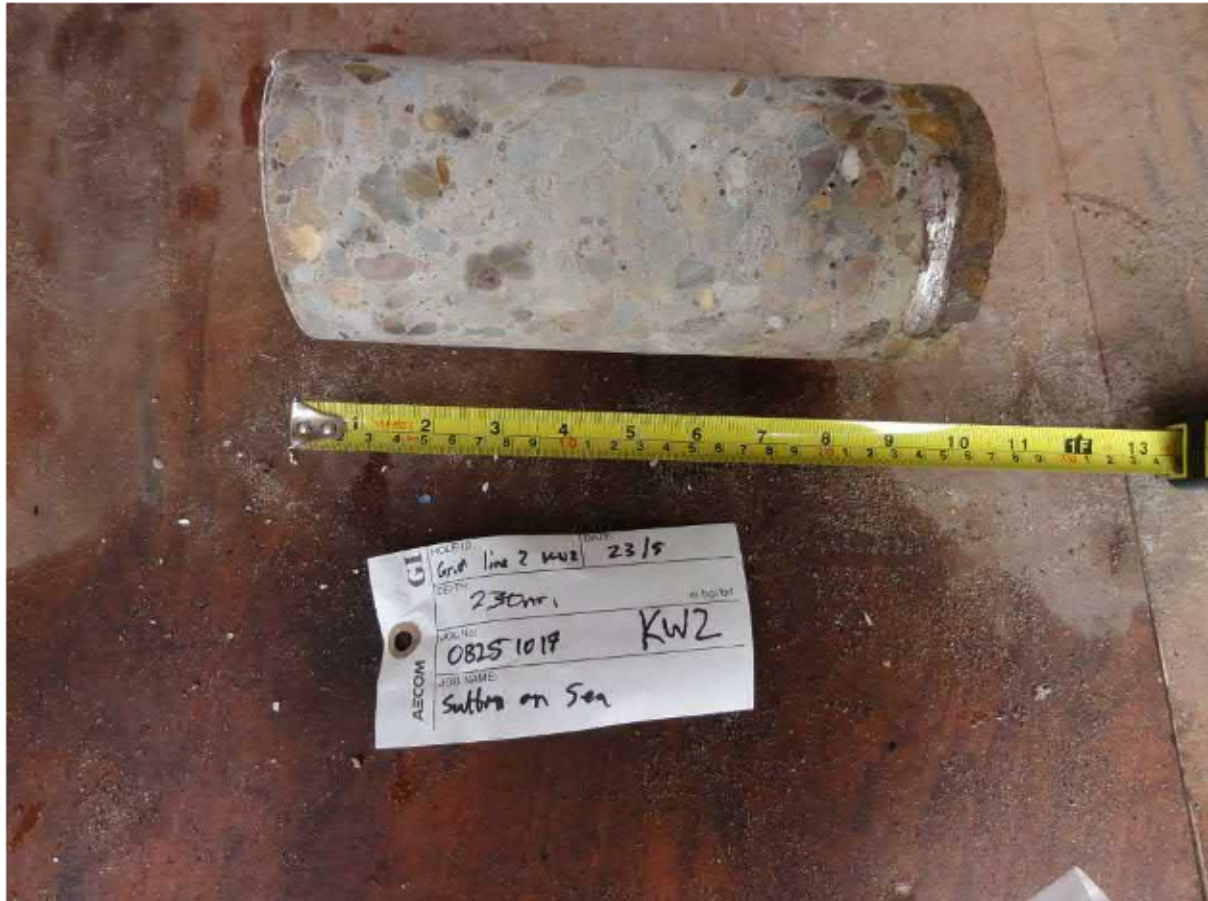
Figure 3: KW2 Gridline 2

Laboratory Ref. No.	57776.03	Max Length Received (mm)	230.0							
Client Reference	KW2 Grid Line 2	Min Length Received (mm)	220.0							
Orientation	Horizontal	Diameter (mm)	98.0							
Site Curing Condition	Average	Saturated density by displacement (Kg/m³)	2425							
Max. nom. size of agg.	14mm	Excess Voidage (%)	0.5							
Date Drilled	23.05.18	Length After Capping (mm)	102.0							
Visual inspection including abnormalities	Normal	Length Diameter Ratio	1.04							
Condition Of Storage	Water	Reinforcement								
Date Cast	N/K

Diameter ϕ	d*	0	0	0	0	0	0
Diameter ϕ	d*									
0	0									
0	0									
0	0									
Date Tested	20.06.18	* Distance of bar axis from nearest end								
Moisture condition at test	SSD	Load At Failure (kN)	450.6							
Lab. Water Curing (Days)	6	Core Strength (N/mm²)	59.7

Method of preparation	Sulphur Capping
Condition on receipt	OK
Failure type and observations	Normal
Mix details	Not Known
Deviation from standard	None

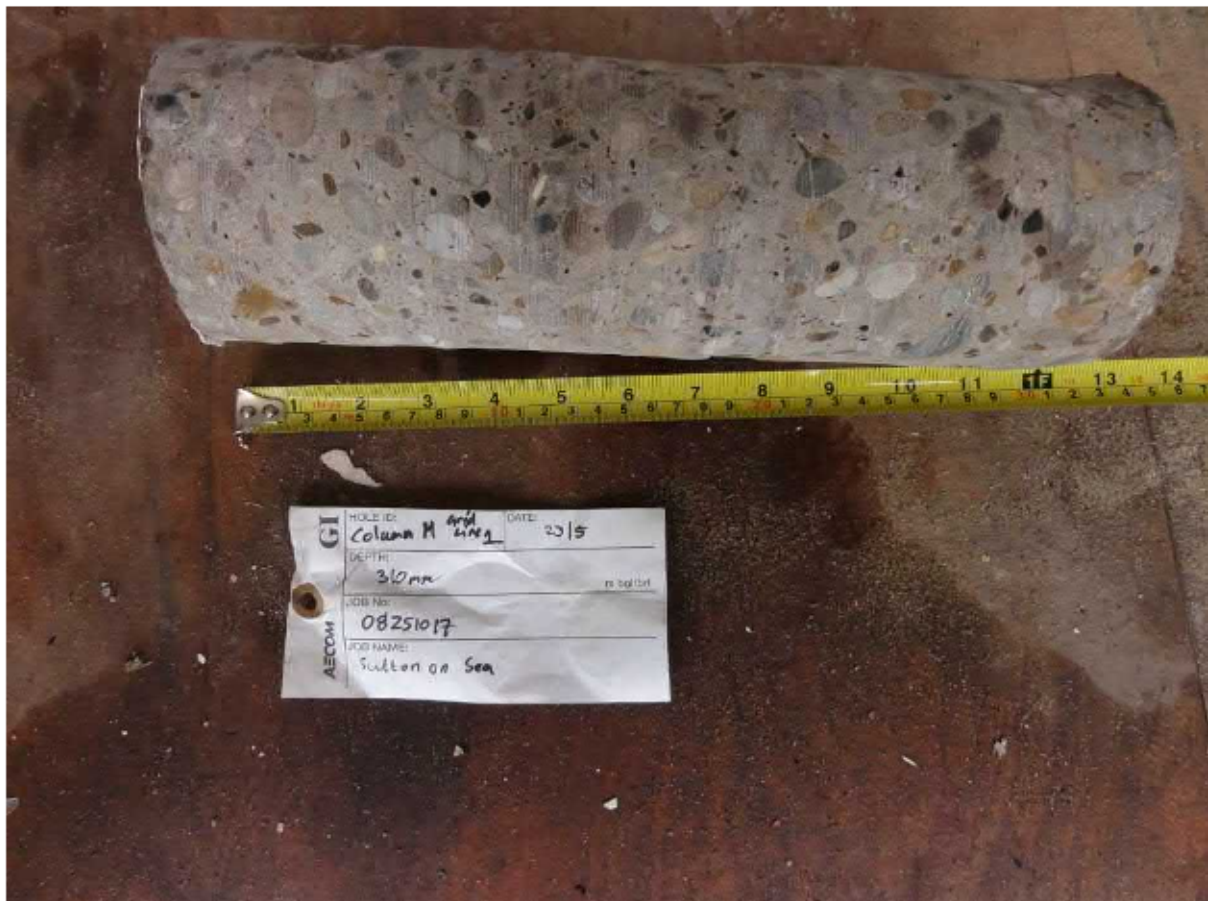
Figure 4: Column Gridline 1

Laboratory Ref. No.	57776.04	Max Length Received (mm)	310.0							
Client Reference	Col M Grid Line 1	Min Length Received (mm)	305.0							
Orientation	Horizontal	Diameter (mm)	98.0							
Site Curing Condition	Average	Saturated density by displacement (Kg/m³)	2388							
Max. nom. size of agg.	14mm	Excess Voidage (%)	1.0							
Date Drilled	23.05.18	Length After Capping (mm)	99.0							
Visual inspection including abnormalities	Normal	Length Diameter Ratio	1.01							
Condition Of Storage	Water	Reinforcement								
Date Cast	N/K

Diameter ϕ	d*	0	0	0	0	0	0
Diameter ϕ	d*									
0	0									
0	0									
0	0									
Date Tested	20.06.18	* Distance of bar axis from nearest end								
Moisture condition at test	SSD	Load At Failure (kN)	338.9							
Lab. Water Curing (Days)	6	Core Strength (N/mm²)	44.9

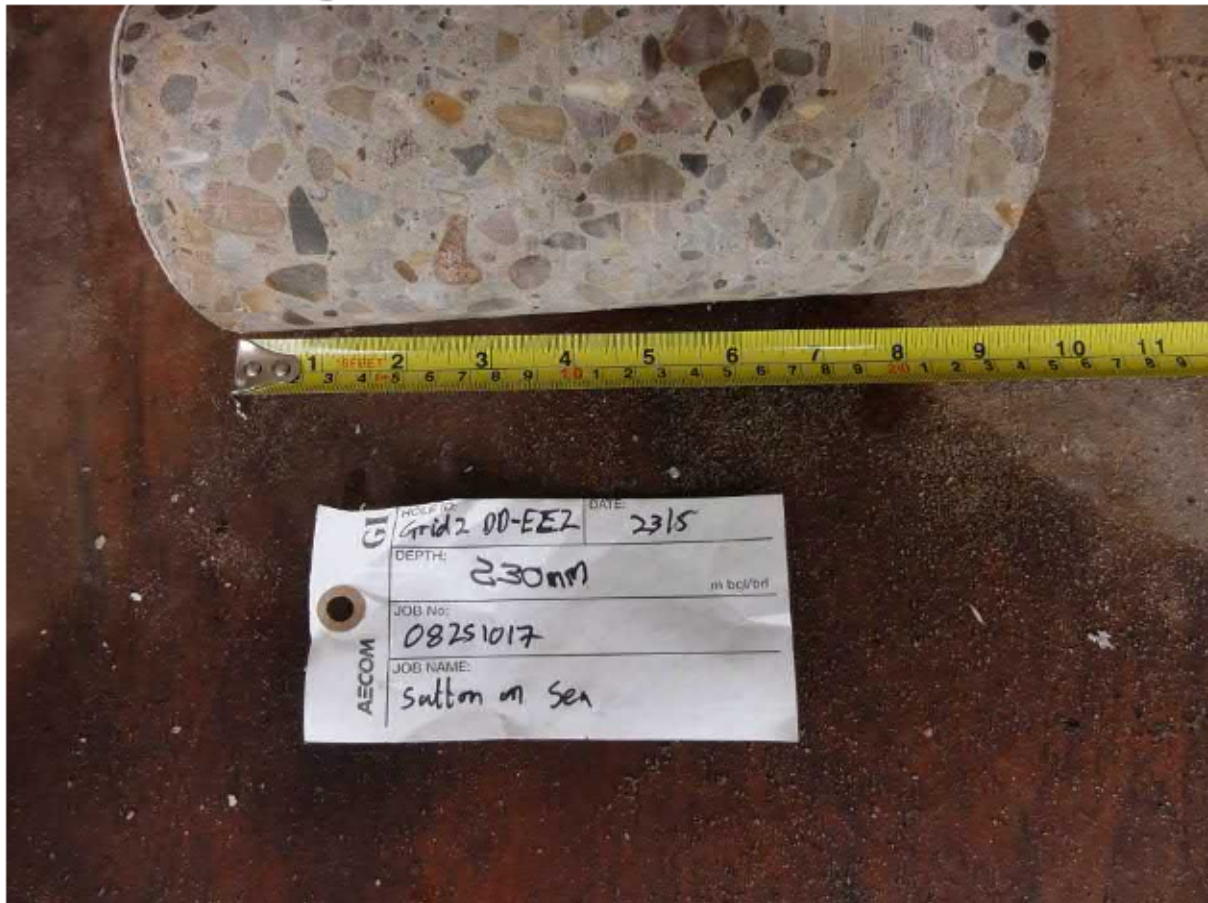
Figure 5: Grid 2 DD-EE2

Laboratory Ref. No.	57776.05	Max Length Received (mm)	225.0								
Client Reference	Grid Line DD-EE,2	Min Length Received (mm)	220.0								
Orientation	Horizontal	Diameter (mm)	99.0								
Site Curing Condition	Average	Saturated density by displacement (Kg/m3)	2362								
Max. nom. size of agg.	14mm	Excess Voidage (%)	0.5								
Date Drilled	23.05.18	Length After Capping (mm)	96.0								
Visual inspection including abnormalities	Normal	Length Diameter Ratio	0.97								
Condition Of Storage	Water	Reinforcement									
Date Cast	N/K

Diameter ϕ	d*	0	0	0	0	0	0
Diameter ϕ	d*										
0	0										
0	0										
0	0										
Date Tested	20.06.18	* Distance of bar axis from nearest end									
Moisture condition at test	SSD	Load At Failure (kN)	373.2								
Lab. Water Curing (Days)	6	Core Strength (N/mm²)	48.5

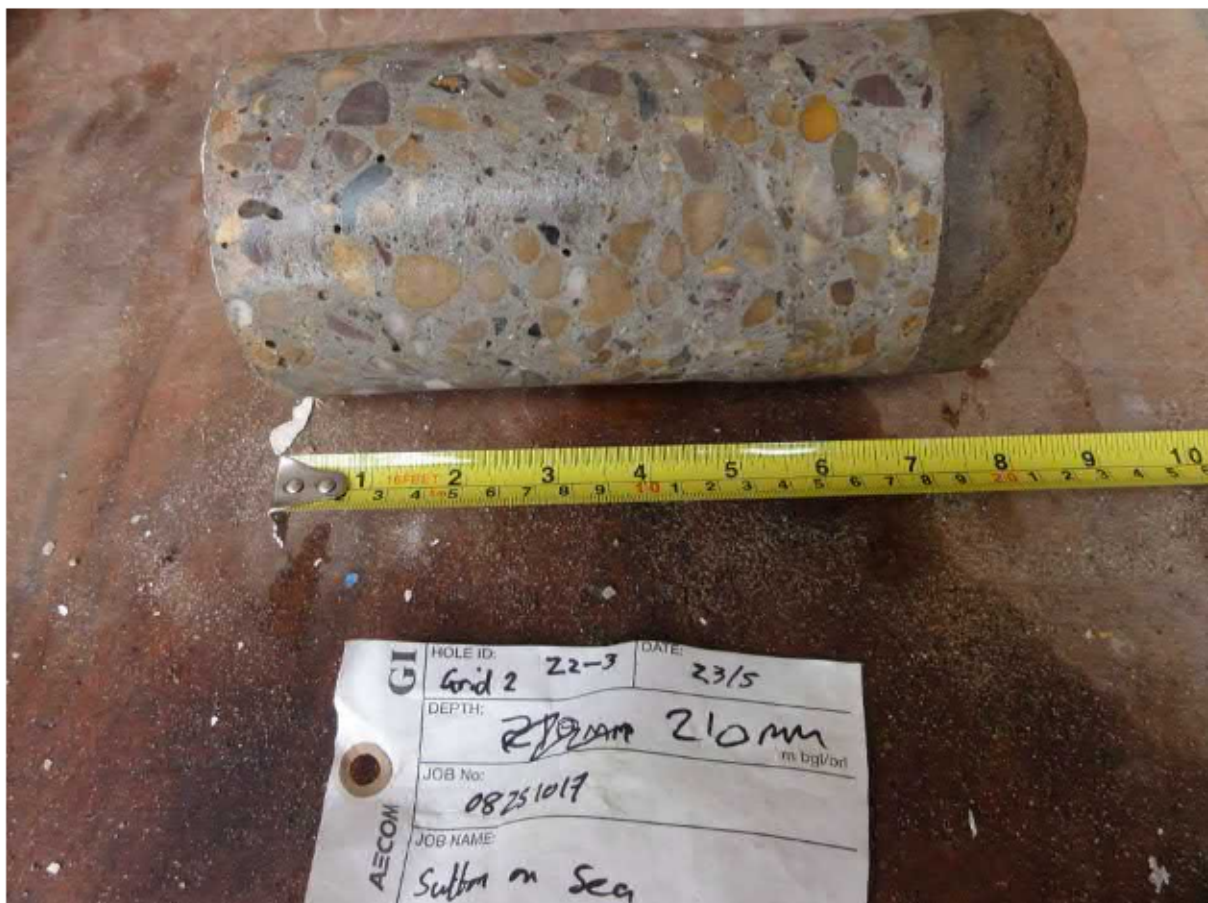
Figure 6: Grid 2 22-3

Laboratory Ref. No.	57776.07	Max Length Received (mm)	185.0								
Client Reference	GL Z,2-3 Grid Line 2	Min Length Received (mm)	185.0								
Orientation	Horizontal	Diameter (mm)	99.0								
Site Curing Condition	Average	Saturated density by displacement (Kg/m³)	2322								
Max. nom. size of agg.	10mm	Excess Voidage (%)	0.5								
Date Drilled	23.05.18	Length After Capping (mm)	103.0								
Visual inspection including abnormalities	2 pieces	Length Diameter Ratio	1.04								
Condition Of Storage	Water	Reinforcement									
Date Cast	N/K

Diameter ϕ	d*	0	0	0	0	0	0
Diameter ϕ	d*										
0	0										
0	0										
0	0										
Date Tested	20.06.18	* Distance of bar axis from nearest end									
Moisture condition at test	SSD	Load At Failure (kN)	362.9								
Lab. Water Curing (Days)	6	Core Strength (N/mm²)	47.1

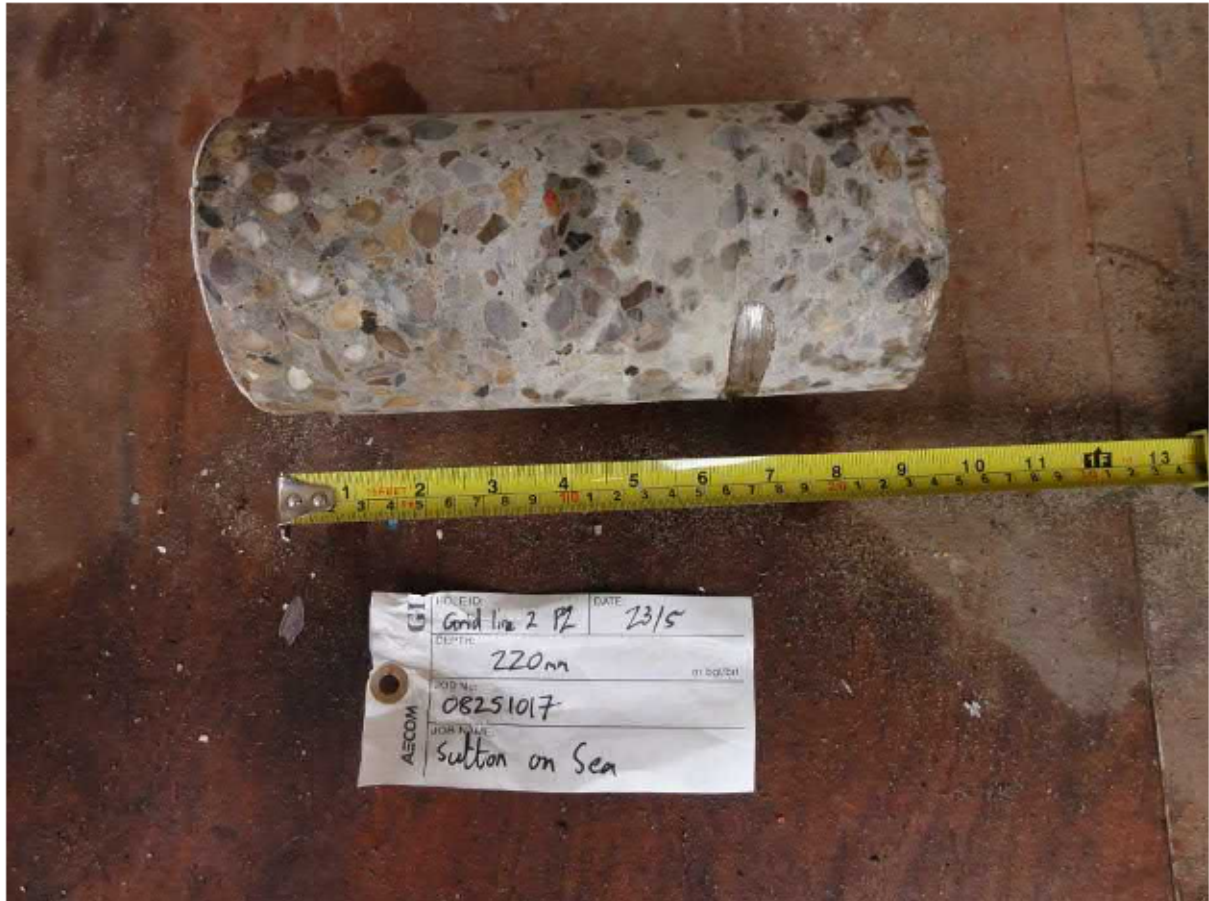
Figure 7: Gridline 2 P2

Laboratory Ref. No.	57776.06	Max Length Received (mm)	220.0							
Client Reference	Grid Line P2 Grid Line 2	Min Length Received (mm)	220.0							
Orientation	Horizontal	Diameter (mm)	99.0							
Site Curing Condition	Average	Saturated density by displacement (Kg/m³)	2377							
Max. nom. size of agg.	10mm	Excess Voidage (%)	1.0							
Date Drilled	23.05.18	Length After Capping (mm)	99.0							
Visual inspection including abnormalities	Normal	Length Diameter Ratio	1.00							
Condition Of Storage	Water	Reinforcement								
Date Cast	N/K

Diameter ϕ	d*	0	0	0	0	0	0
Diameter ϕ	d*									
0	0									
0	0									
0	0									
Date Tested	20.06.18	* Distance of bar axis from nearest end								
Moisture condition at test	SSD	Load At Failure (kN)	483.7							
Lab. Water Curing (Days)	6	Core Strength (N/mm²)	62.8

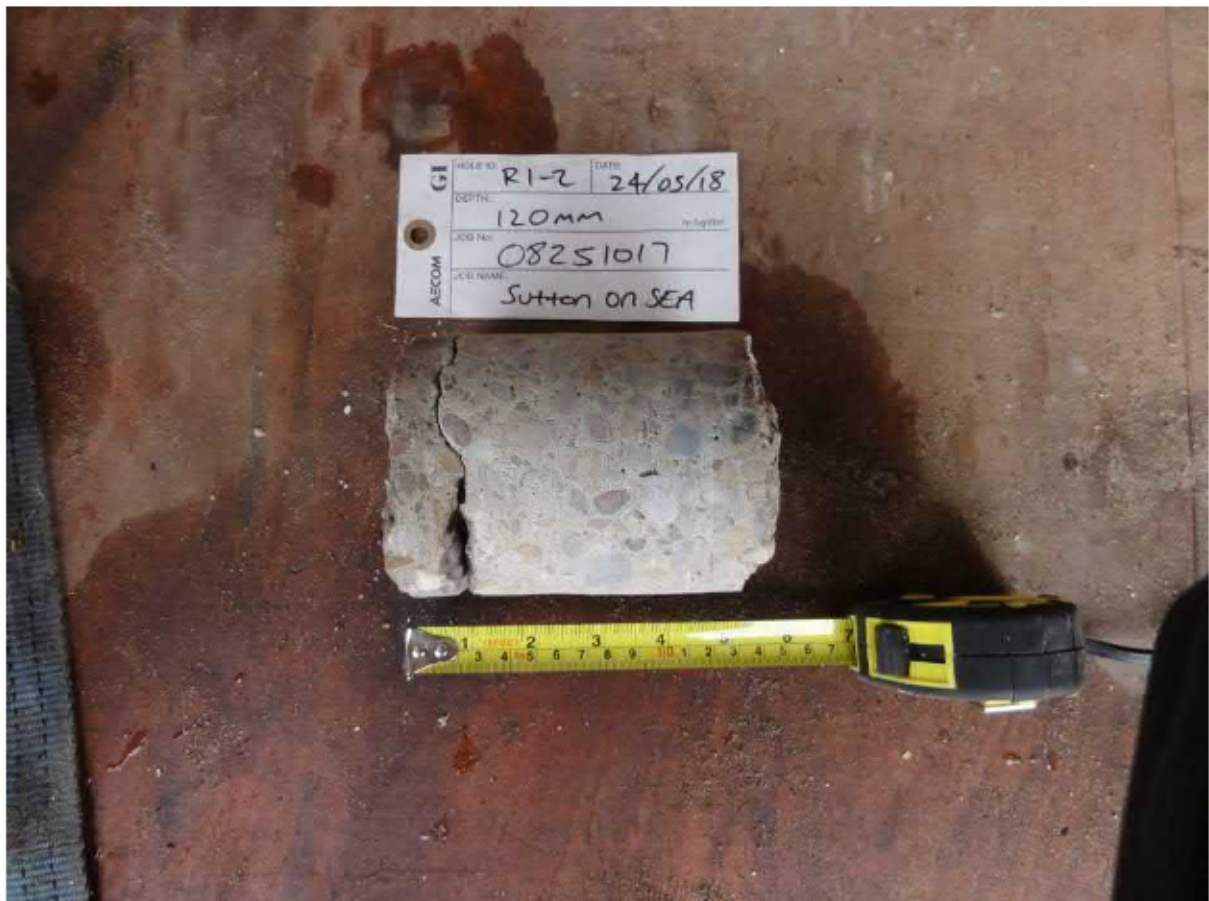
Figure 8: R1-2

Laboratory Ref. No.	57776.08	Max Length Received (mm)	110.0							
Client Reference	Grid Line R,1-2	Min Length Received (mm)	90.0							
Orientation	Vertical	Diameter (mm)	93.5							
Site Curing Condition	Average	Saturated density by displacement (Kg/m³)	2403							
Max. nom. size of agg.	14mm	Excess Voidage (%)	0.5							
Date Drilled	24.05.18	Length After Capping (mm)	73.0							
Visual inspection including abnormalities	2 pieces - short sample	Length Diameter Ratio	0.78							
Condition Of Storage	Water	Reinforcement								
Date Cast	N/K

Diameter ϕ	d*	0	0	0	0	0	0
Diameter ϕ	d*									
0	0									
0	0									
0	0									
Date Tested	20.06.18	* Distance of bar axis from nearest end								
Moisture condition at test	SSD	Load At Failure (kN)	371.1							
Lab. Water Curing (Days)	6	Core Strength (N/mm²)	54.0

Method of preparation	Sulphur Capping
Condition on receipt	OK
Failure type and observations	Normal
Mix details	Not Known
Deviation from standard	Short Core

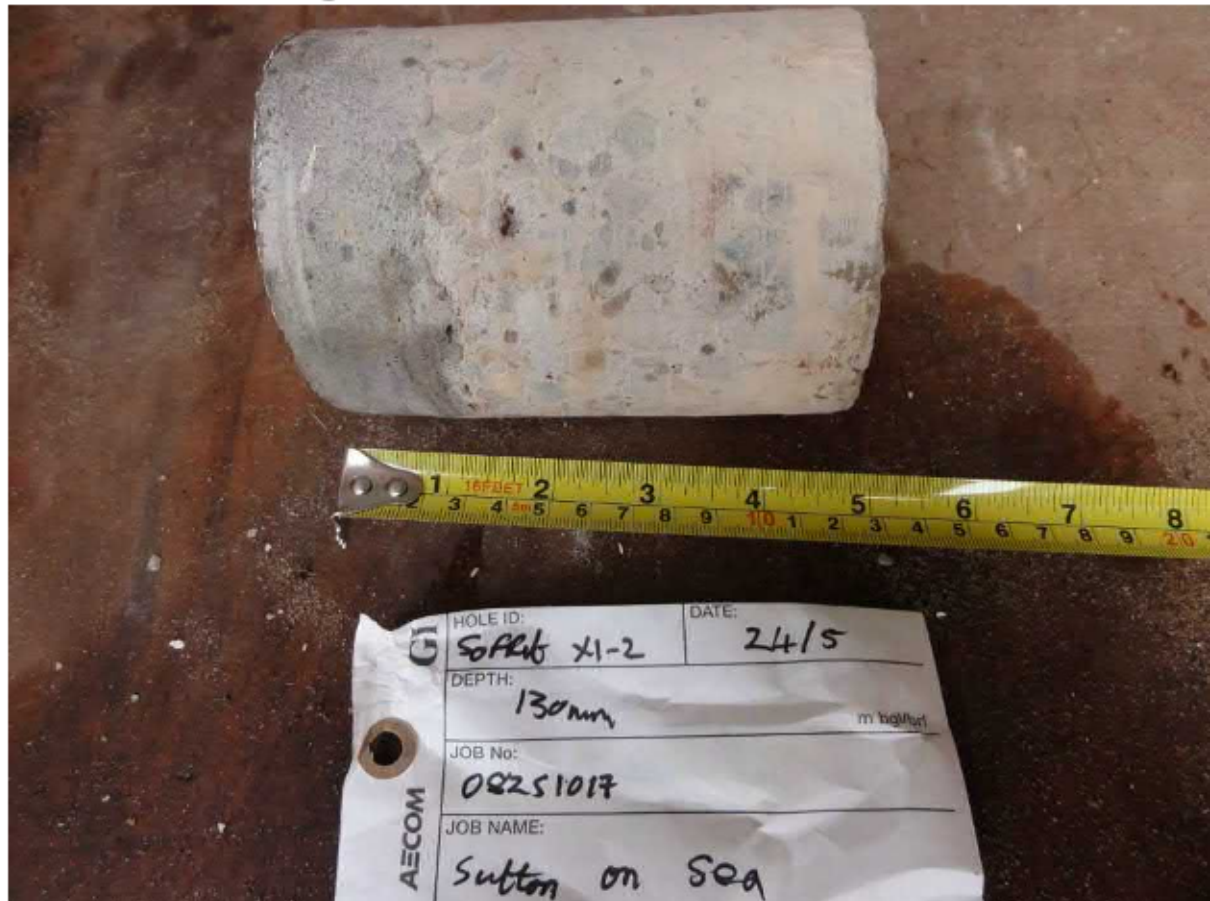
Figure 9: X1-2

Laboratory Ref. No.	57776.09	Max Length Received (mm)	105.0							
Client Reference	Grid Line X,1-2	Min Length Received (mm)	90.0							
Orientation	Vertical	Diameter (mm)	93.5							
Site Curing Condition	Average	Saturated density by displacement (Kg/m³)	2357							
Max. nom. size of agg.	10mm	Excess Voidage (%)	0.5							
Date Drilled	24.05.18	Length After Capping (mm)	86.0							
Visual inspection including abnormalities	Normal	Length Diameter Ratio	0.92							
Condition Of Storage	Water	Reinforcement								
Date Cast	N/K

Diameter ϕ	d*	0	0	0	0	0	0
Diameter ϕ	d*									
0	0									
0	0									
0	0									
Date Tested	20.06.18	* Distance of bar axis from nearest end								
Moisture condition at test	SSD	Load At Failure (kN)	225							
Lab. Water Curing (Days)	6	Core Strength (N/mm²)	32.8
